Town of Seabrook Island  
Comprehensive Beach Management Plan

Initial "Beachfront Management Plan" Adopted by the Town of Seabrook Island  
November 19, 1992  
Updated December 16, 2014  
This Version Adopted by the Town of Seabrook Island  
**December XX, 2019**

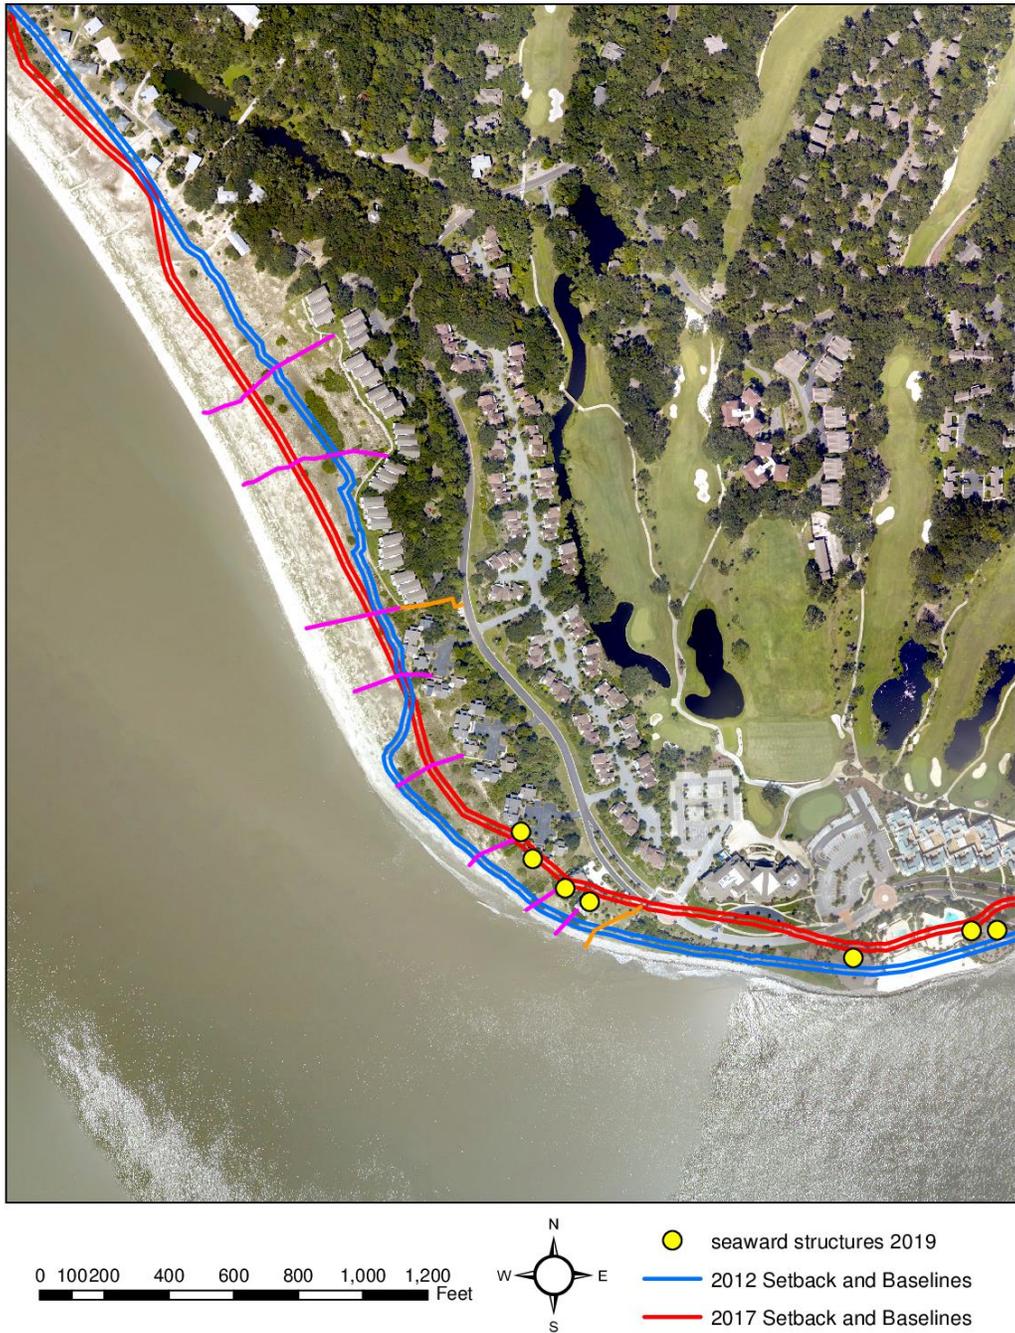
**FIGURE 2.3.1 (a)** West Seabrook Island Beach accesses and structures seaward of the Setback Line

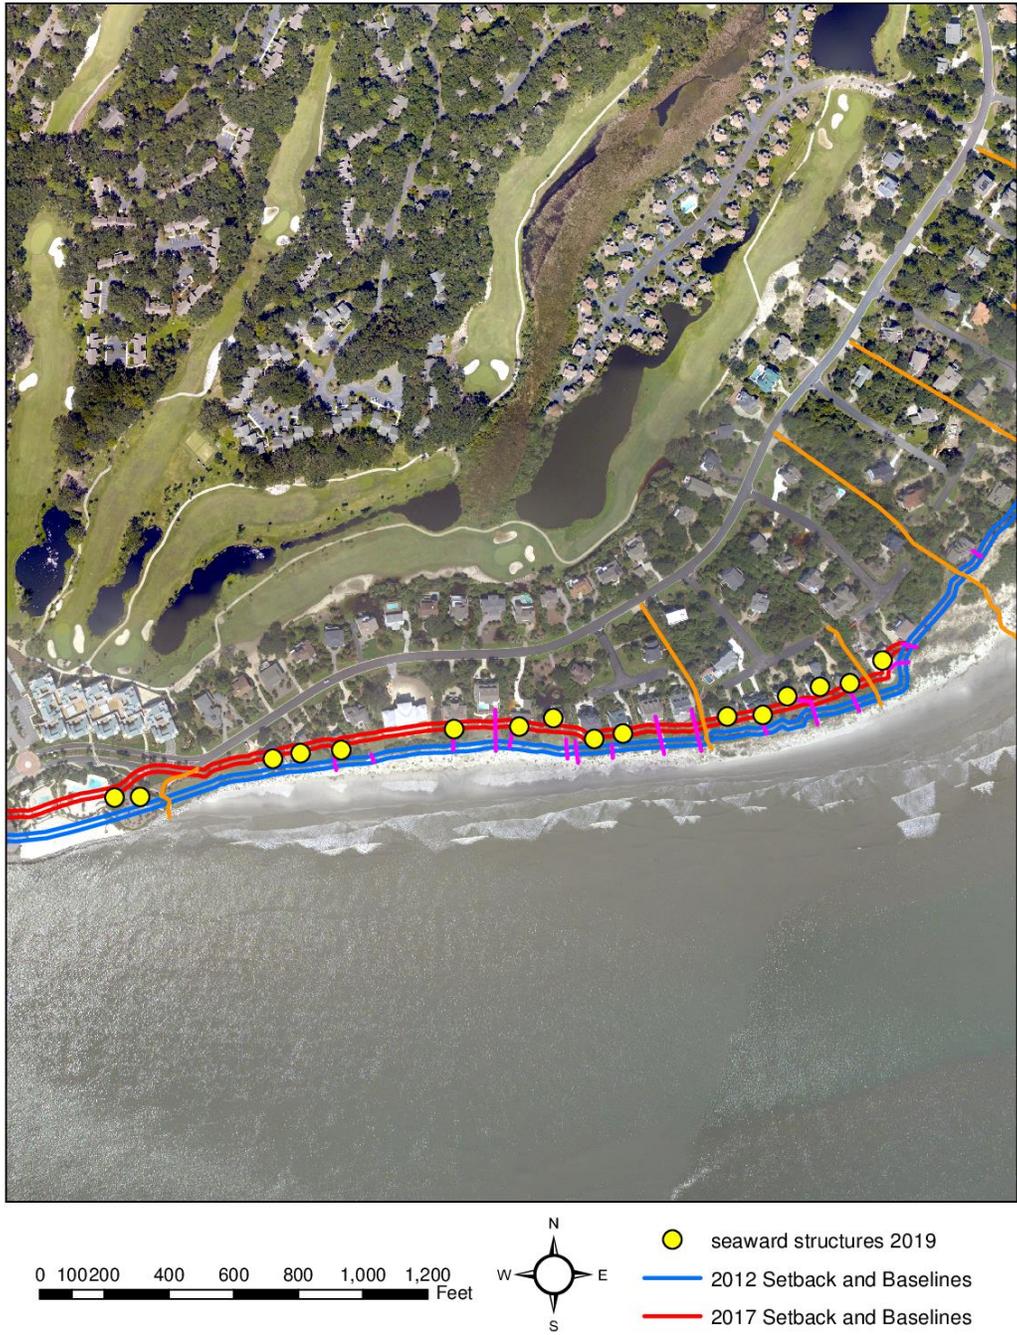
**FIGURE 2.3.1 (b)** South Beach Seabrook Island beach accesses and structures seaward of the Setback Line

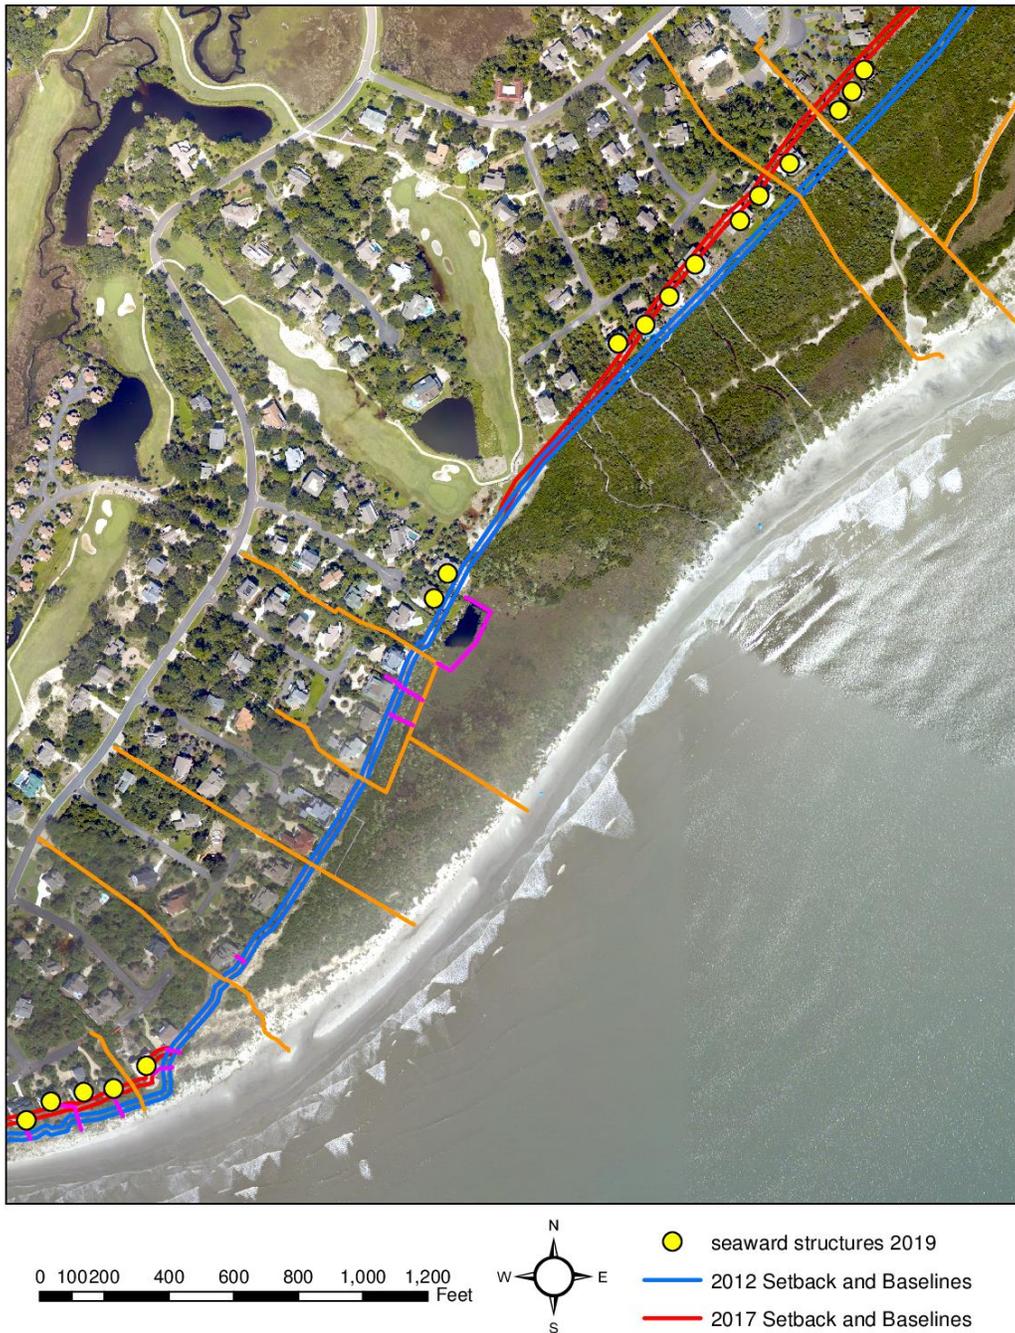
**FIGURE 2.3.1 (c)** Boardwalk #5 or Renken Point to Boardwalk #1b or North Beach Seabrook Island beach accesses and structures seaward of the Setback Line

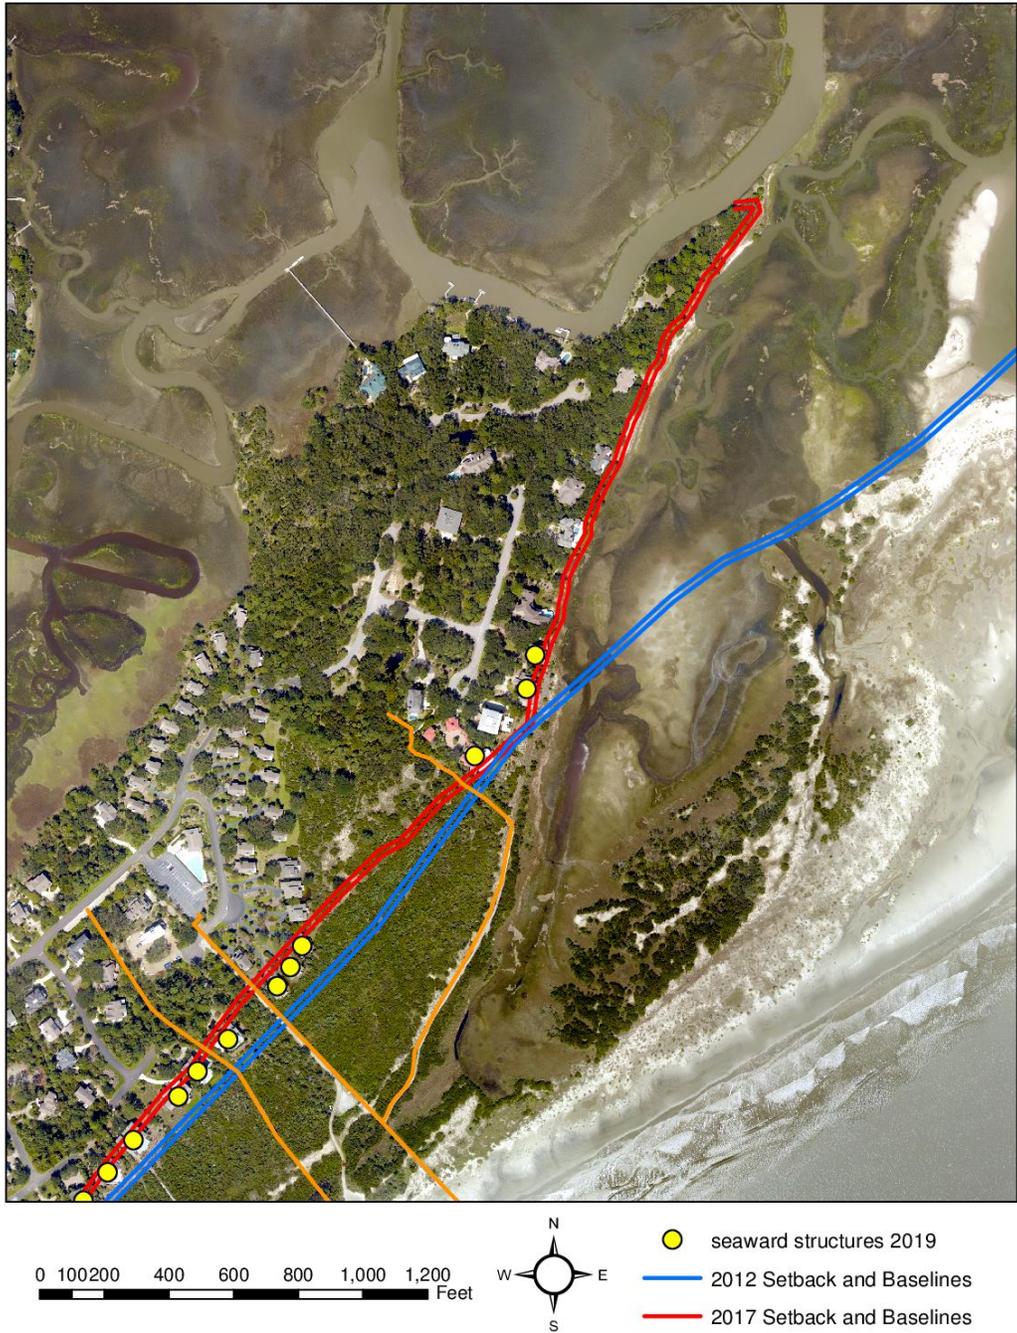
**FIGURE 2.3.1 (d)** Boardwalk #1 to Capt Sams Inlet or North Beach Seabrook Island beach accesses and structures seaward of the Setback Line

Figure 2.3.1 (d) shows northeast end of the Island’s beach from Boardwalk # 1b to Capt. Sams Inlet or North Beach.

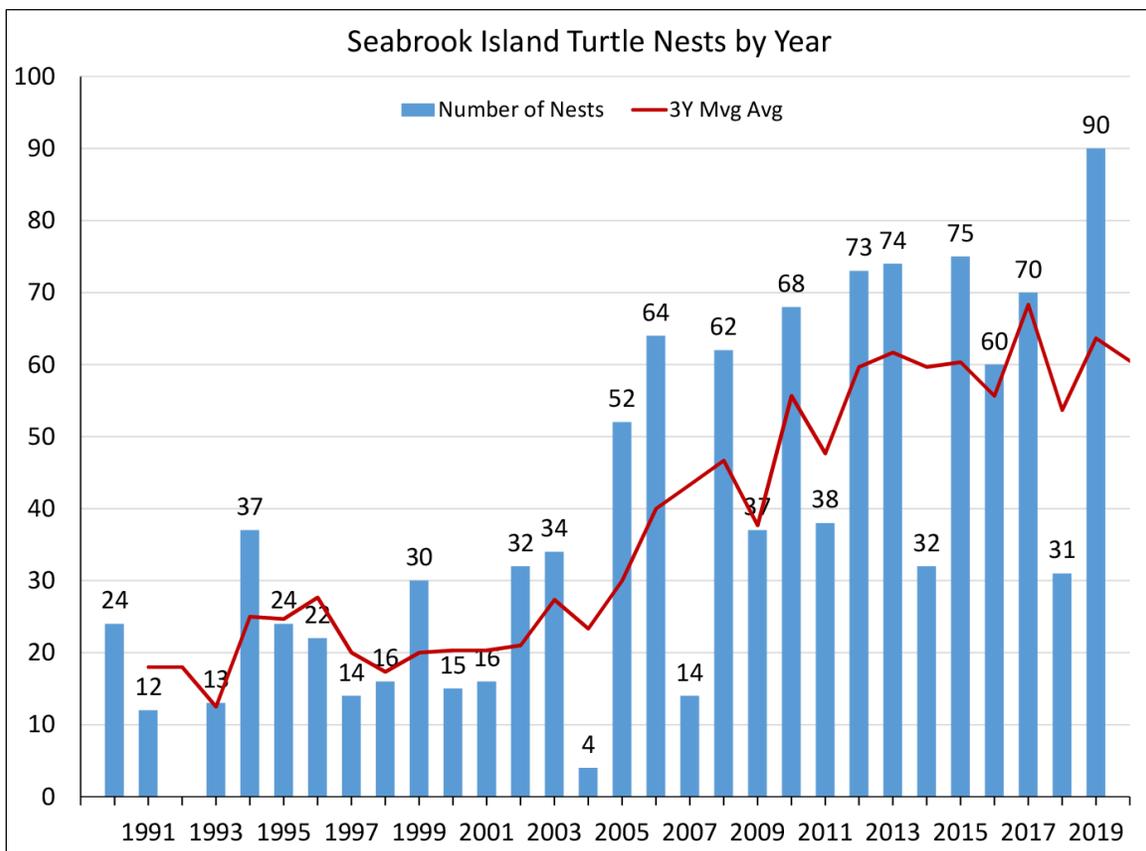
**FIGURE 2.4.2a.** Sea turtle nest counts, Seabrook Island, 1990 to 2019. Nest counts have steadily increased over the past ~30 years, likely because of the efforts of local and state-wide organizations to promote conservation and efforts such as lights-off ordinances designed to protect endangered turtle species.

Table 2.4.2a and Figure 2.4.2a depict trends and statistics for the Seabrook Island sea turtle nests. Rates of hatch success typically fall around 65-75%, although in 2014 there was an abnormally high rate of success. This may be related to the relatively small number of nests inventoried that year (32, in most years somewhere around 60 or 70 nests). Additionally, the number of nests inventoried by the patrol has increased steadily in the Turtle Patrol’s foundation in 1990 (Figure 2.4.2). The 3-year moving average, shown as a red curve in Figure 2.4.2a, confirms total nest counts have increased from around 15-20 per year in the 1990s to ~60 per year during the 2010s. The most recent year (2019) saw the highest number of nests to date (90), which parallels record nest numbers throughout South Carolina and neighboring states.

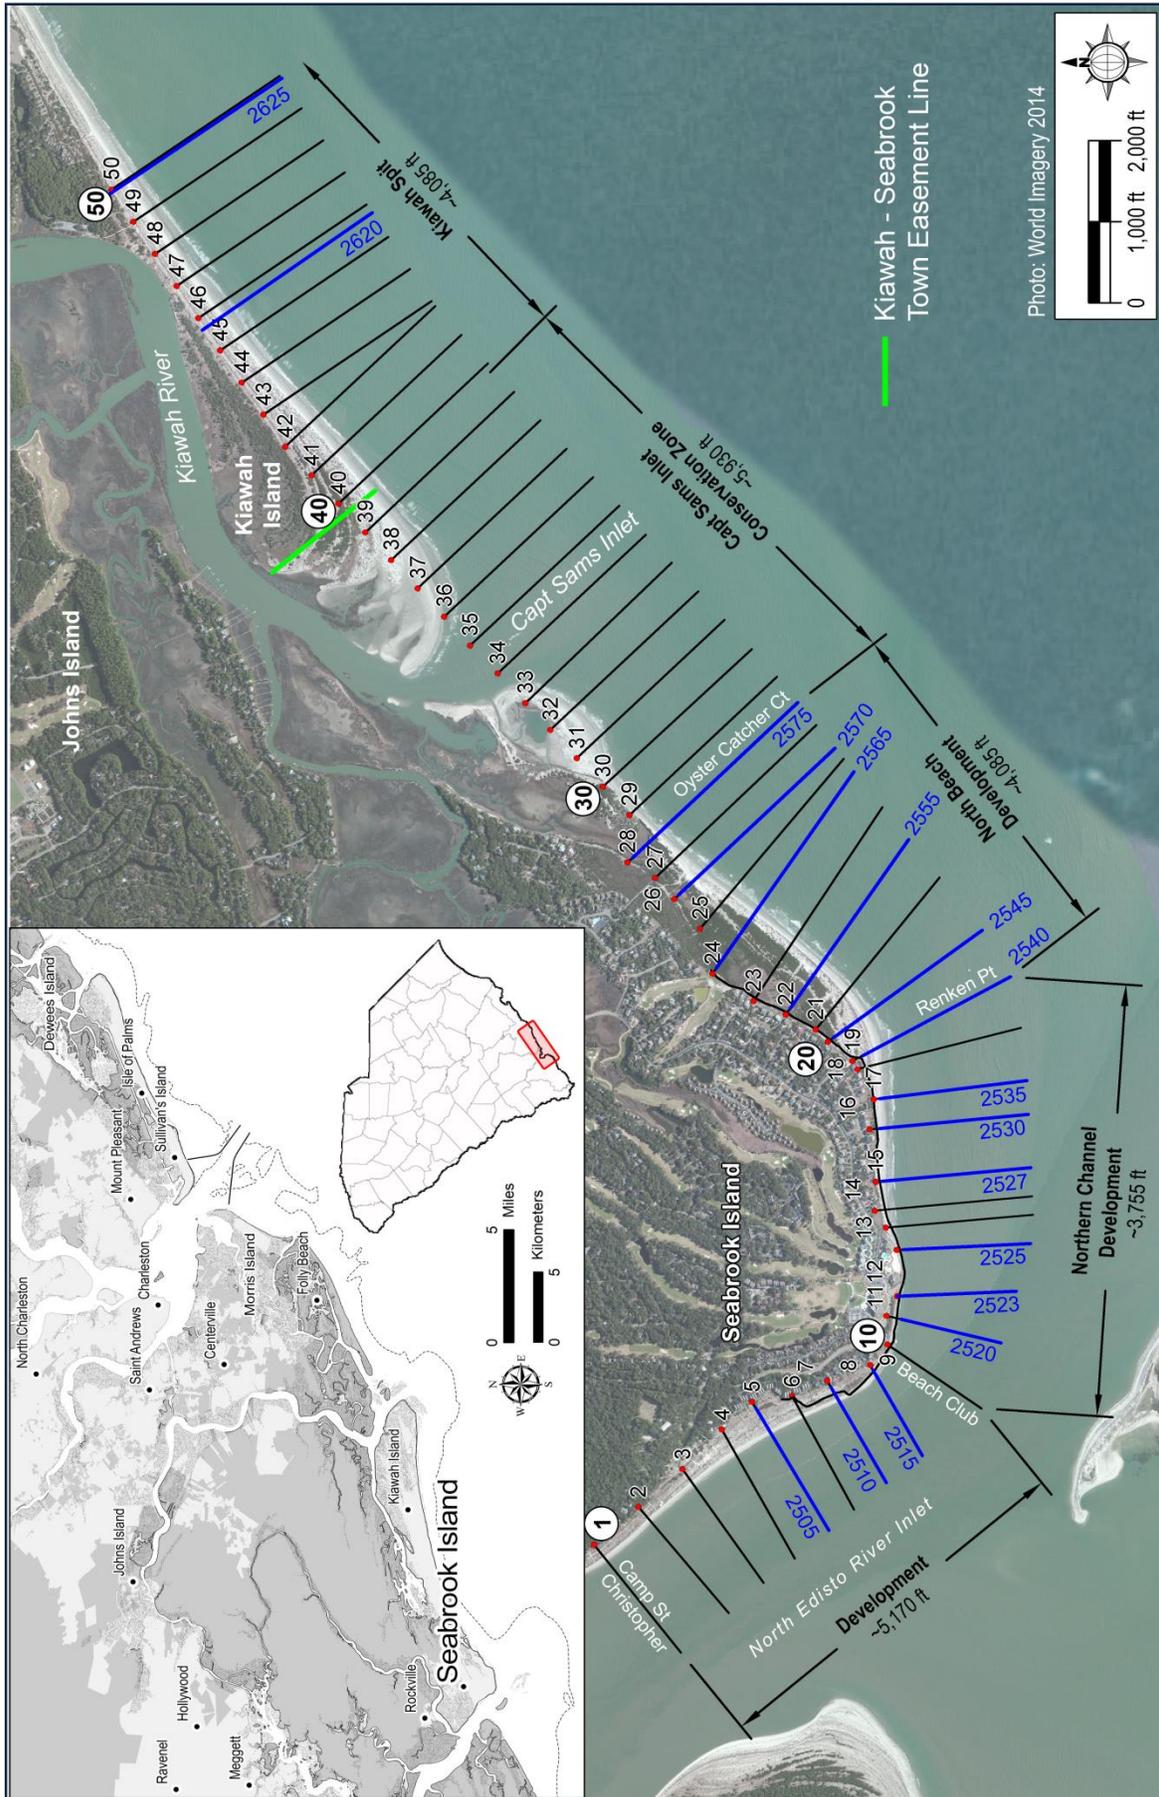
**FIGURE 5.1a** Seabrook Island showing the major features along the coast. Approximately one-third of the shoreline is the Captain Sams Inlet conservation zone over which the inlet has migrated during the past ~50 years.

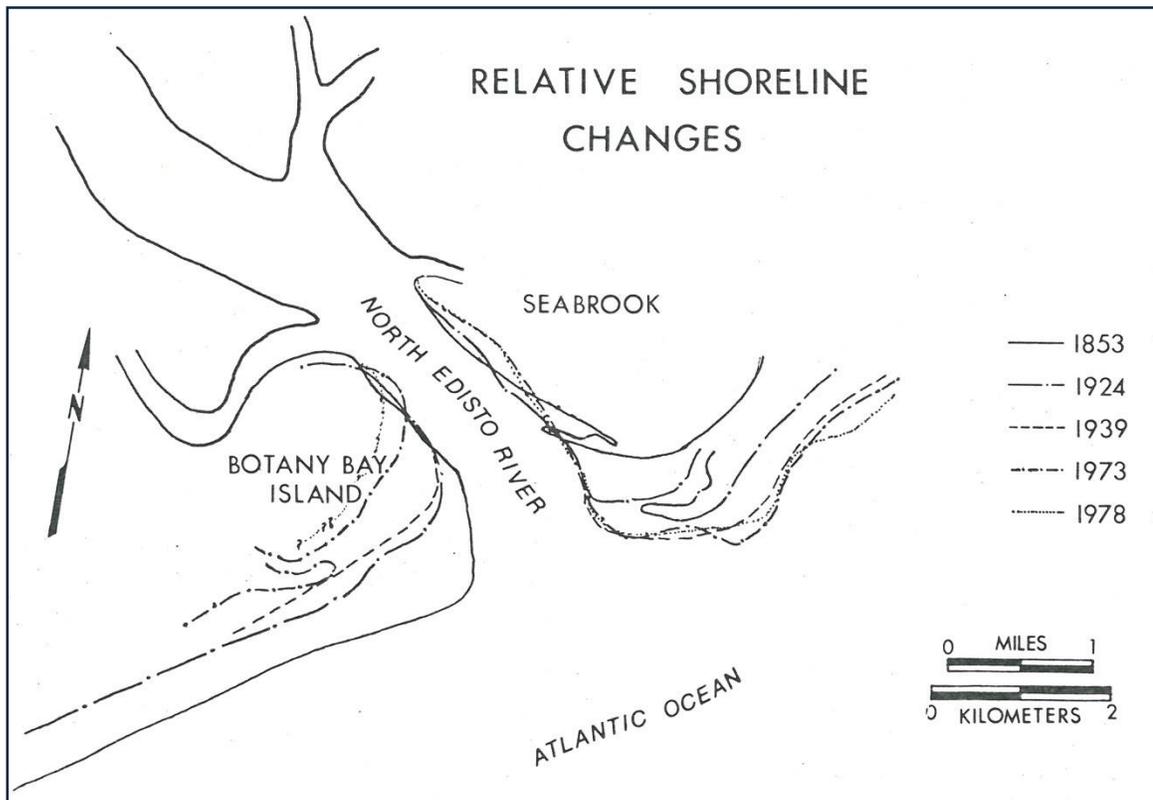
**FIGURE 5.1a** Sketch of historical shorelines at North Edisto River Inlet (from Hayes et al 1979).

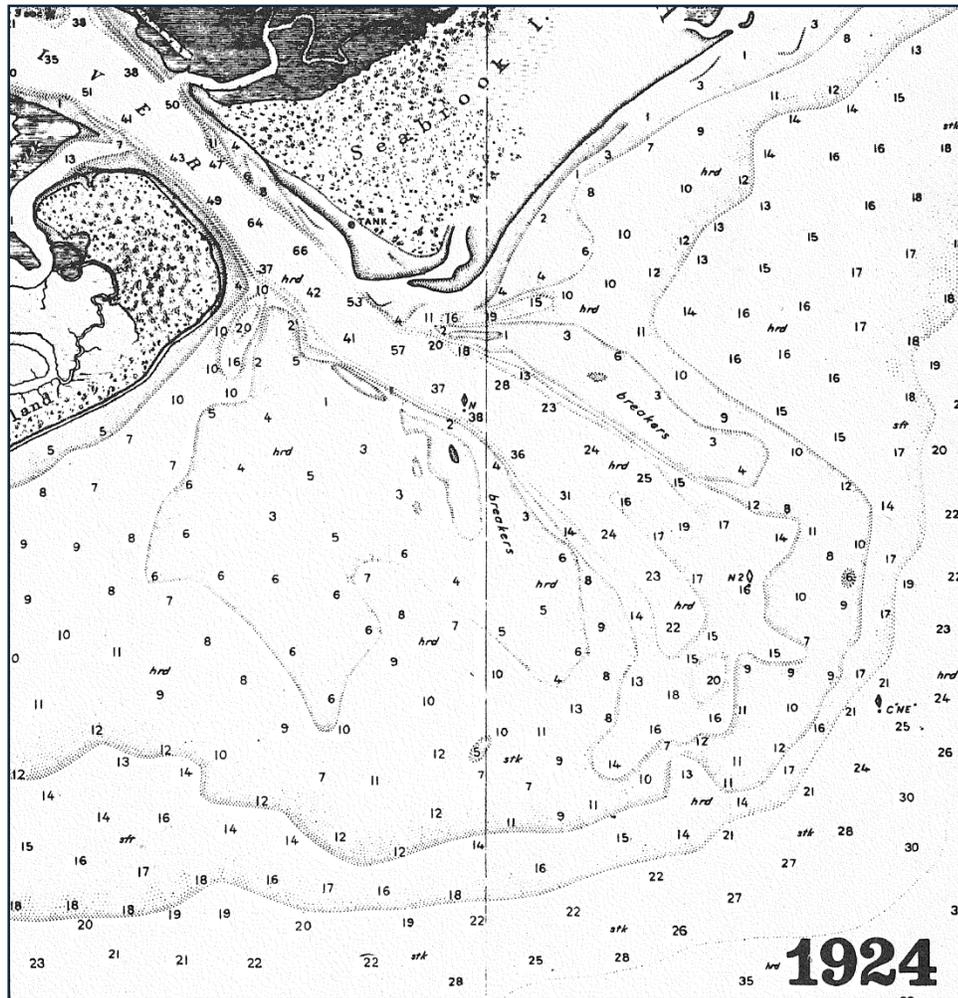
**FIGURE 5.1b** Section of USCGS (now NOAA-NOS) chart of Seabrook Island prepared in 1924. Note two small inlets discharging at either end of Seabrook Island prior to any development. [From Hayes et al 1979]

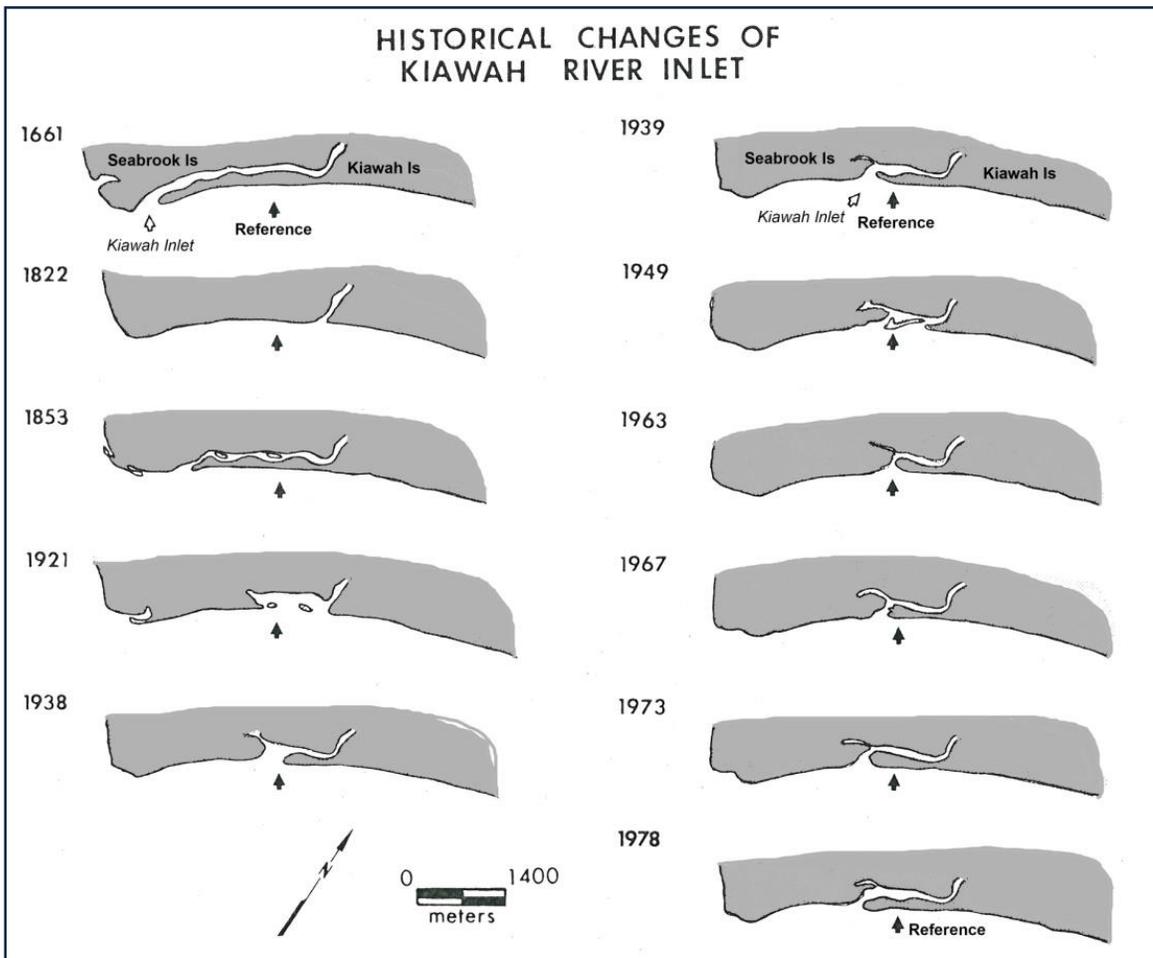
**FIGURE 5.1c** Sketch of Seabrook Island shorelines showing various locations of Captain Sams Inlet (aka Kiawah River Inlet). [From Hayes et al 1979]

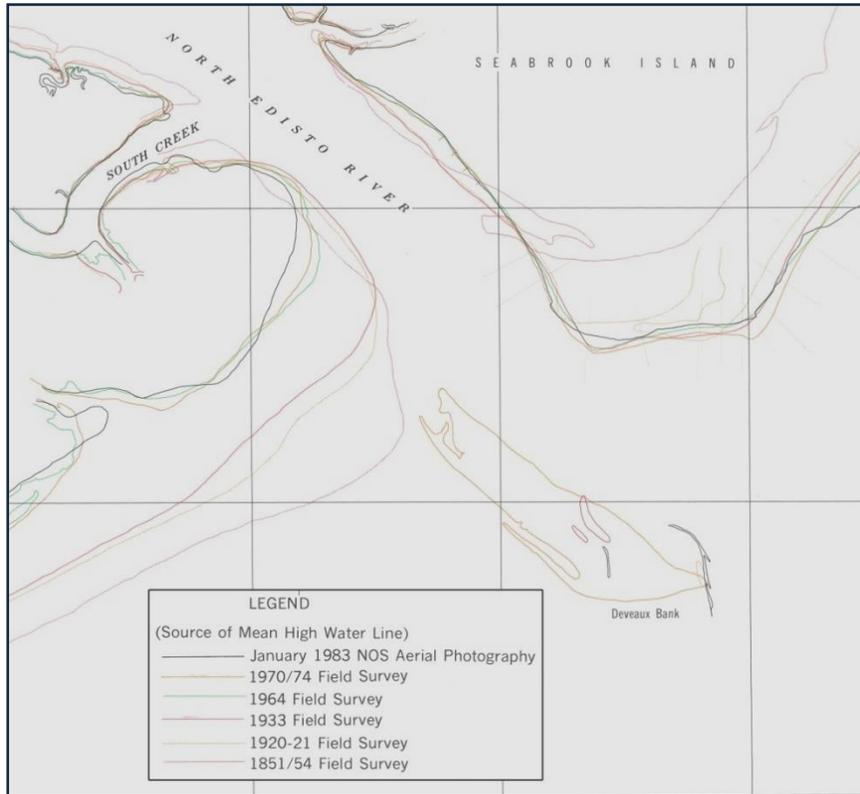
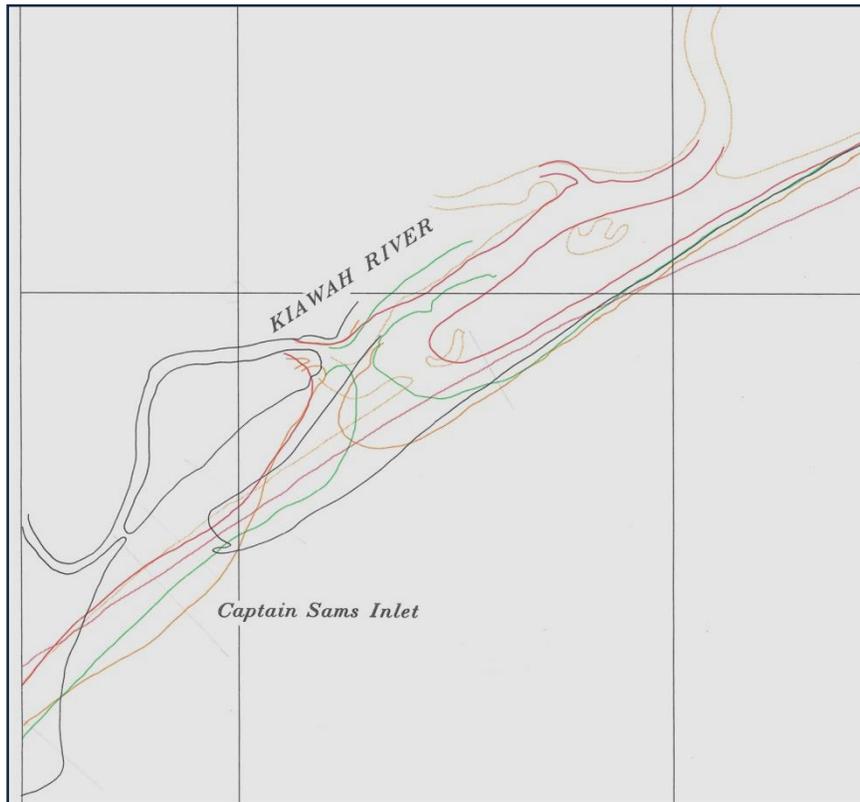
**FIGURE 5.1d** Official historical shorelines developed by NOAA–NOS Cooperative Shoreline Study (1983) for the Seabrook Island area.

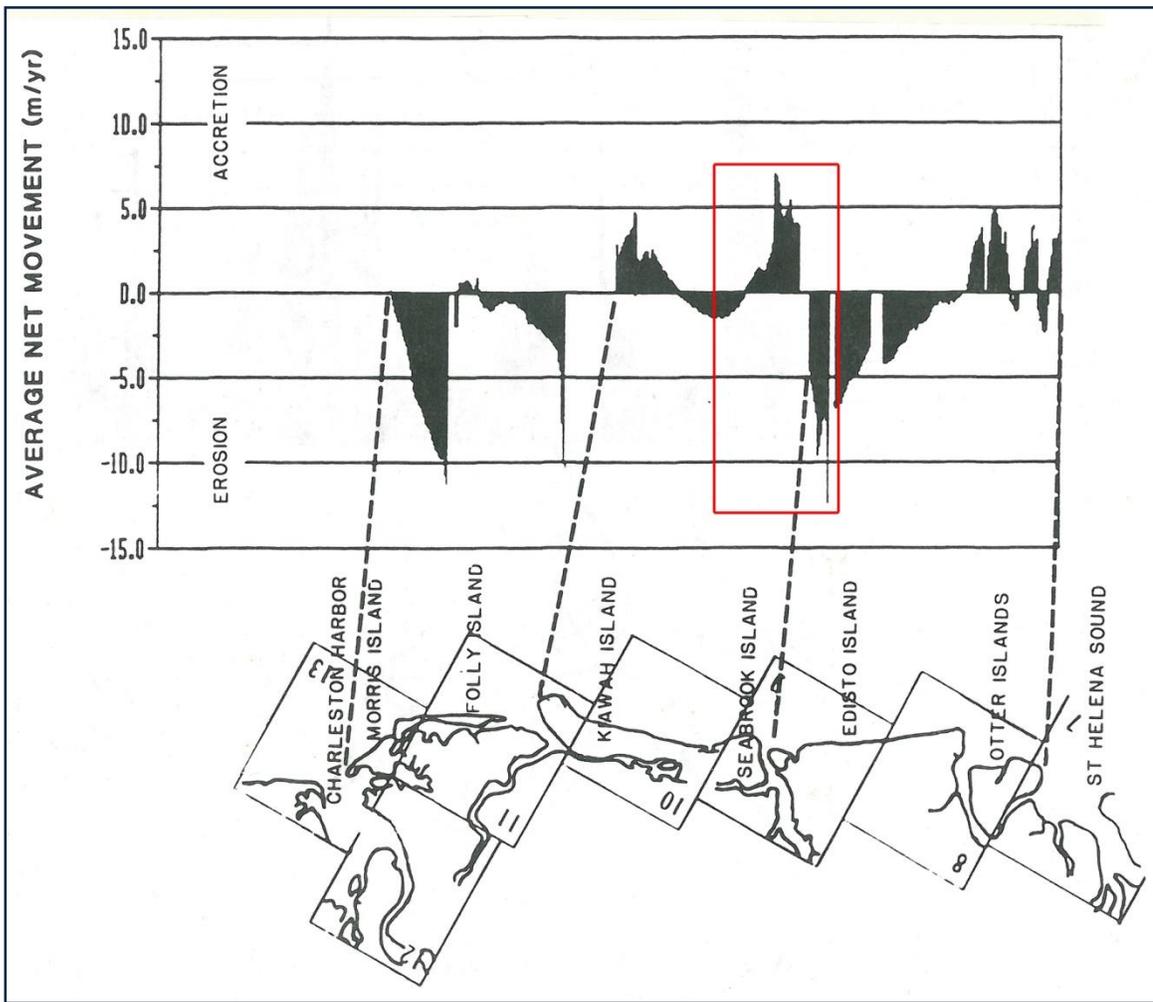
**FIGURE 5.1e** Average net shoreline movement along the central South Carolina coast for the period 1851–1983. [From Anders et al 1990, Fig 27]

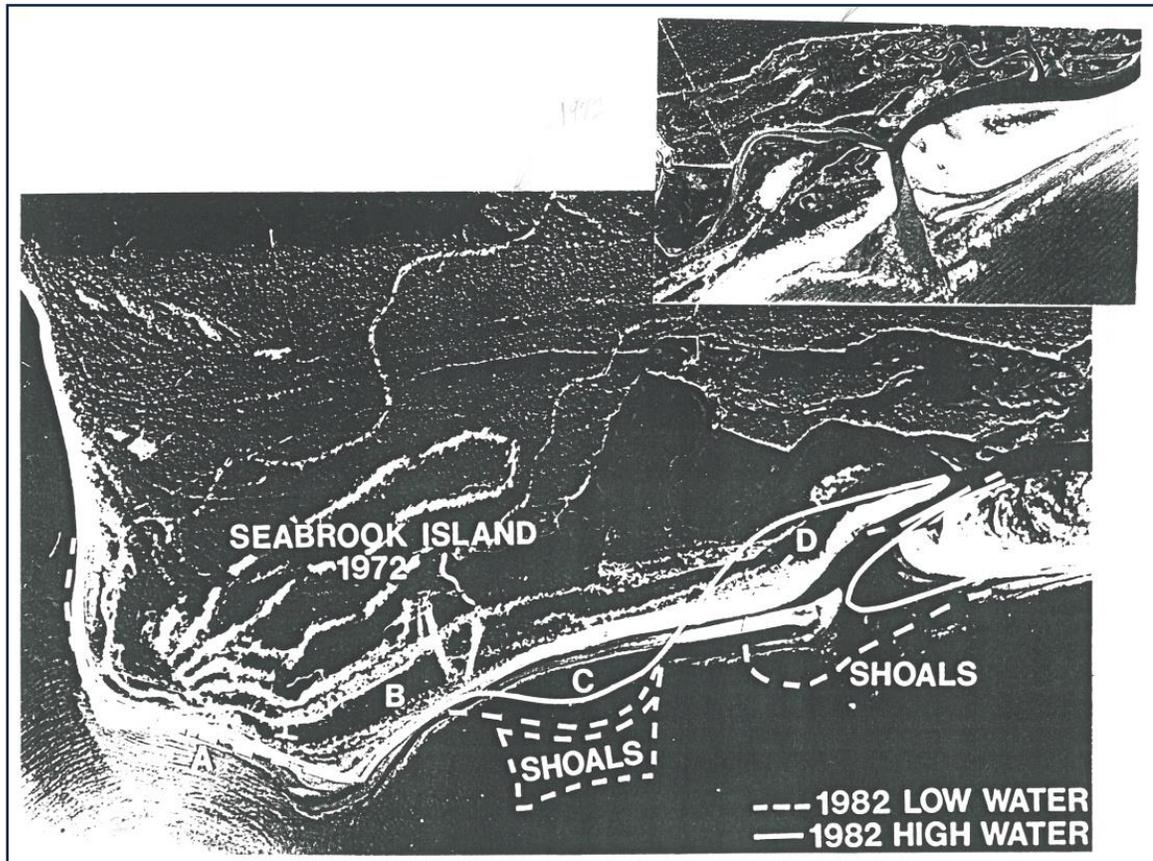
**FIGURE 5.1f** Seabrook Island in 1972 with the 1982 shoreline superimposed. Reaches A, B, C, and D are referenced in the text. The shoreline morphology becomes increasingly irregular as Captain Sams Inlet (Reach D) migrates toward North Edisto River Inlet (Reach A and left margin of the image). The inset photo shows Captain Sams inlet in 1963. [After Kana 1989]

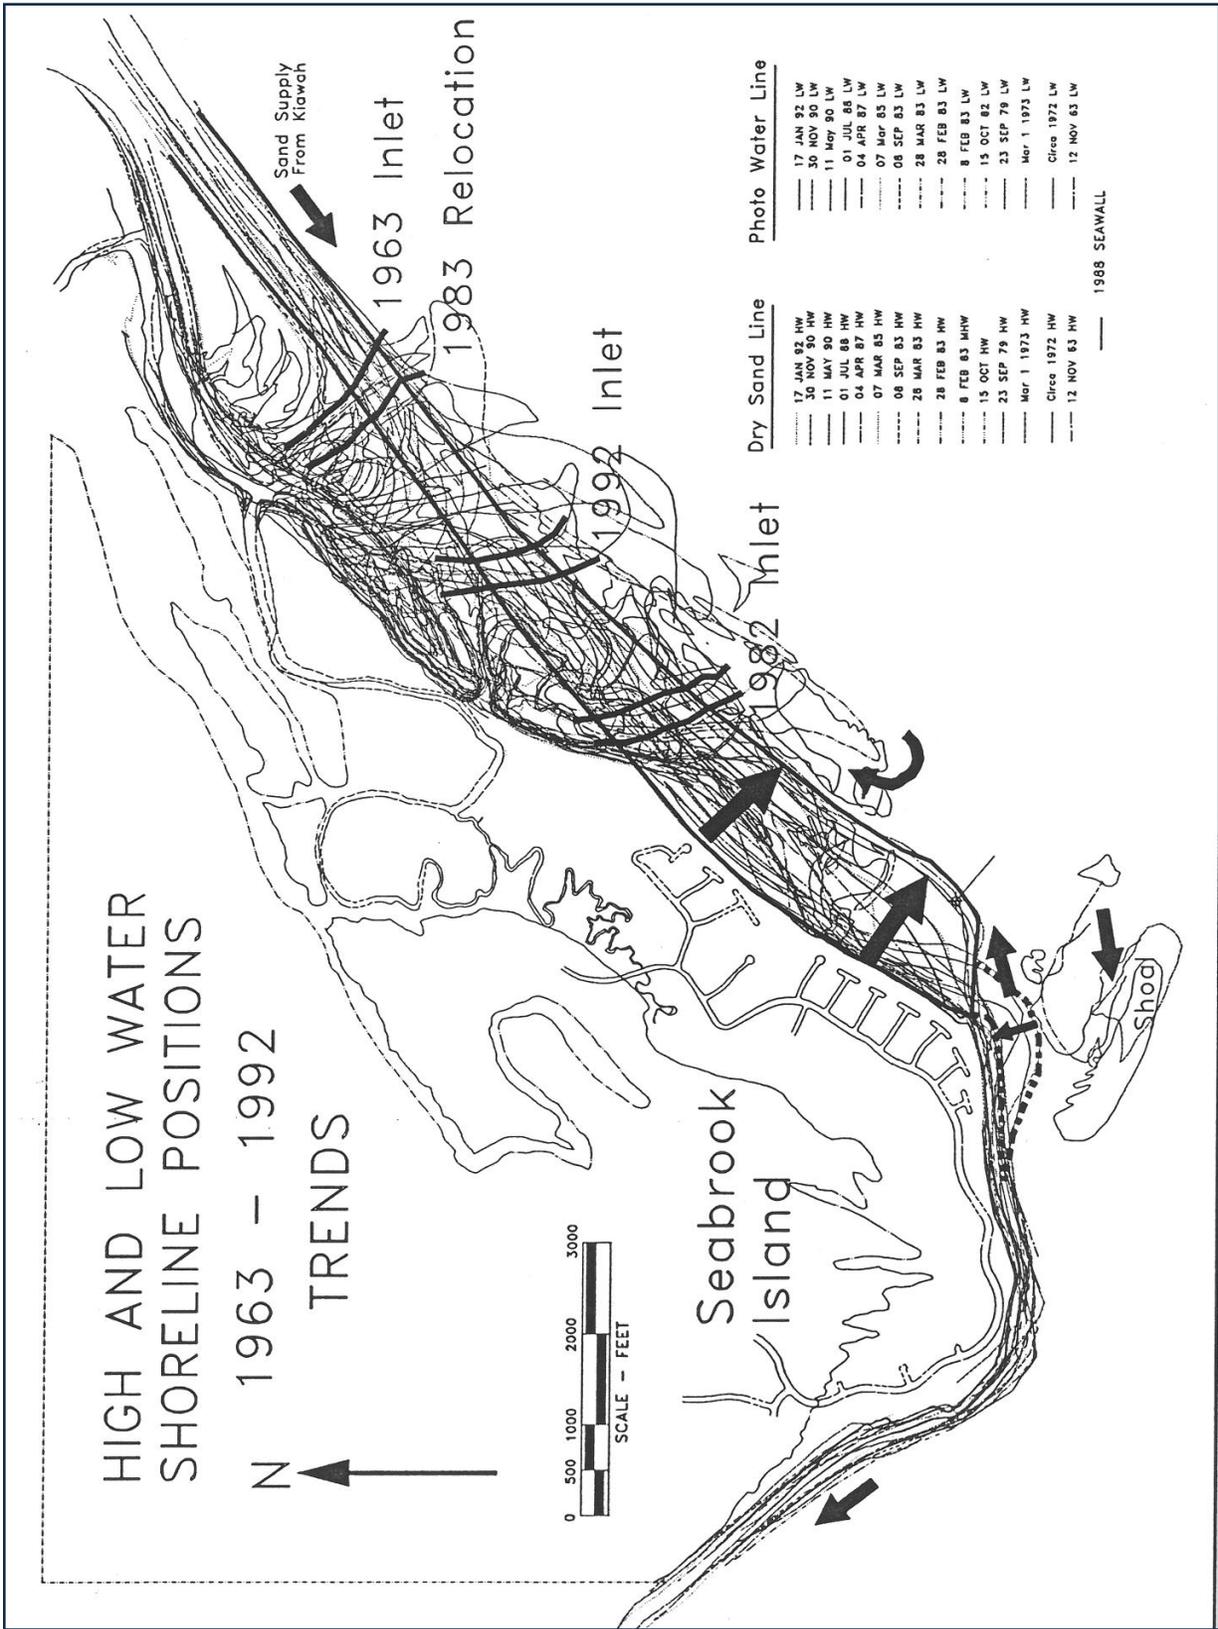
**FIGURE 5.1g** High and low water shoreline positions along Seabrook Island between November 1963 and January 1992. Bold lines and arrows highlight trend of accretion along North Beach and erosion at Renken Point. Positions of Captain Sams Inlet at various times are highlighted. [After Kana and Andrassy 1993]

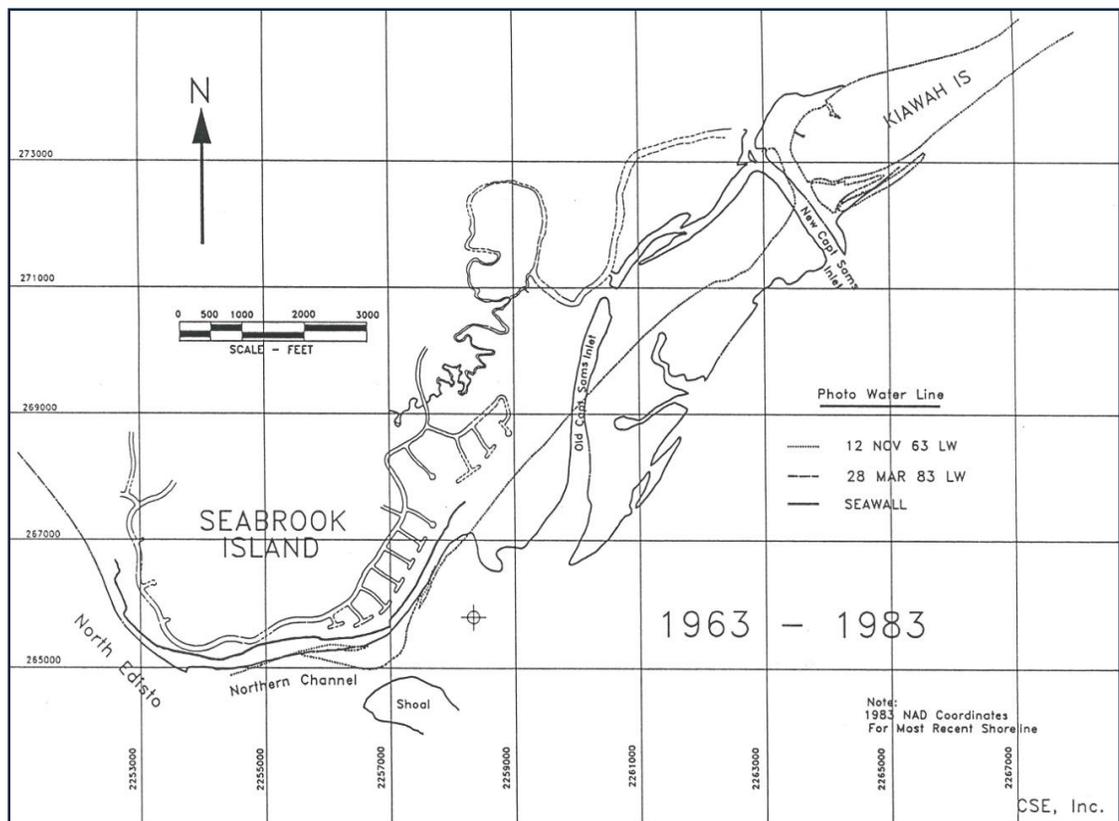
**FIGURE 5.1h** Low-water shorelines in November 1963 (on which the 1983 inlet relocation point was based) and 28 March 1983, one month after Captain Sams Inlet was relocated. The extensive intertidal bars of the abandoned inlet migrated onshore and downcoast over the next several years. [After Kana & Andrassy 1993]

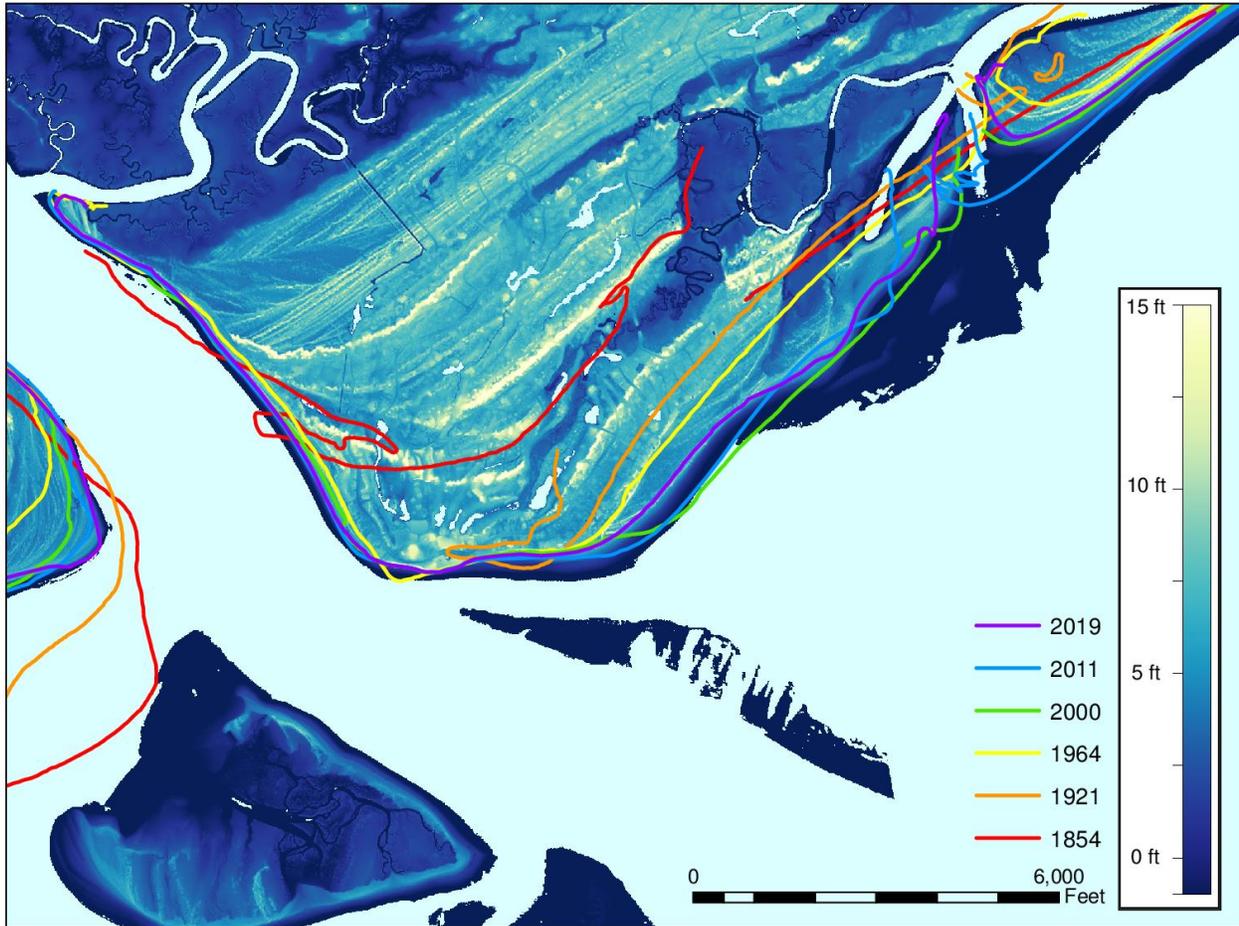
**FIGURE 5.1i** Updated historical shorelines combining the NOAA-NOS (1983) data with shorelines from 2019 superimposed on a 2016 high-resolution elevation model showing the various ridges along Seabrook Island and the neighboring Kiawah Spit (to the east) and Botany Bay (to the west). Previous shoreline positions are often associated with topographic highs on South Carolina barriers, due to the accumulation of dune sand into a high continuous ridge during periods of shoreline stability.

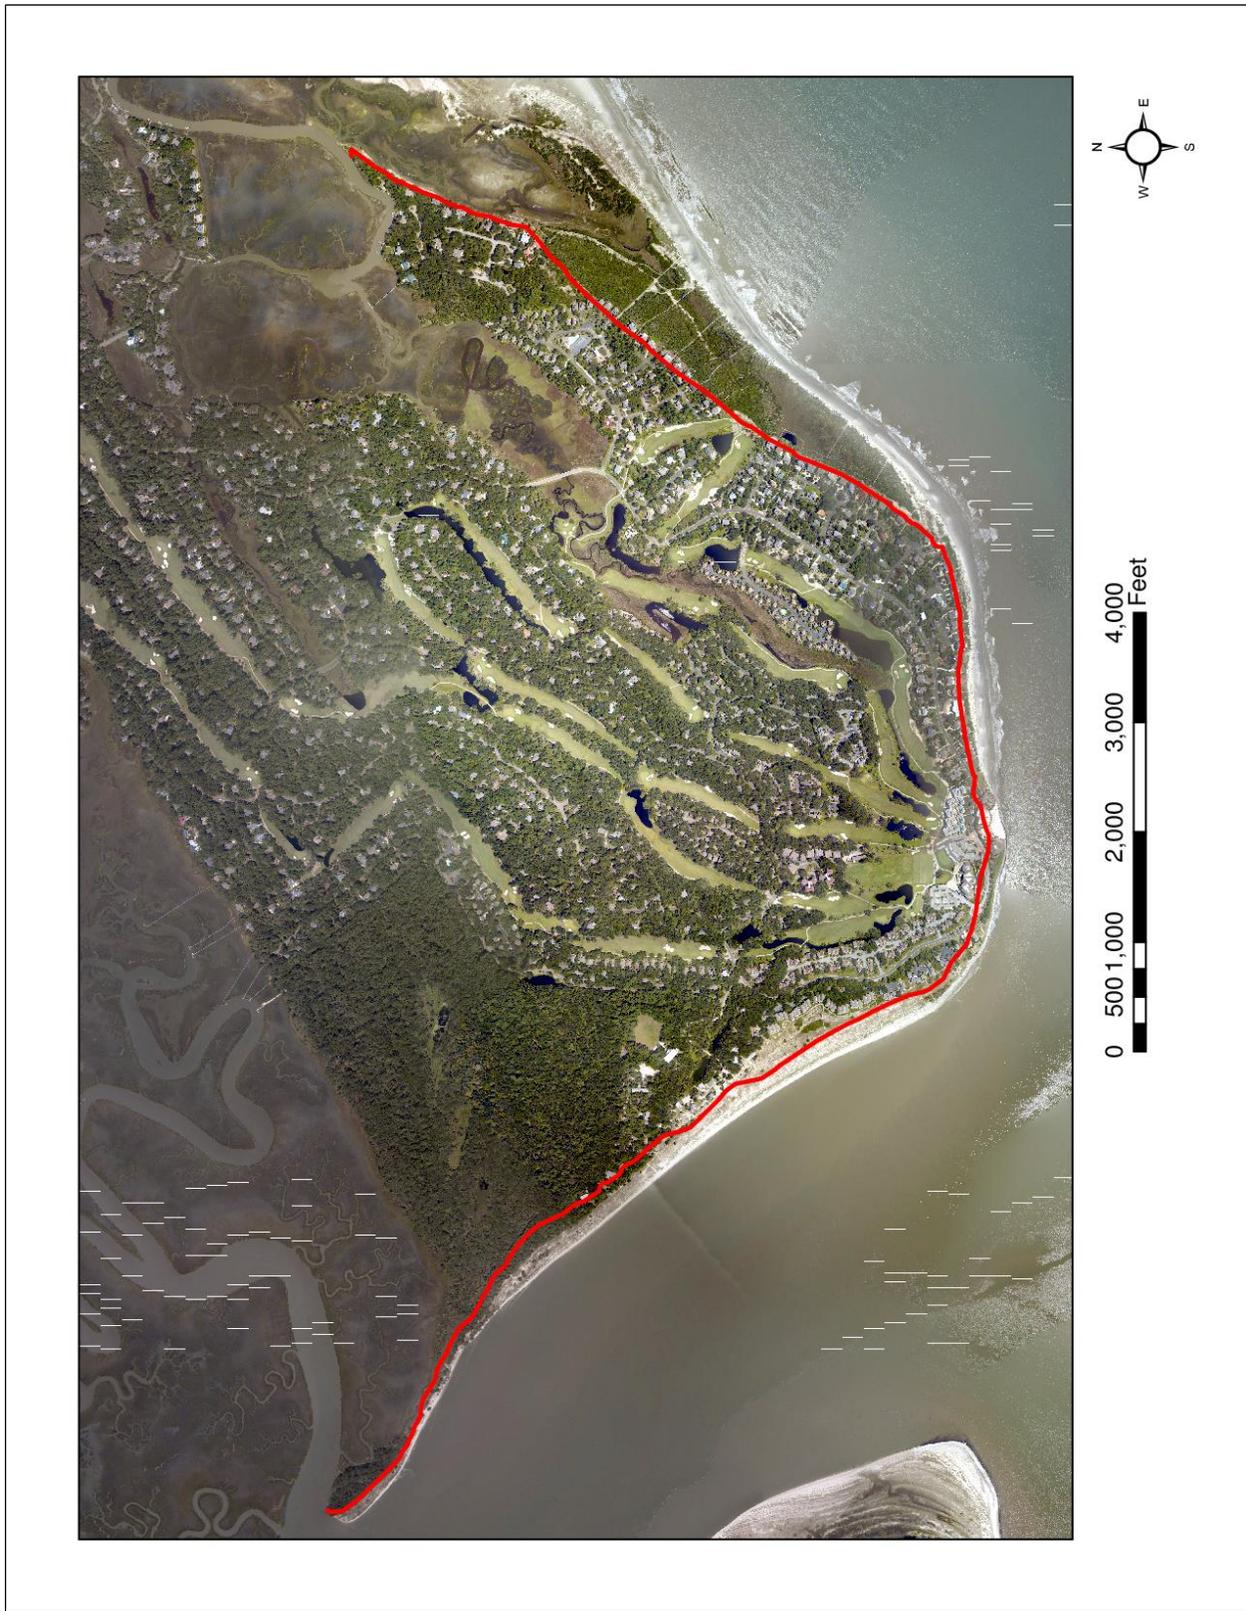
**FIGURE 5.1j** Official 2017 OCRM Setback Line for a portion of Seabrook Island superimposed on a 2019 rectified aerial orthophotograph. Landward translation of the setback line between the 2017 re-drawing and previous issuance in 2012 resulted in several dozen structures along Seabrook Island now being located seaward of the setback line. Image taken close to high tide.

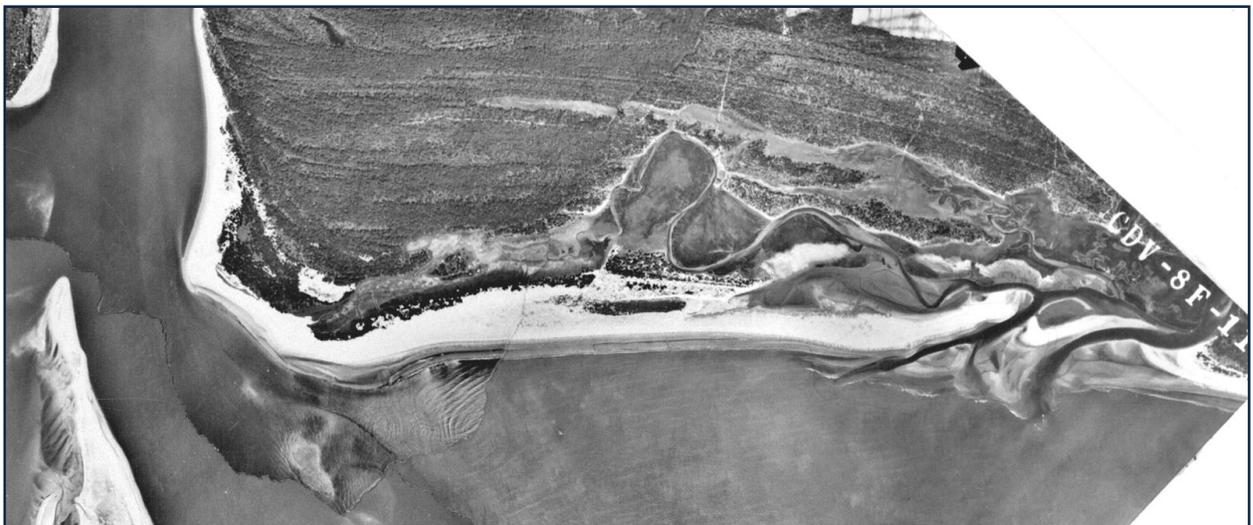
**FIGURE T-2.** Vertical photograph (1949) of Seabrook Island before development. Sometime in 1948, Captain Sams Inlet breached the Kiawah Spit near present-day Beachwalker Park (right side of image). The northeastern channel became dominant in the 1950s.
