Town of Seabrook Island  
Comprehensive Beach Management Plan

Initial "Beachfront Management Plan" Adopted by the Town of Seabrook Island  
November 19, 1992  
Updated December 16, 2014  
This Version Adopted by the Town of Seabrook Island  
**December XX, 2019**

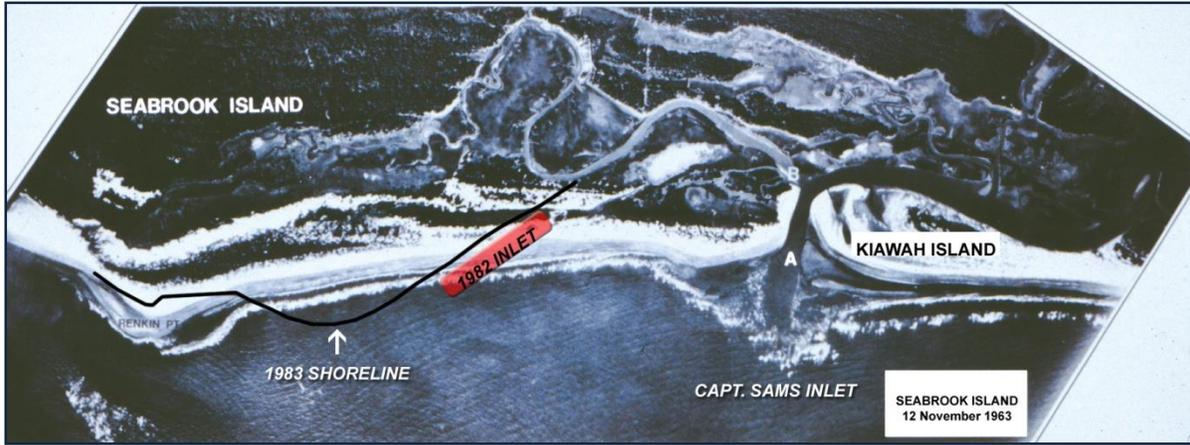
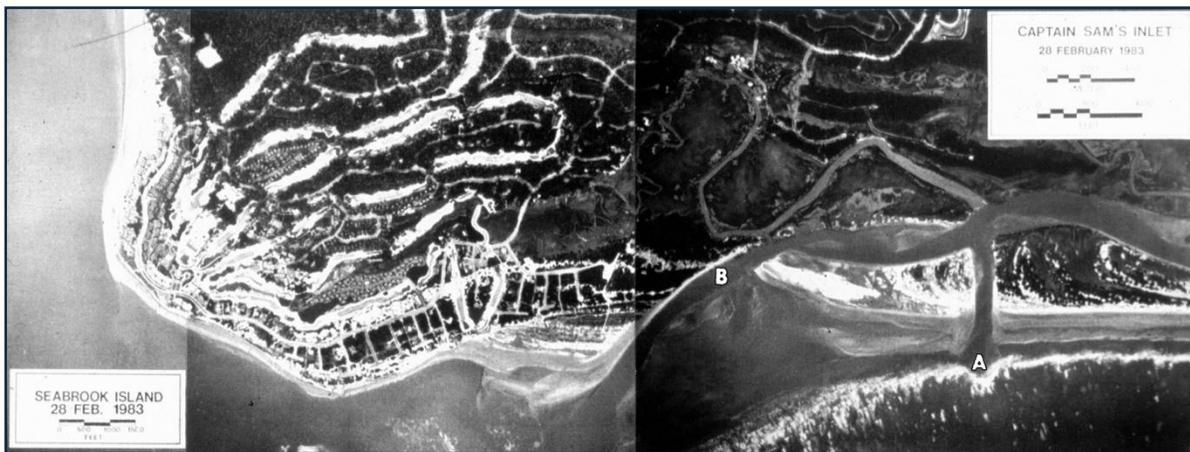
**FIGURE T-3.** Seabrook Island and Captain Sams Inlet in 1963 (upper) and 1983 (lower). The 1963 condition served as a model for the plan to relocate Captain Sams Inlet. Lower photo shows the new channel (A) open before the old channel (B) was closed on 4 March 1983.

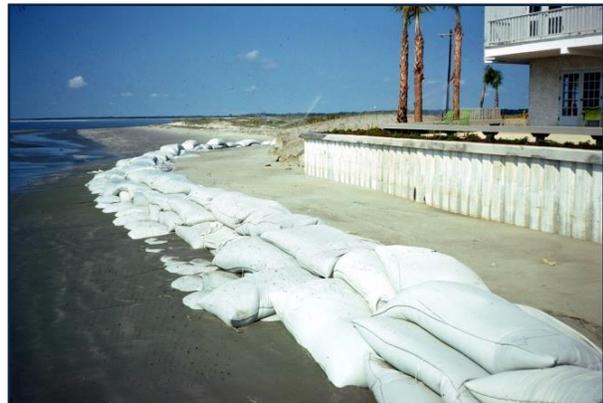
**FIGURE T-4.** Shore-protection structures at the Beach Club in September 1974 prior to the club's opening.

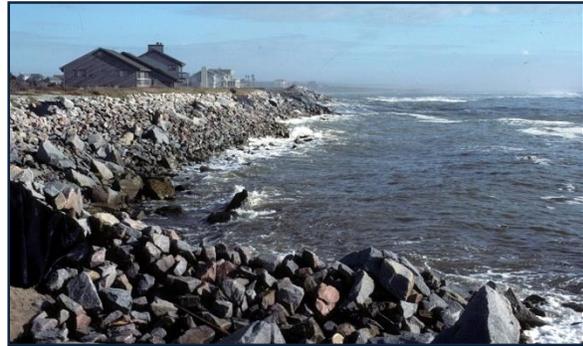
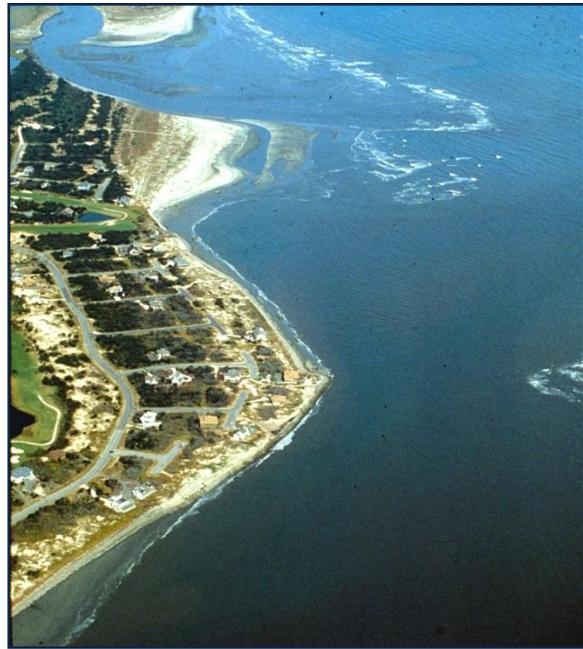
**FIGURE T-5.** During the early 1980s, much of Seabrook lacked any beach even at low tide. [UPPER] View north from Renken Point at mid tide. [LOWER] Oblique aerial (1982) looking north at low tide showing no beach around Renken Point.

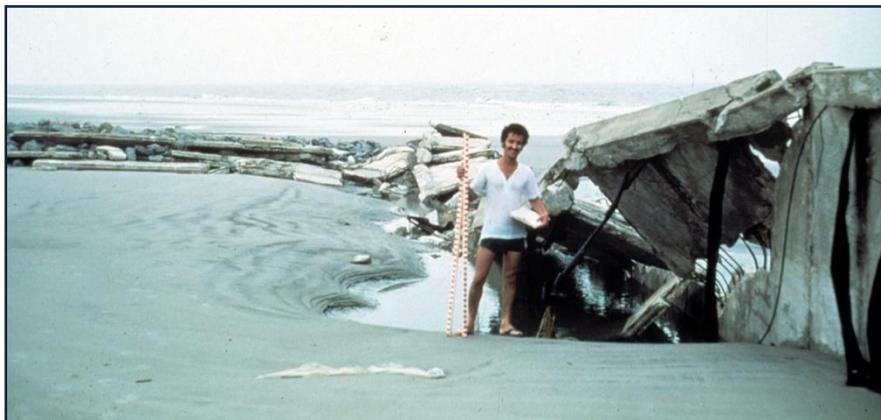
**FIGURE T-6.** Collapse of the concrete seawall at Renken Point in September 1979 during Hurricane *David*.

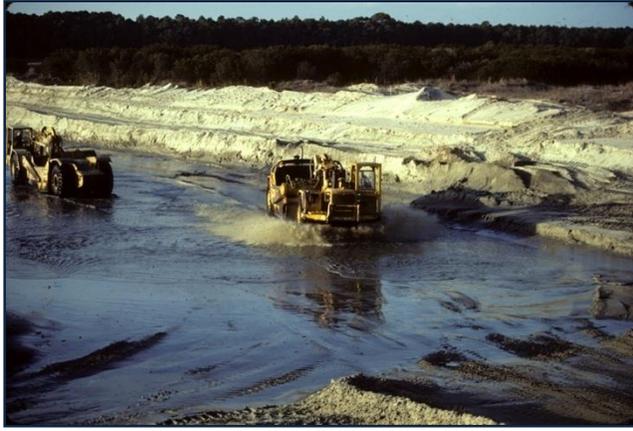
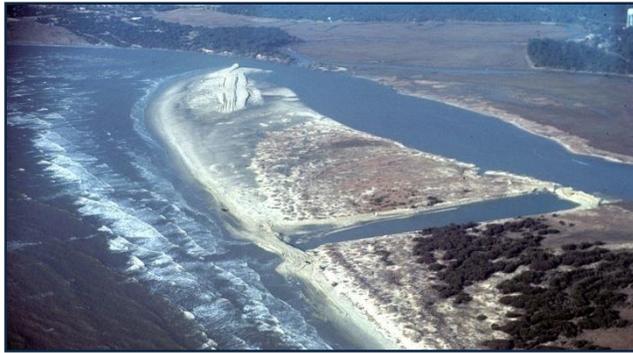
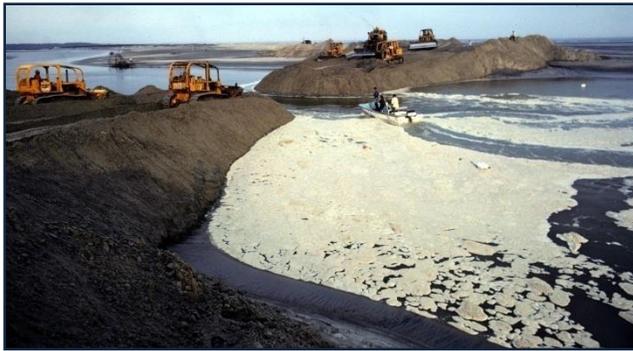
**FIGURE T-7.** February-March 1983.

**MAR 1983** First relocation of Captain Sams Inlet ~1.5 miles north to its 1963 position. Old inlet closed by trucks hauling sand from the new channel basin. Cost of project is (~)\$300,000 (Fig T-7).

**LATE 1980s** North Beach is restored by natural processes as sand from the delta of abandoned Captain Sams Inlet migrates onshore, adding over 1 million cubic yards to Seabrook Island's beach. North Beach is upward of 1,000 ft wide in places, a dry beach is restored, and the rock revetment north of Renken Point begins to be buried by windblown sand.

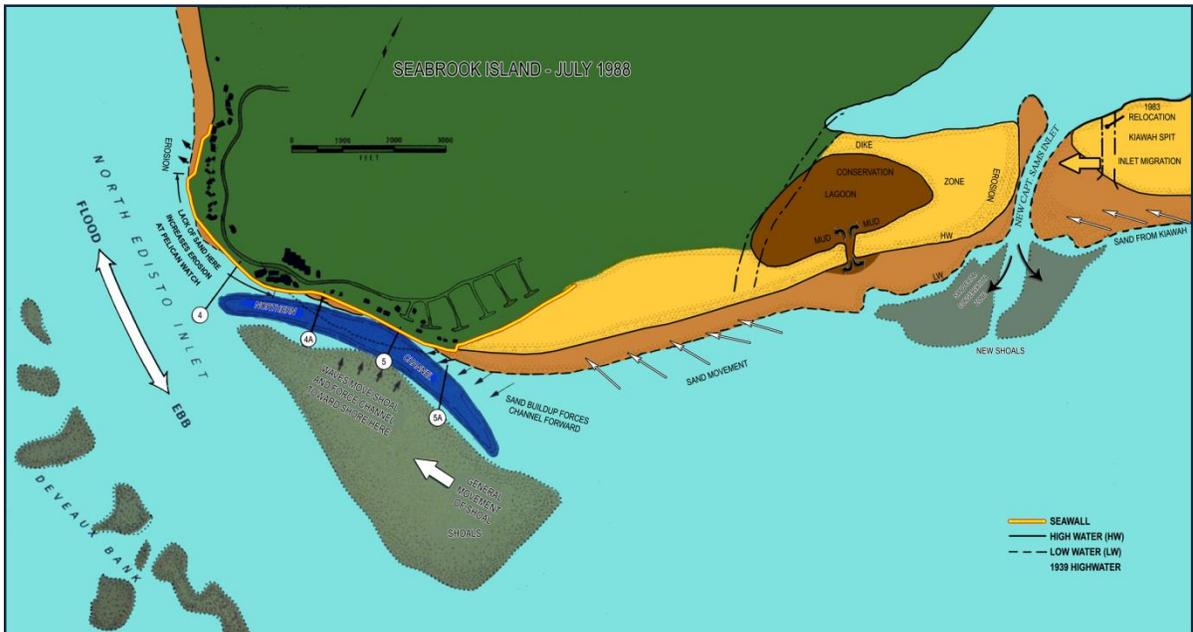
**FIGURE T-8.** [UPPER] Encroachment of the northern channel (deep blue area) of North Edisto Inlet and lack of maintenance leads to [LOWER] collapse of a section of seawall near Beach Court in 1983.

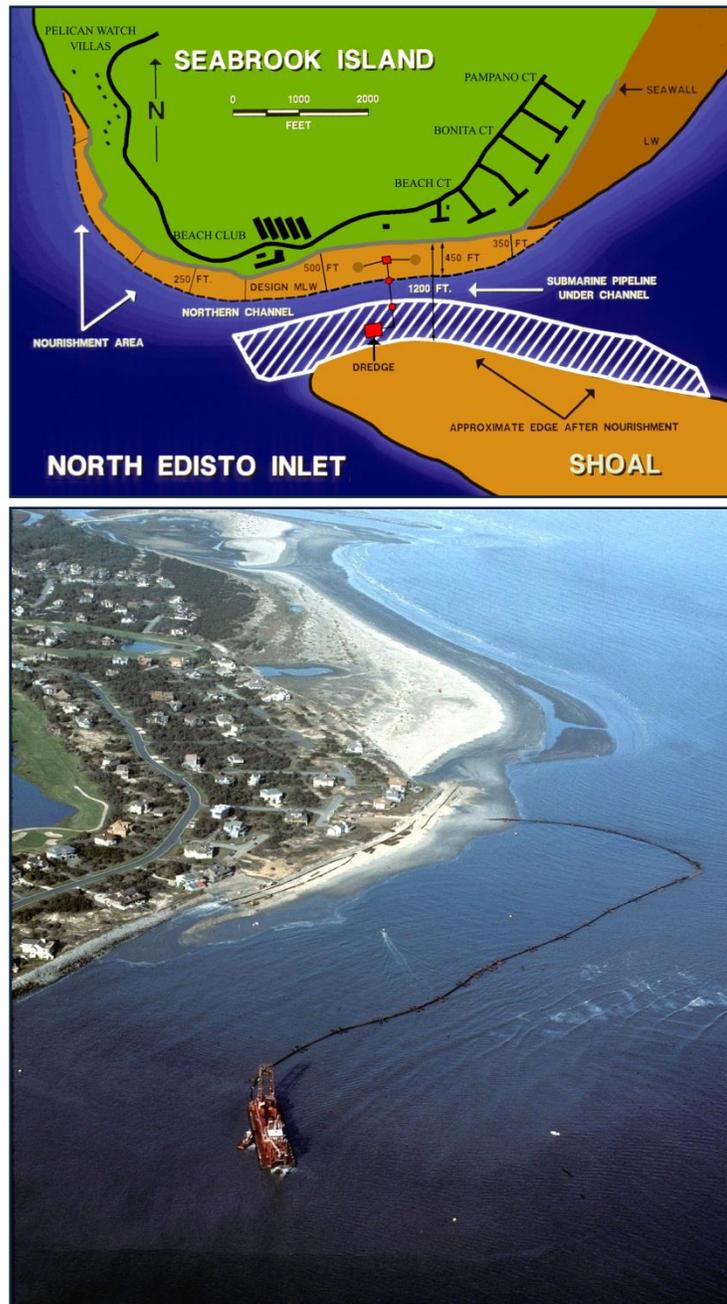
**FIGURE T-9.** [UPPER] 1989 plan for realignment of the northern channel and nourishment south of Renken Point. [LOWER] Start of dredging operations in February 1990 at Renken Point.

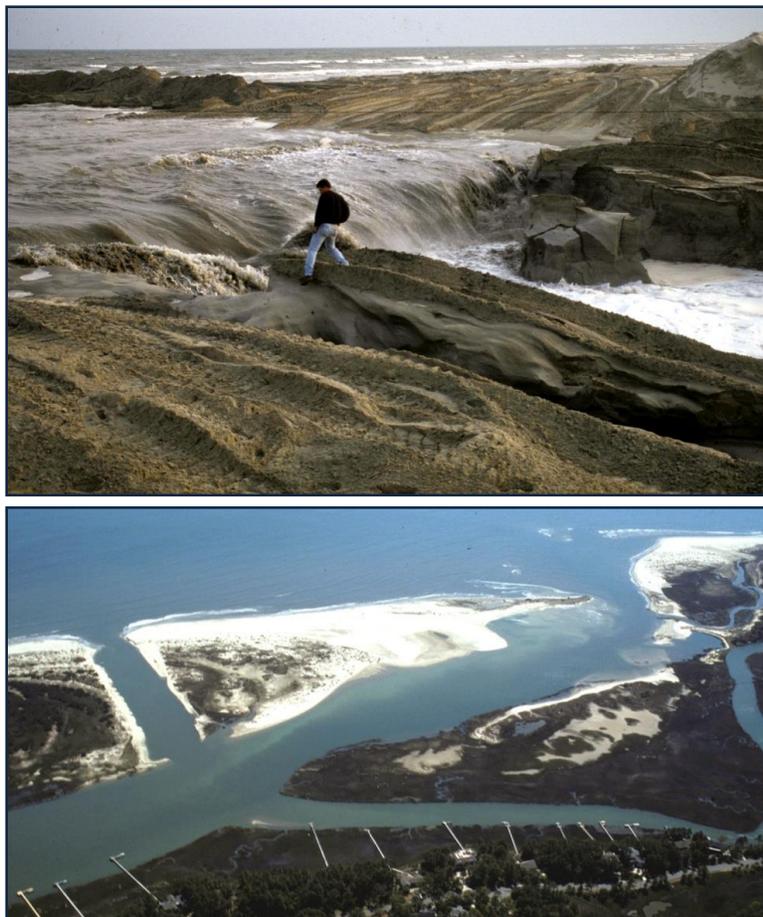
**FIGURE T-10.** The second relocation of Captain Sams Inlet in April 1996. [UPPER] First tide into the channel basin on 4 April during a rising tide. [LOWER] The new channel (left side) before completion of the closure dike across the old channel.

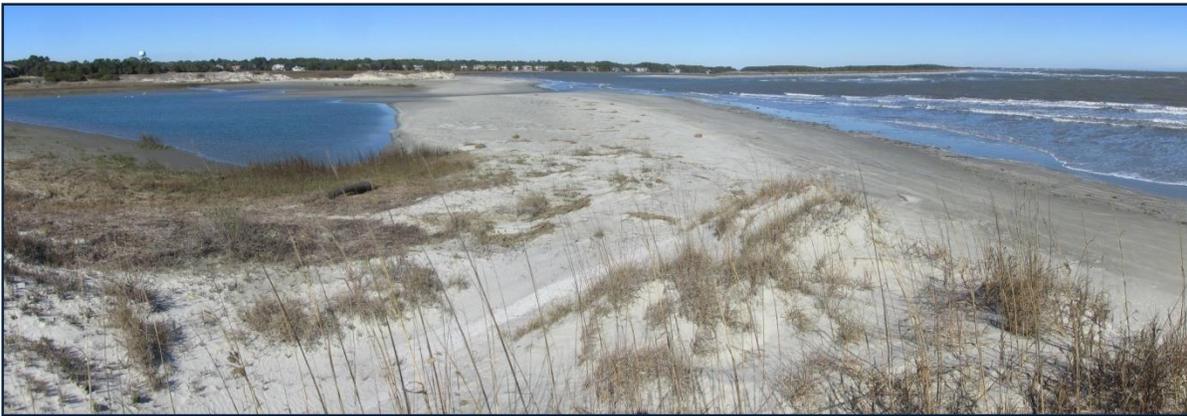
**FIGURE T-11.** Composite image of Captain Sams Inlet area from the Seabrook side in January 2014. The lagoon formed in the abandoned 1996 channel is on the left side of the image.

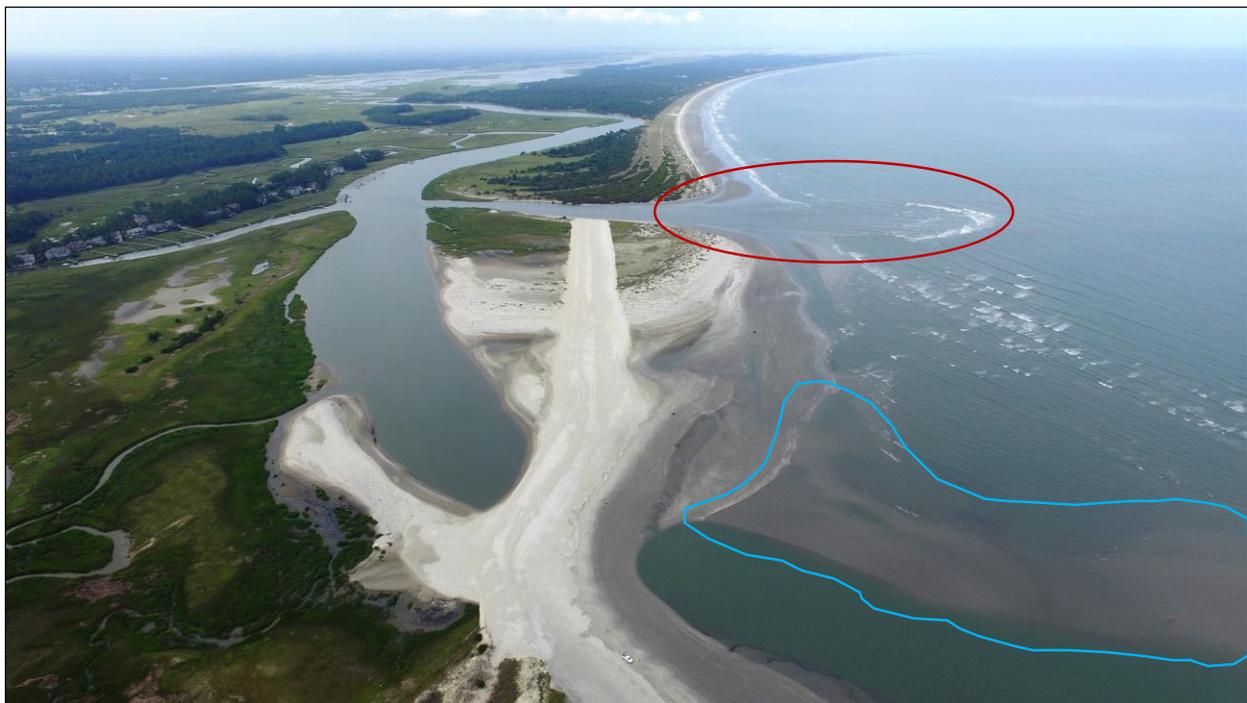
**FIGURE T-12.** Oblique aerial image of Captain Sams Inlet area from the Seabrook side in July 2015, following the third inlet relocation project. The ebb tidal spit along the east bank of the old inlet channel is clearly visible in the foreground (blue highlight), and the new channel’s associated ebb tidal delta is visible in the breakers adjacent to Kiawah Spit (red highlight).

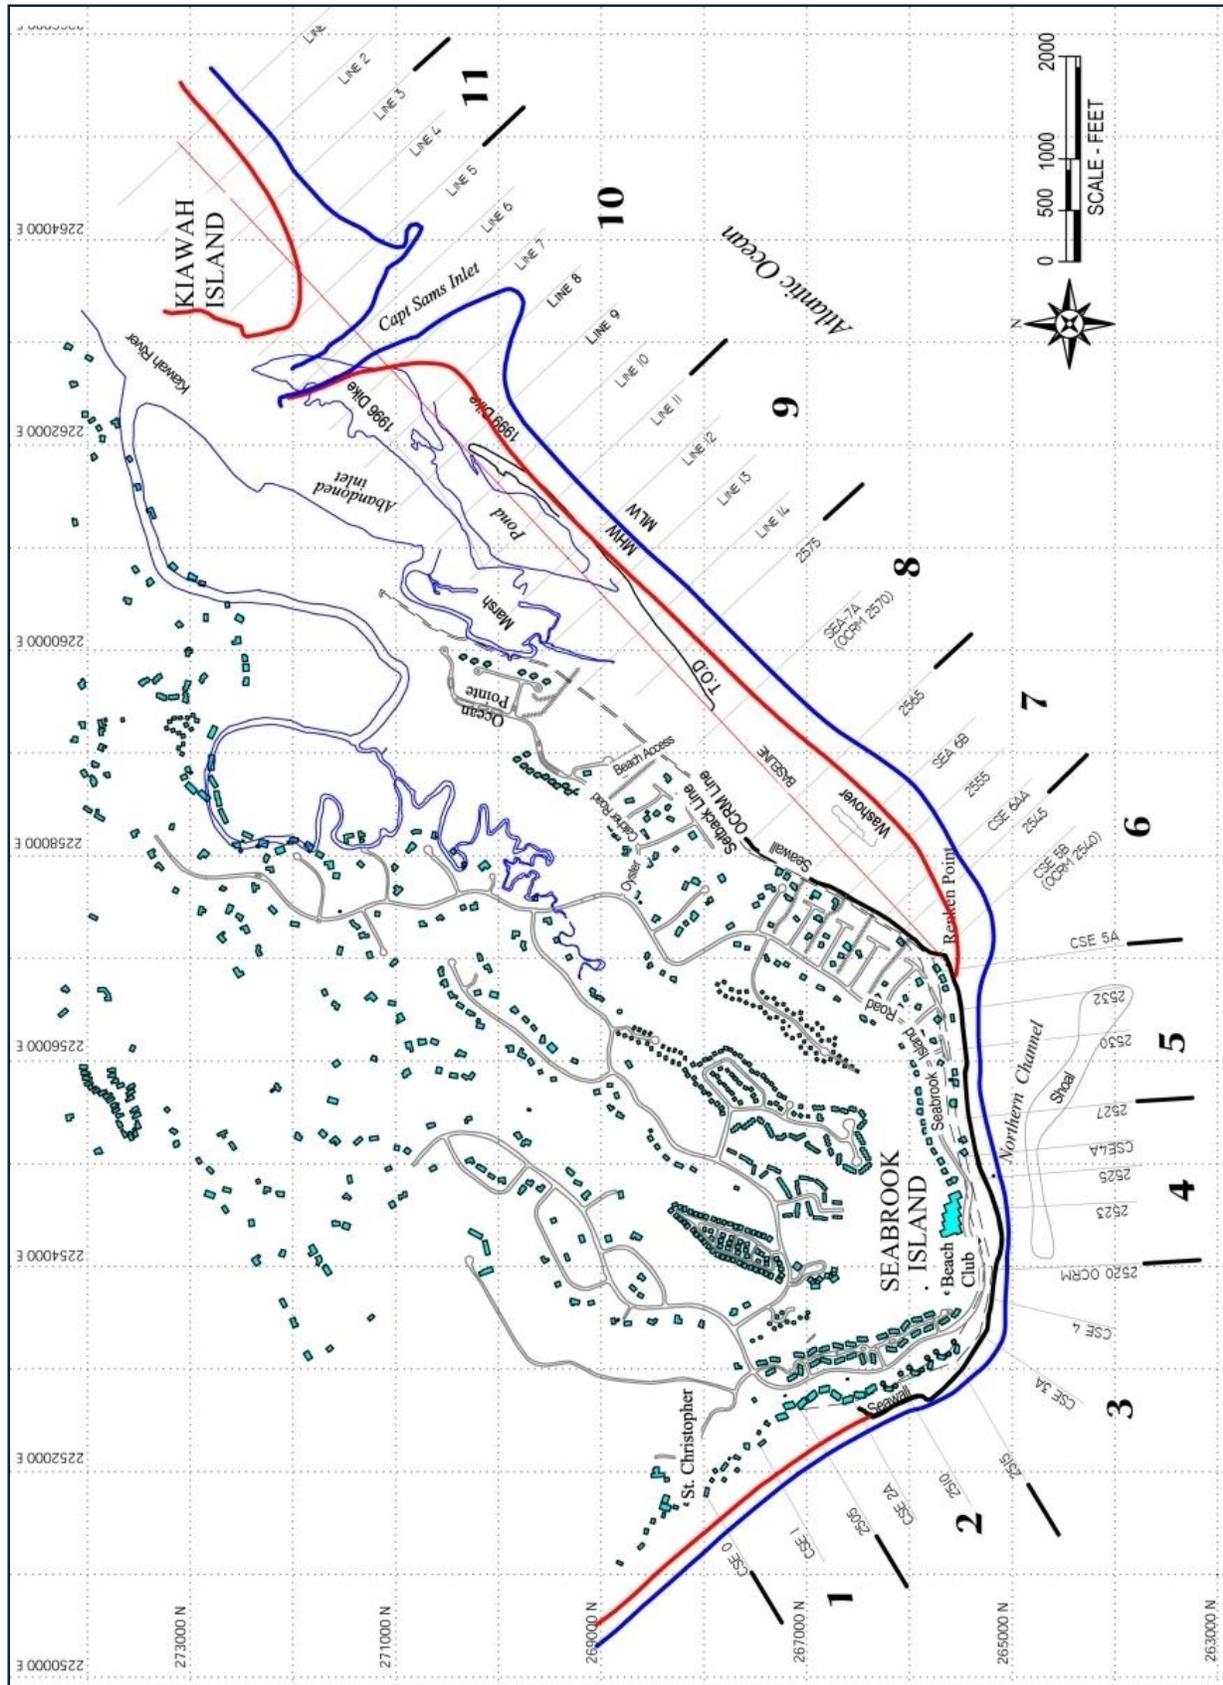
**FIGURE 5.1.1a.** Network of beach monitoring lines used between 1997 and 2011. The equivalent OCRM line numbers are indicated. Groups of lines define erosion analysis “reaches” described in Section 5.1.2. In 2011, several lines were added to the network (see Fig 5.0a) and the azimuths around Renken Point were modified (CSE 2011, 2014).

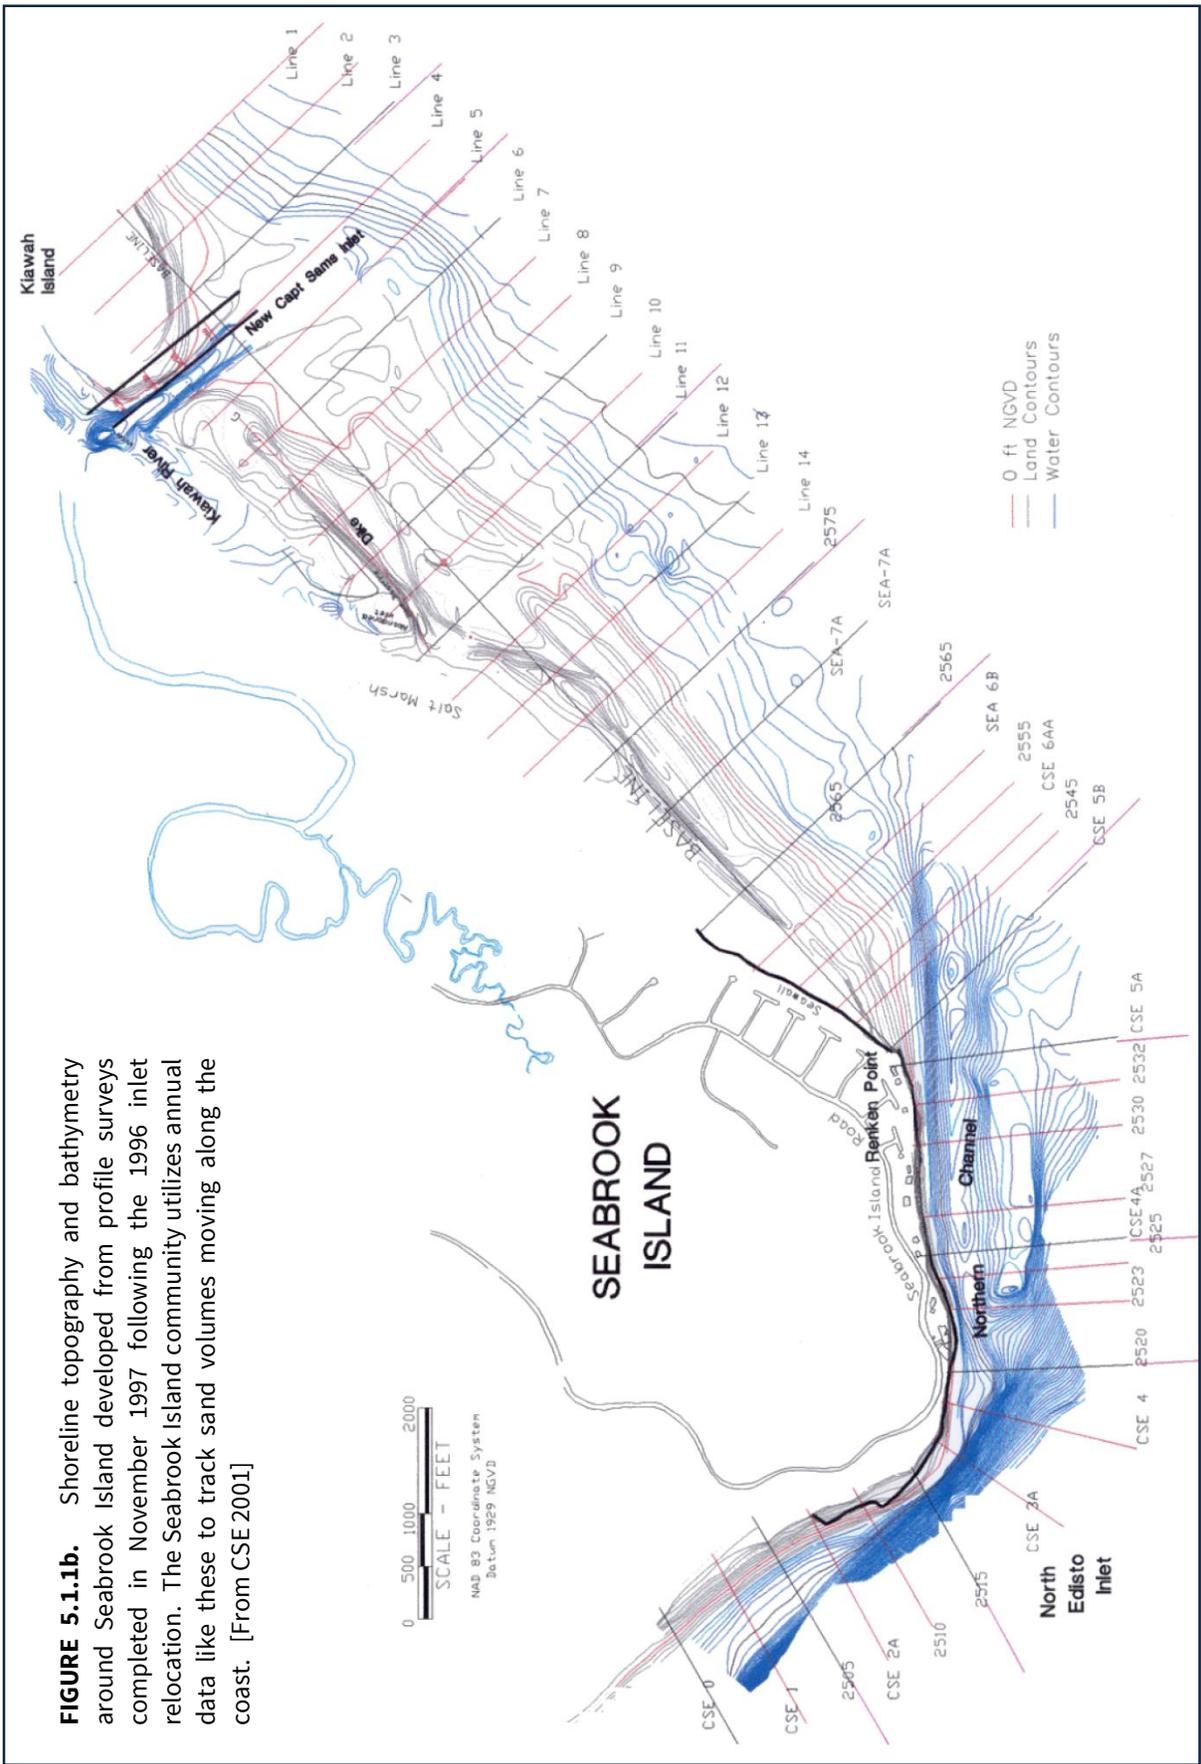
**FIGURE 5.1.1b.** Shoreline topography and bathymetry around Seabrook Island developed from profile surveys completed in November 1997 following the 1996 inlet relocation. The Seabrook Island community utilizes annual data like these to track sand volumes moving along the coast. [From CSE2001]

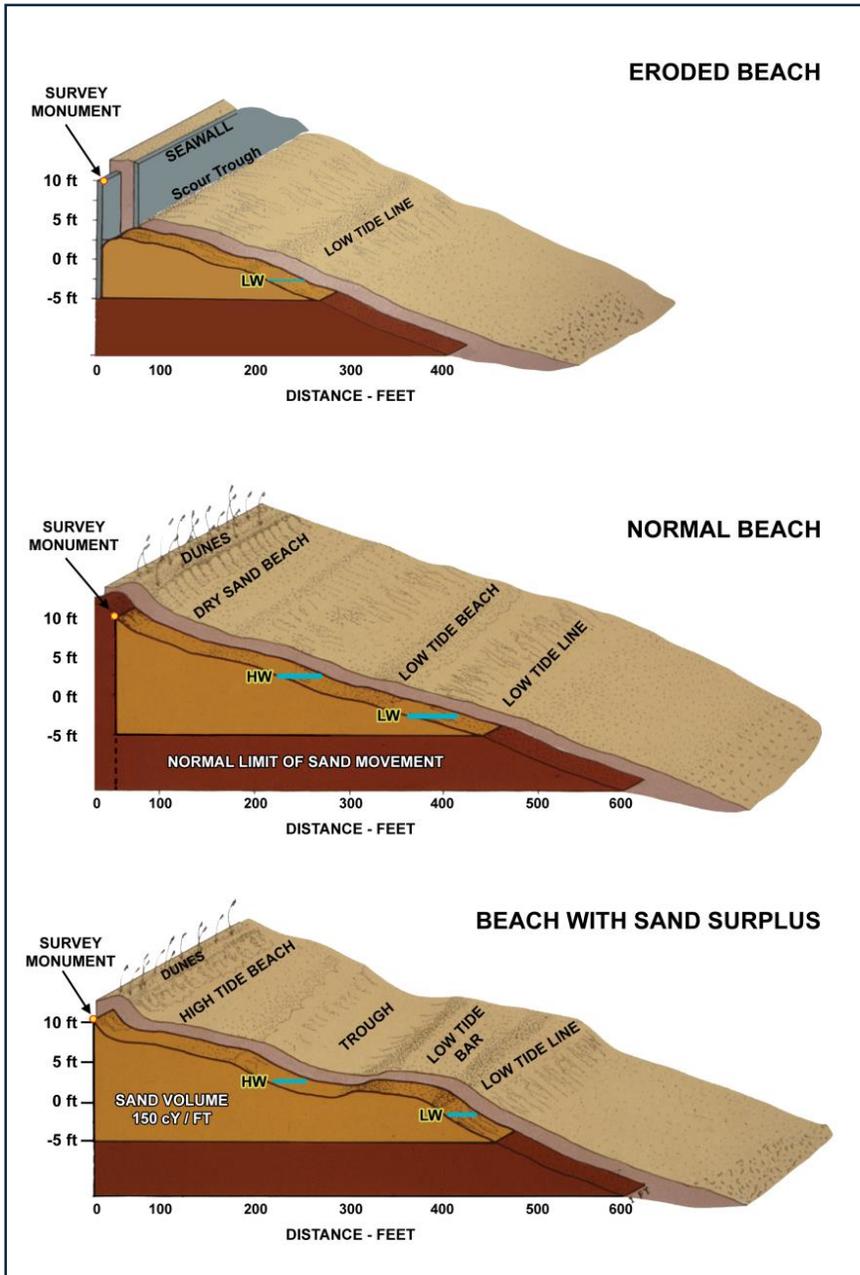
**FIGURE 5.1.1c.** Concept of unit volume—the quantity of sand contained in one unit length of shoreline between defined cross-shore boundaries. The examples illustrate relative volumes for an eroding beach backed by seawalls, a normal beach, and an accreting beach. Seabrook Island typically exhibits all three conditions at any time (from Kana 1990).

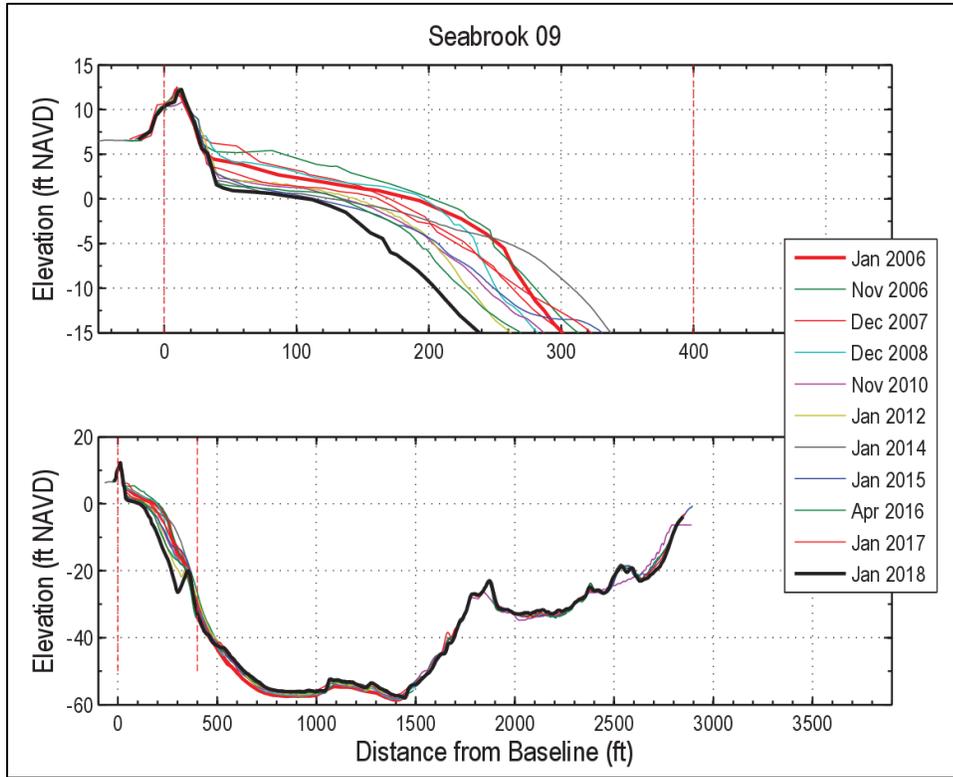
**FIGURE 5.1.1d.** Profiles from **Reach 3** (see Fig 5.1j) at Line 09 (old CSE 3A) near Beach Club Villas on North Edisto River Inlet. The beach is a relatively narrow platform fronting a seawall at the edge of the main channel of North Edisto River Inlet, one of the deepest natural inlets along the South Carolina coast.

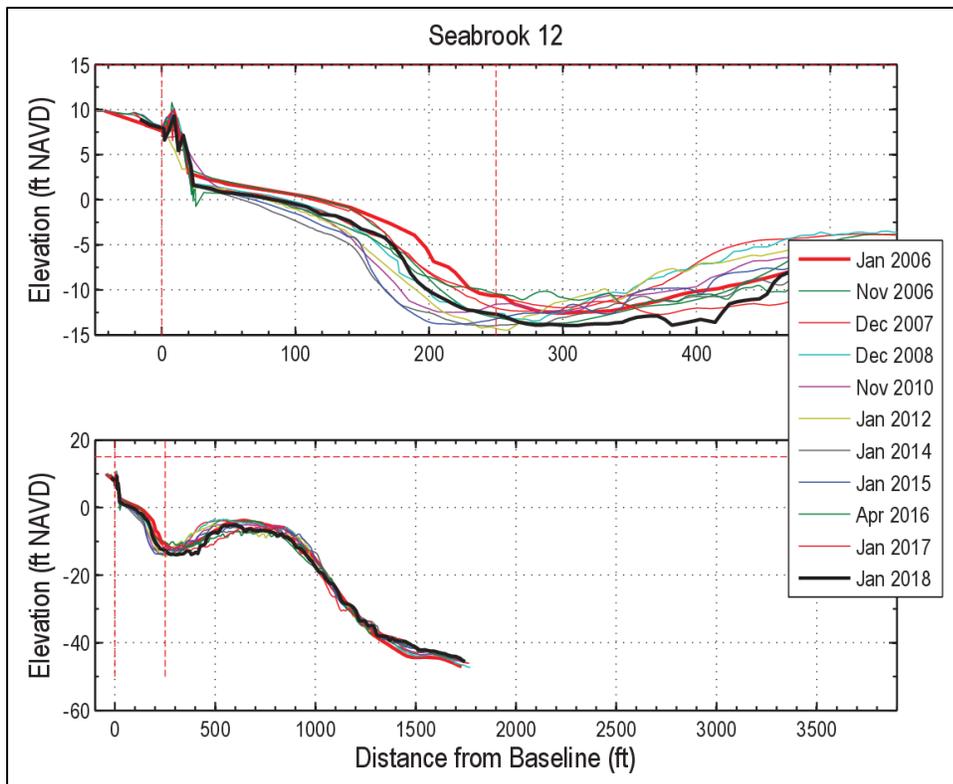
**FIGURE 5.1.1e.** Profiles of Line 12 from **Reach 4** in the vicinity of the Seabrook Island Club facilities.  
Town of Seabrook Island  
Beach Management Plan (Public Comment Draft)

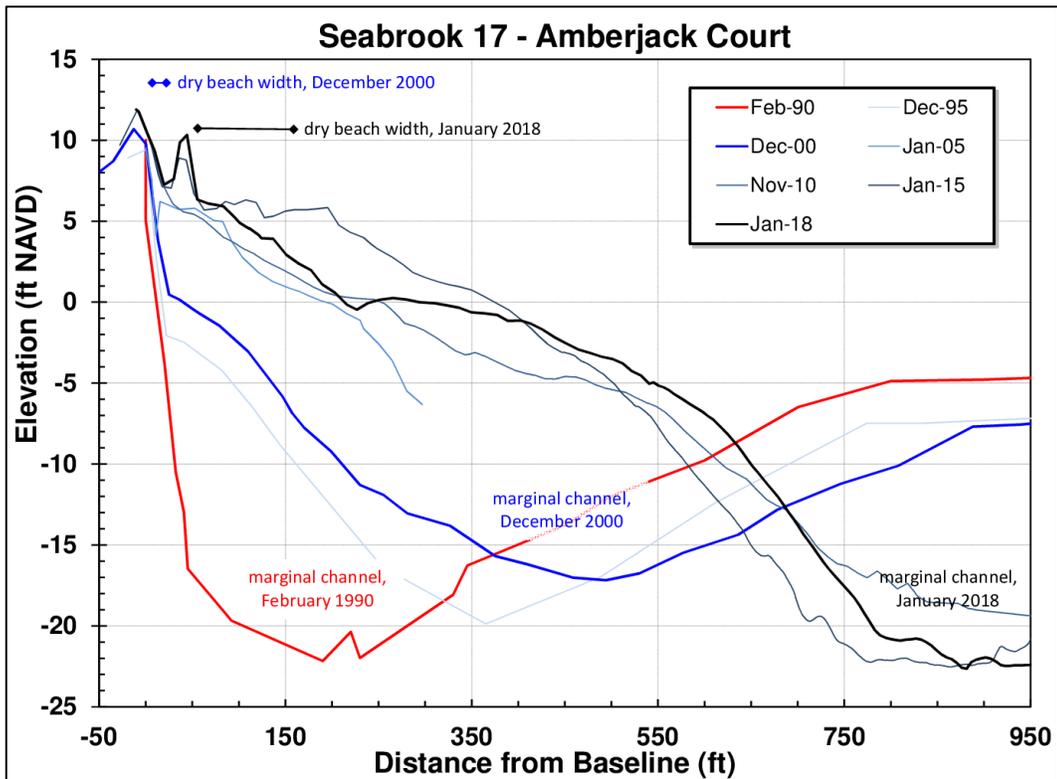
**FIGURE 5.1.1f.** Profiles from Line 17 in Reach 5 adjacent to the northern marginal channel of North Edisto River Inlet. Severe encroachment of the channel in 1990 led to a channel realignment by dredge.

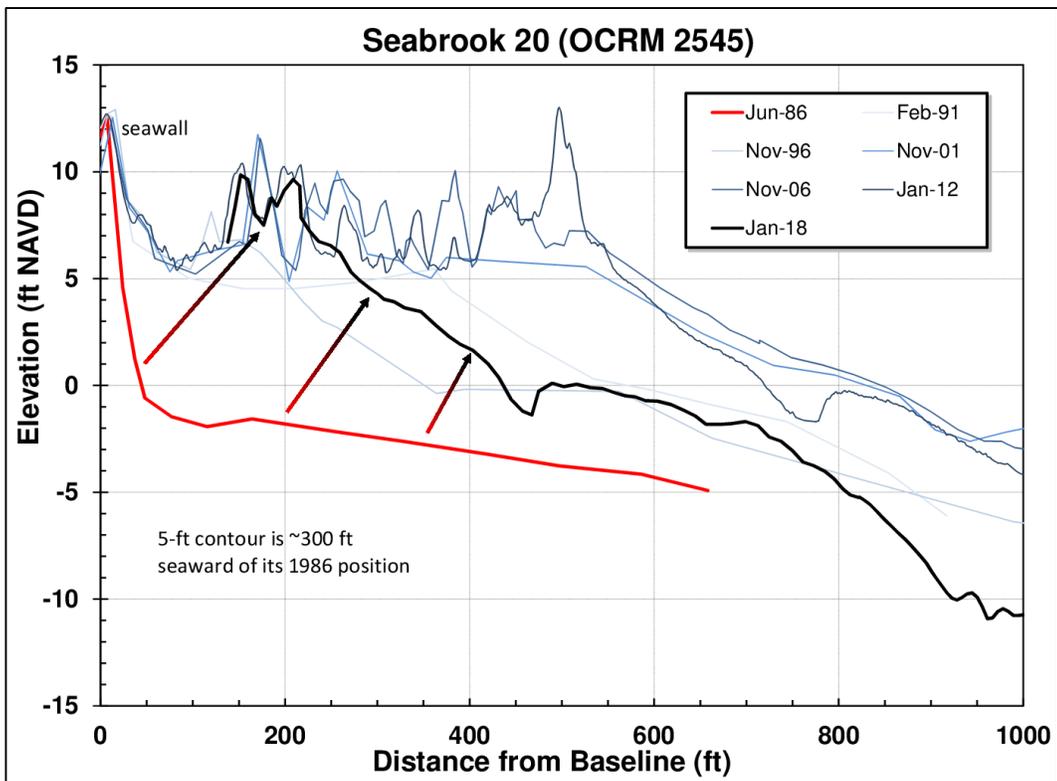
**FIGURE 5.1.1g.** Profiles from Line 20 (Reach 6) along Seabrook Island dating back to 1986, illustrating major growth of the beach and dune system along this section of the island.

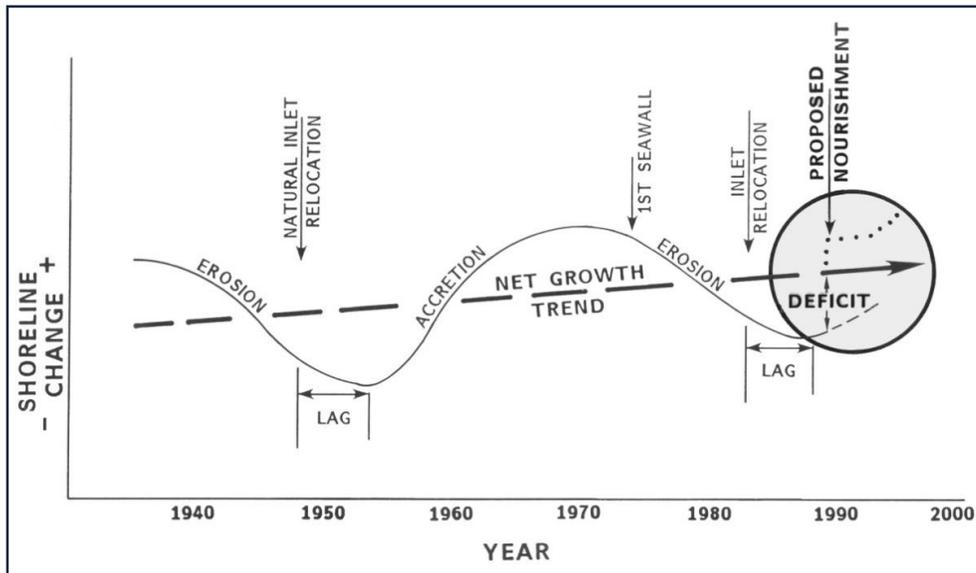
**FIGURE 5.1.2a.** Cycle of shoreline change along the downcoast half of Seabrook Island (south of OCRM 2540) based on historical shoreline analysis. Net trend is accretion at century time scales. Accretion periods lag inlet relocations by about five years. A 1990 project (proposed nourishment) involved placement of sand from North Edisto River Inlet in an attempt to accelerate recovery of the beach. [From CSE 1989]

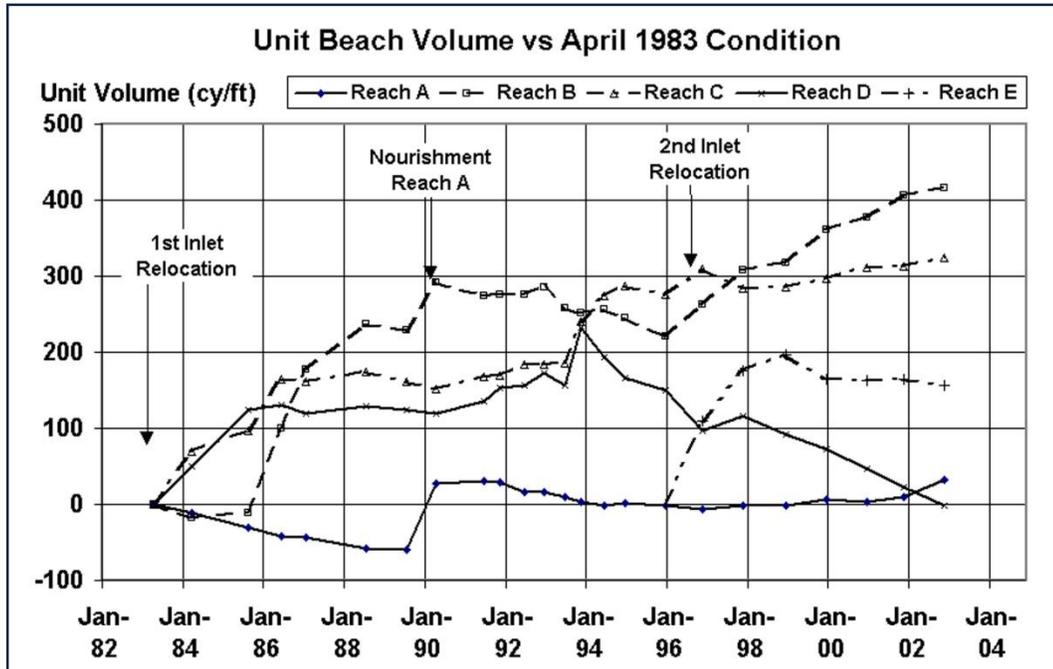
**FIGURE 5.1.2b.** Average unit-volume profile changes by reach along Seabrook Island since inlet relocation (March 1983). See Figure 5.1f for reach locations. [After Kana & McKee 2003]

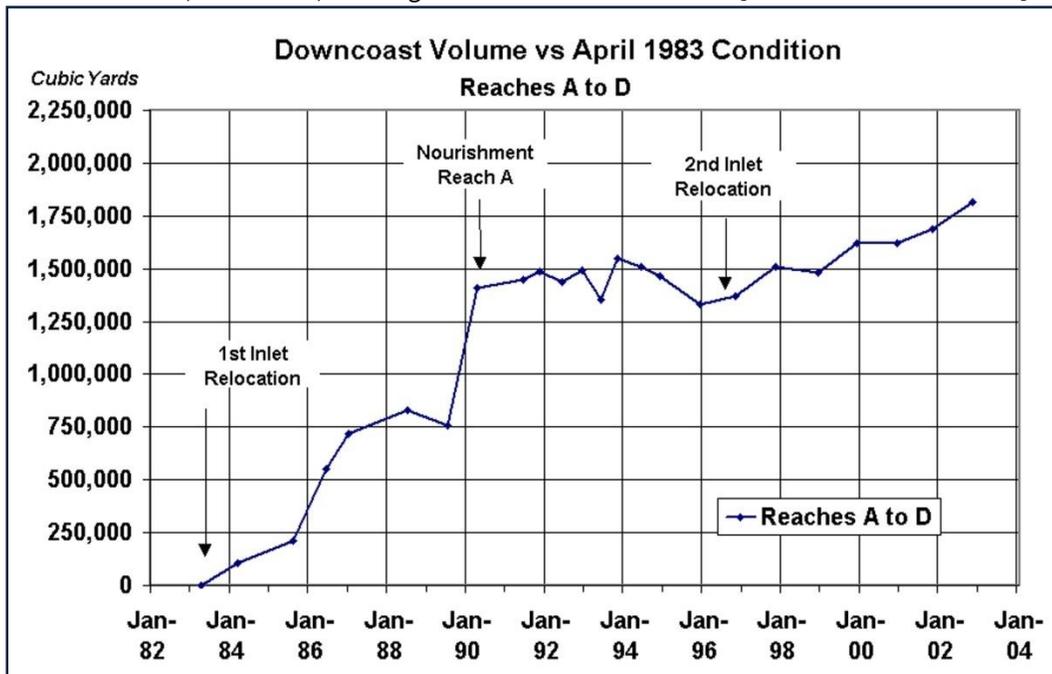
**FIGURE 5.1.2c.** Net volume change along Seabrook Island after the first inlet relocation (March 1983). The northern channel was realigned in February 1990, adding ~685,000 cy to the total. [After Kana & McKee 2003]

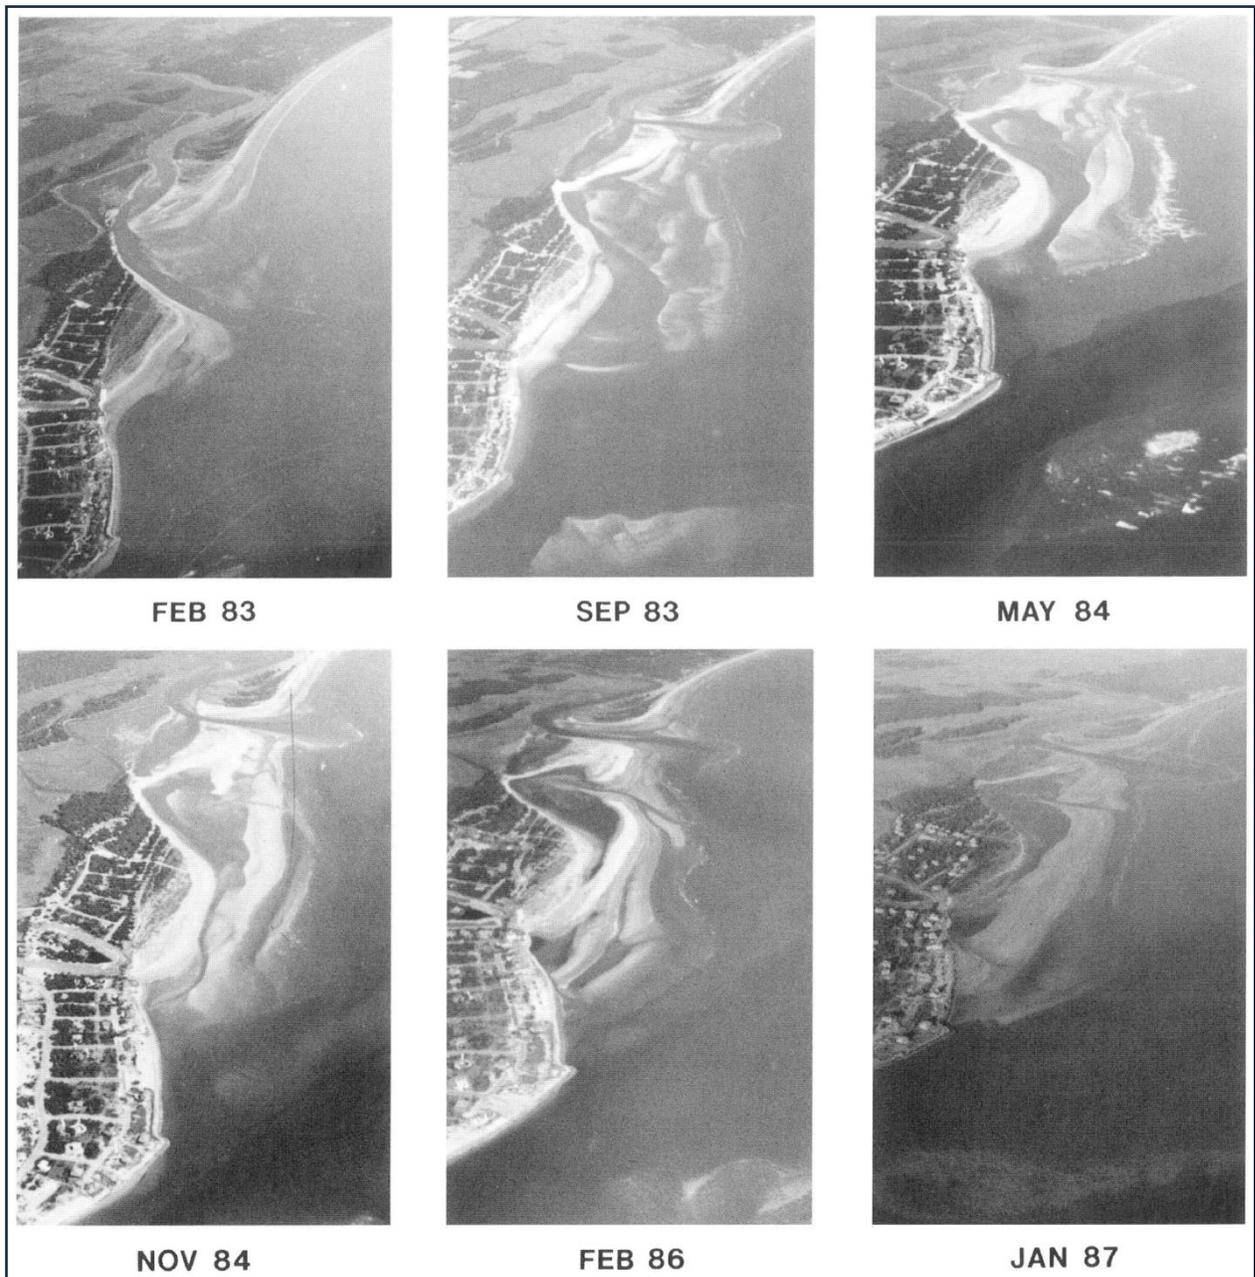
**FIGURE 5.1.2d.** Collapse of abandoned delta shoals and eventual accretion along the downdrift shoreline of Seabrook Island after the 1983 inlet relocation. New channel is at the top of each photo. [After Kana 1989]

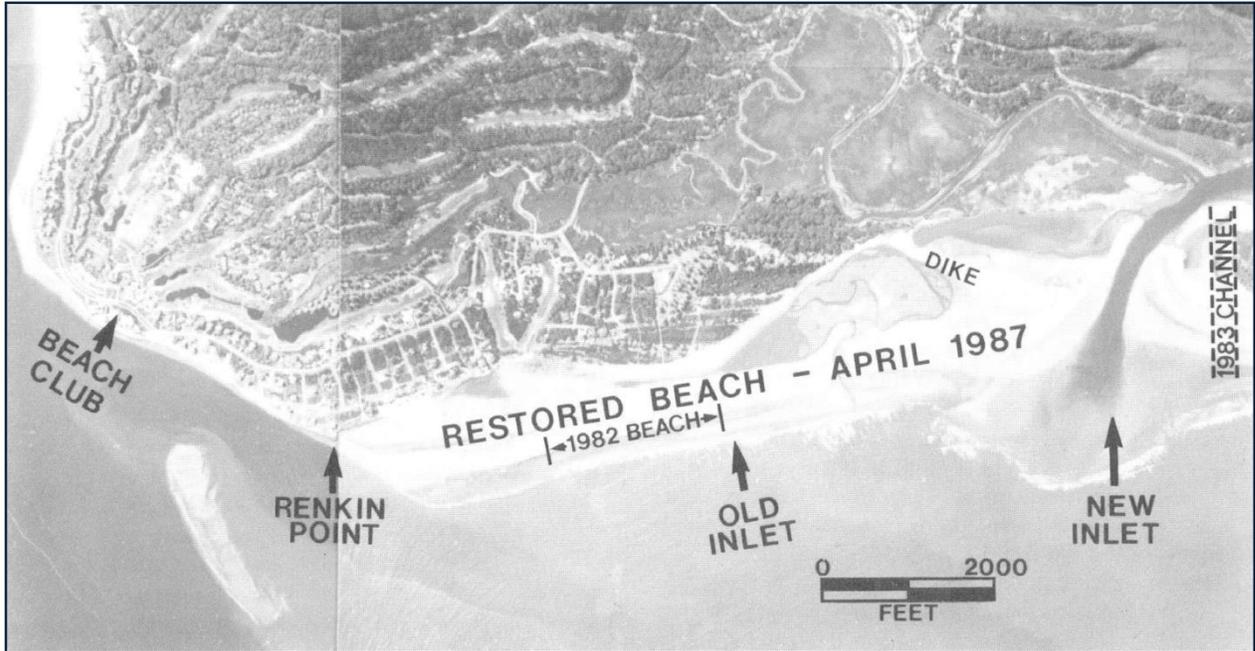
**FIGURE 5.1.2e.** Seabrook Island in April 1987 after natural restoration by inlet relocation. Area south of Renken Point remained unrestored. (Photo: Courtesy of Seabrook Island POA) [After Kana 1989]

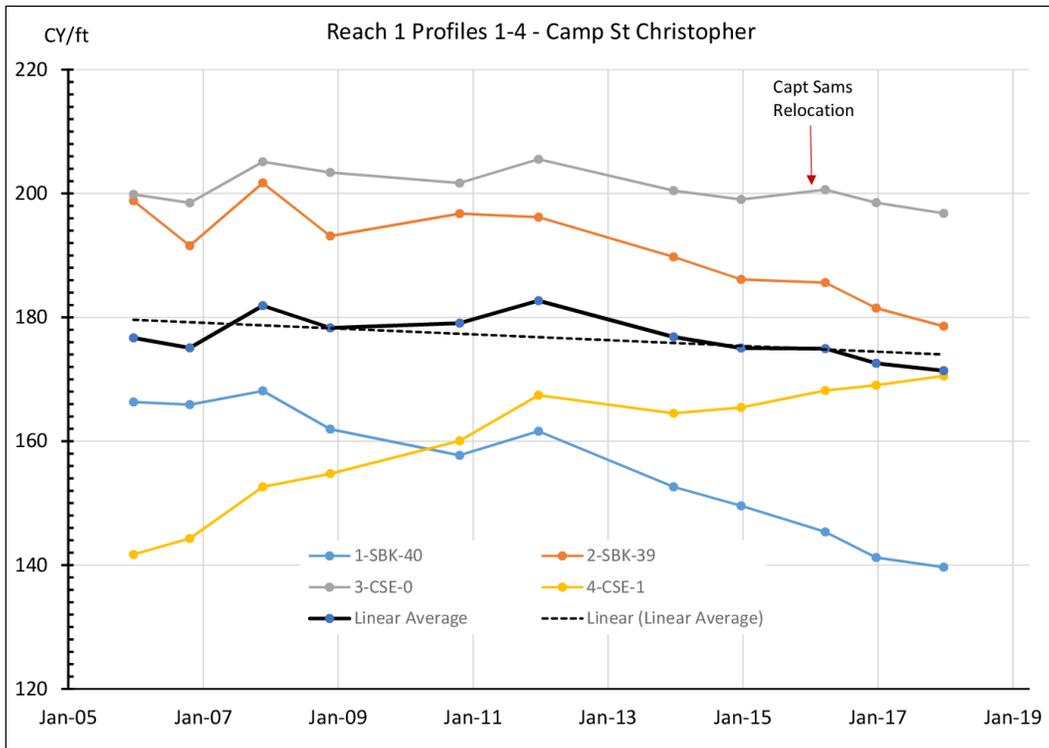
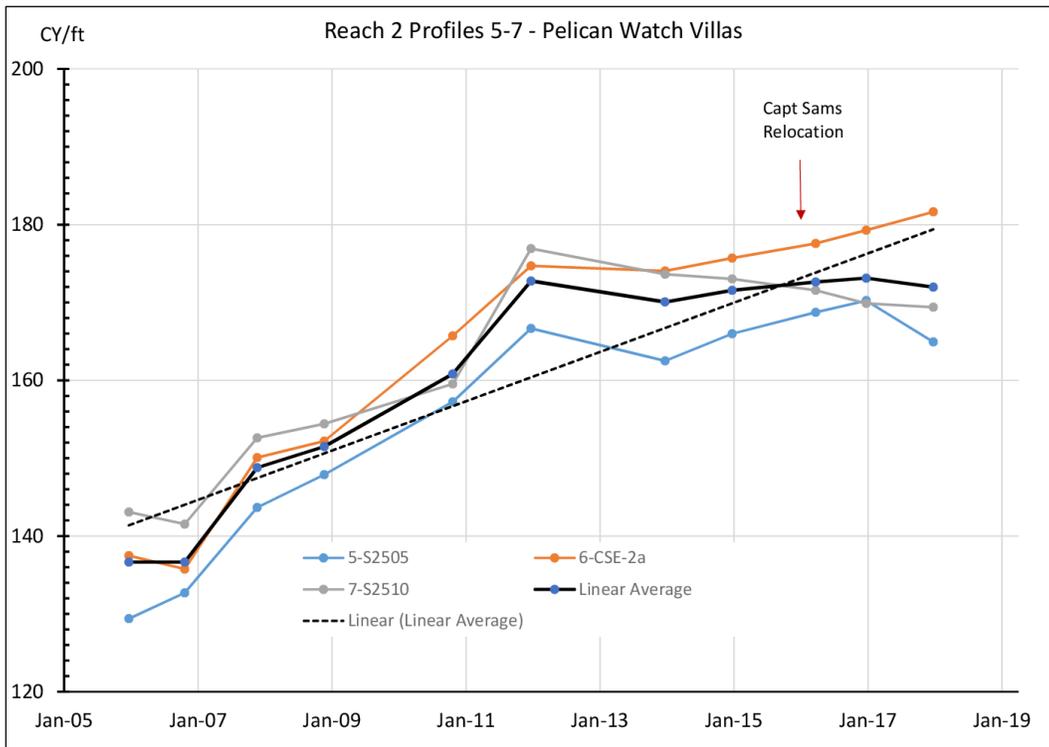
**FIGURE 5.1.2f.** Reaches 1–2 showing the 14-year average unit-volume change rate by station. Order of transects is from downcoast to upcoast (generally southwest to northeast). Linear average of all stations within the reach is shown in black.
