Town of Seabrook Island  
Comprehensive Beach Management Plan

Initial "Beachfront Management Plan" Adopted by the Town of Seabrook Island  
November 19, 1992  
Updated December 16, 2014  
This Version Adopted by the Town of Seabrook Island  
**December XX, 2019**

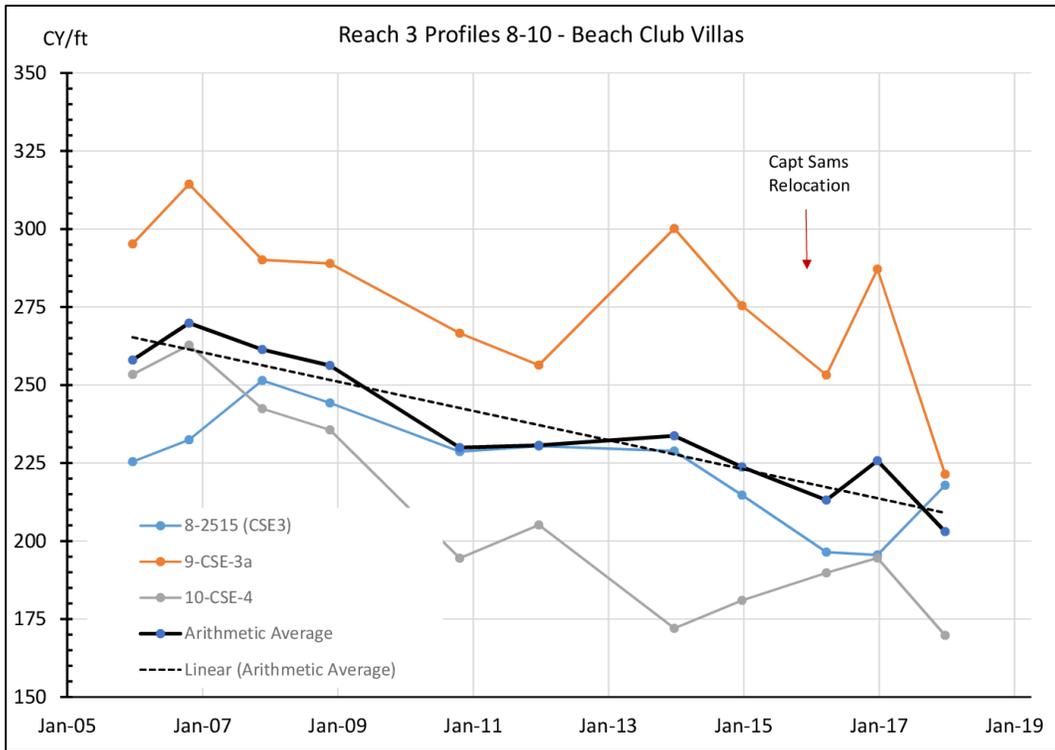
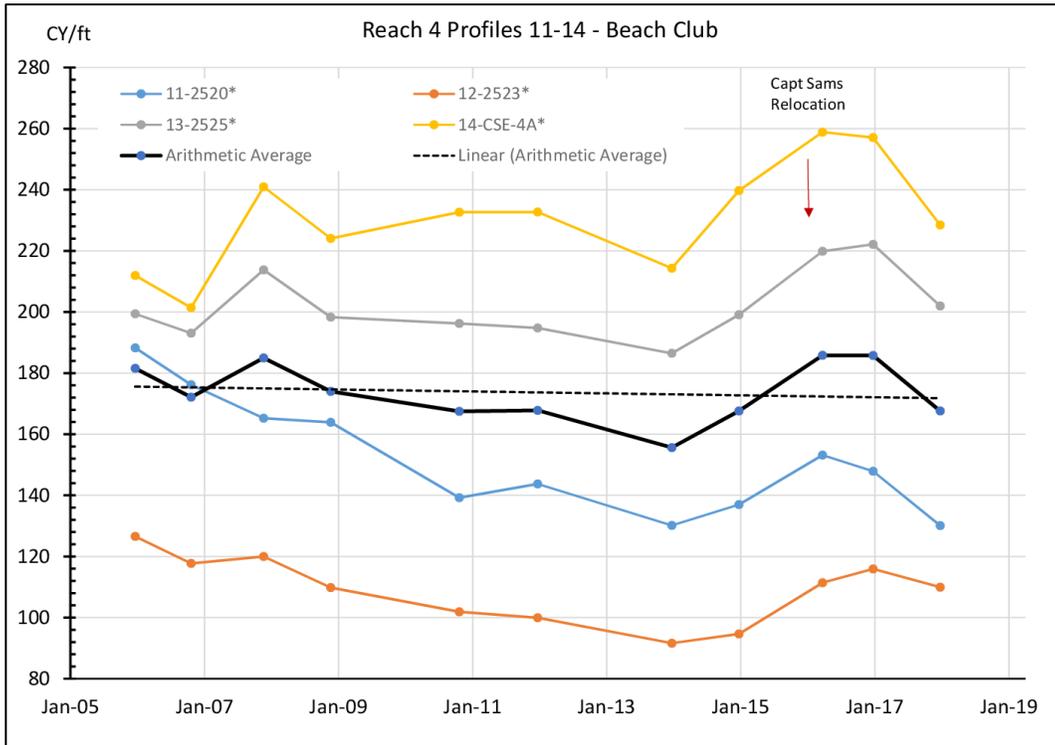
**FIGURE 5.1.2g.** Reaches 3–4 showing the 14-year average unit-volume change rate by station. Order of transects is from downcoast to upcoast (generally southwest to northeast). Linear average of all stations within the reach is shown in black.

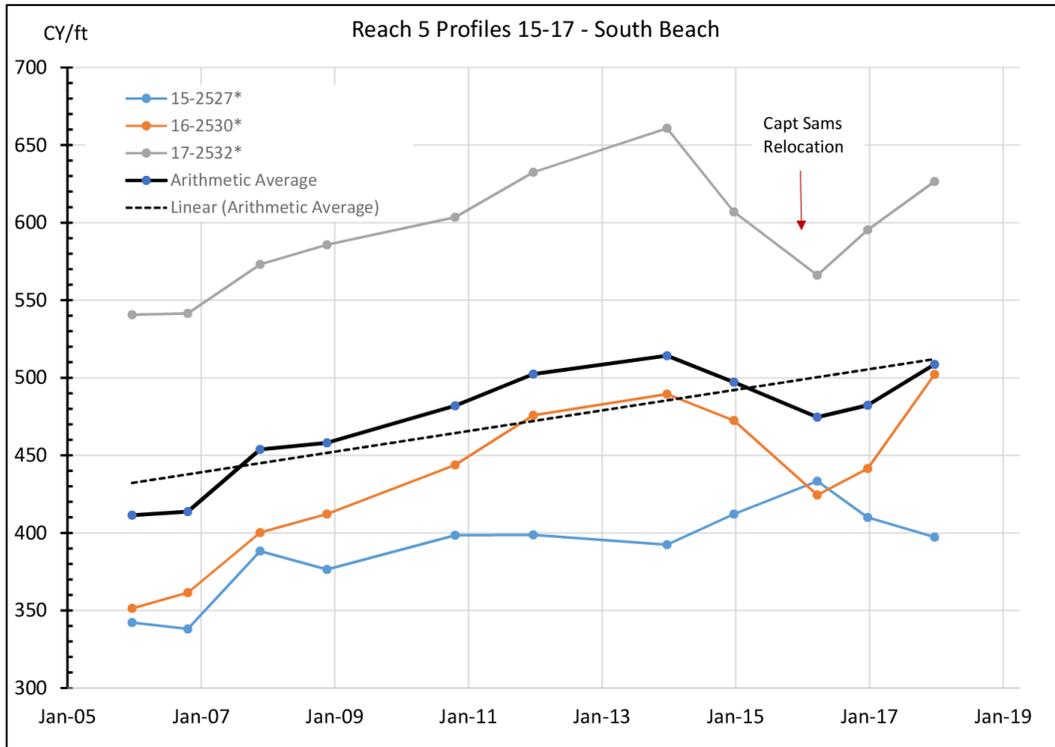
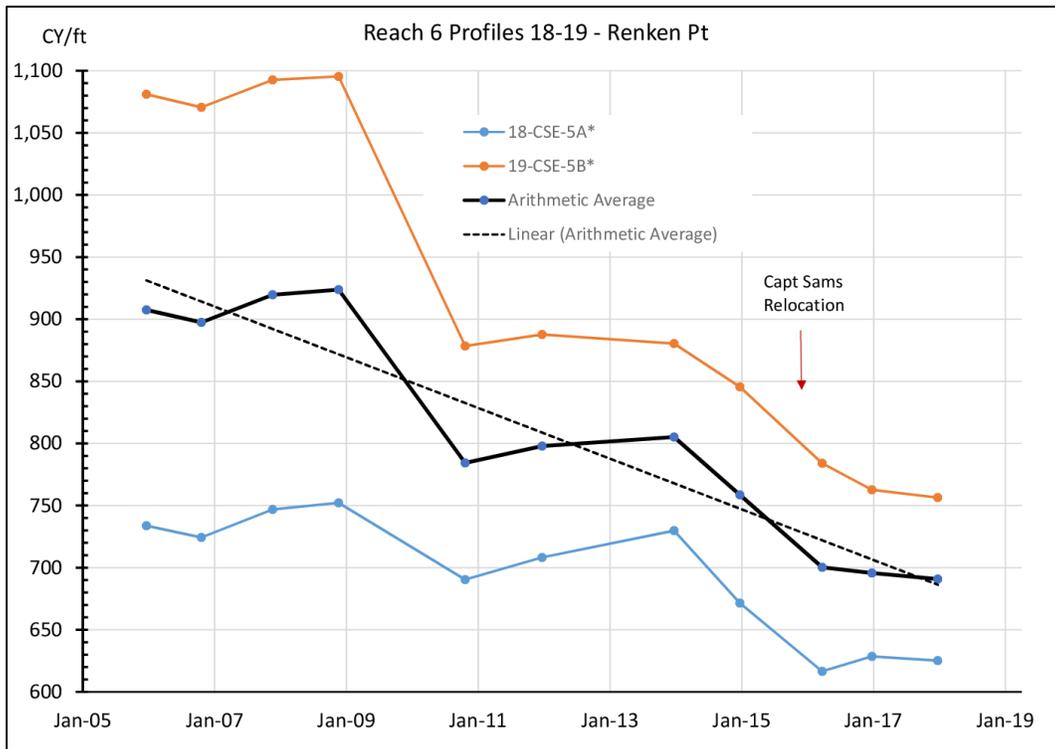
**FIGURE 5.1.2h.** Reaches 5–6 showing the 14-year average unit-volume change rate by station. Order of transects is from downcoast to upcoast (generally southwest to northeast). Linear average of all stations within the reach is shown in black.

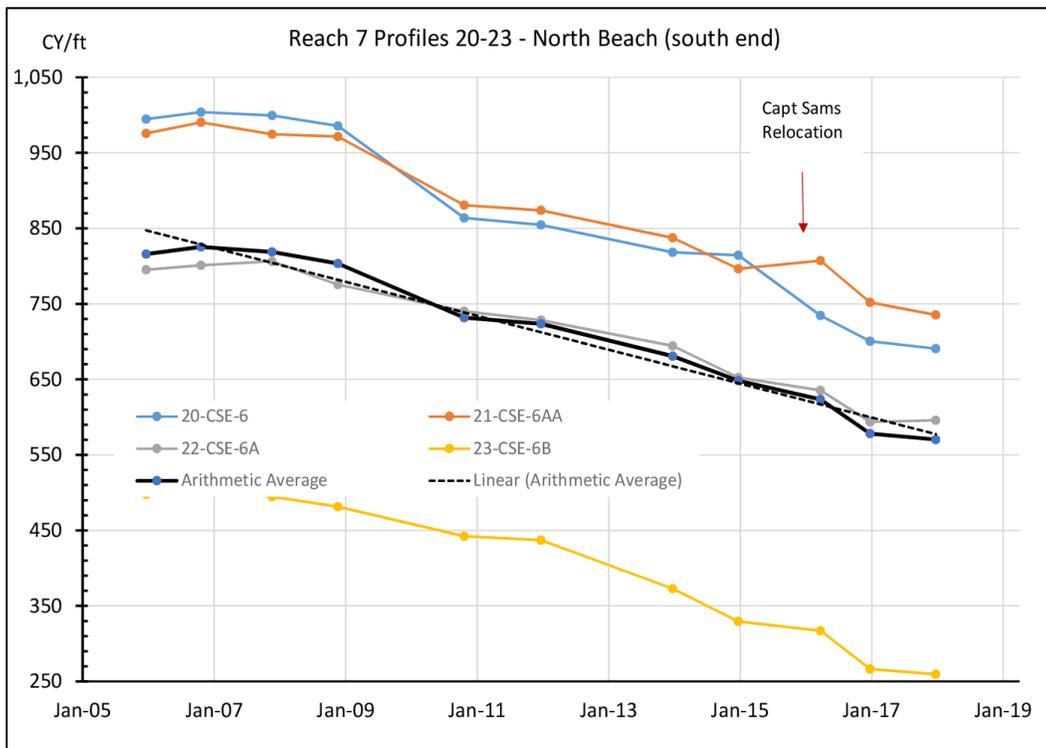
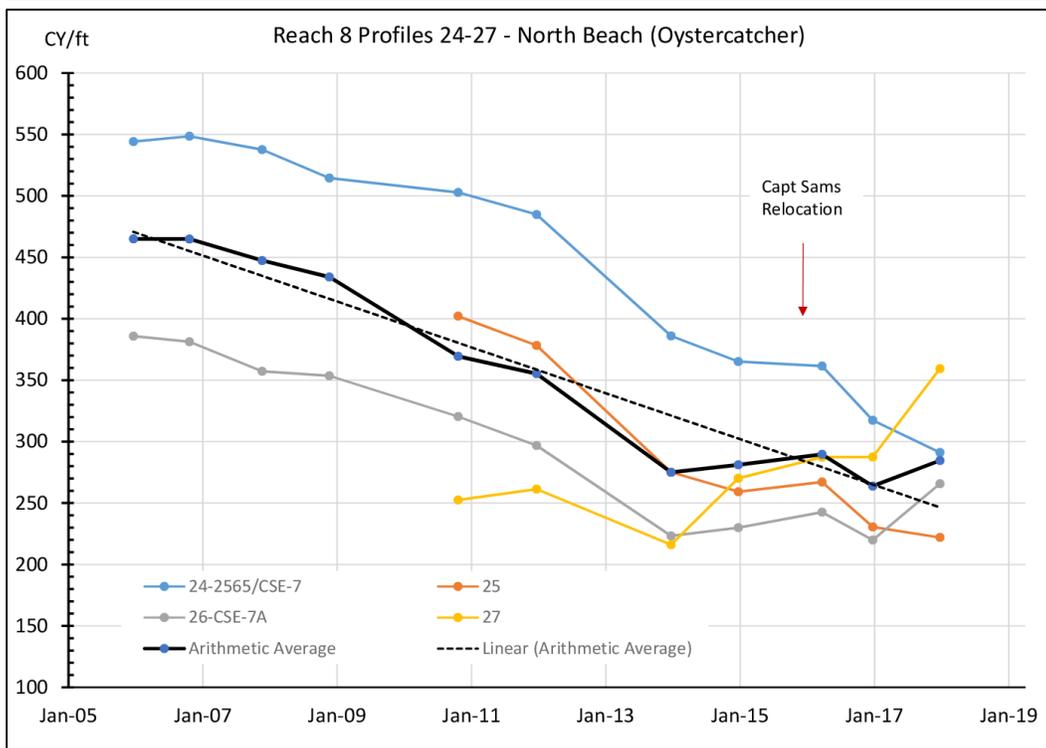
**FIGURE 5.1.2i.** Reaches 7–8 showing the 14-year average unit-volume change rate by station. Order of transects is from downcoast to upcoast (generally southwest to northeast). Linear average of all stations within the reach is shown in black.

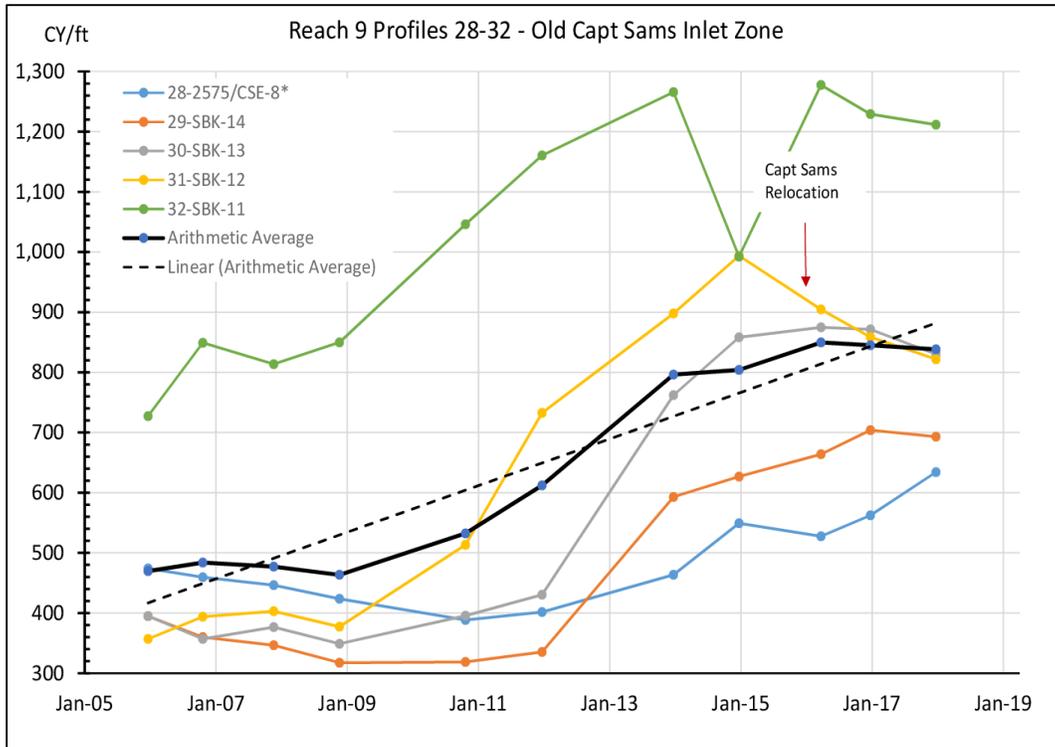
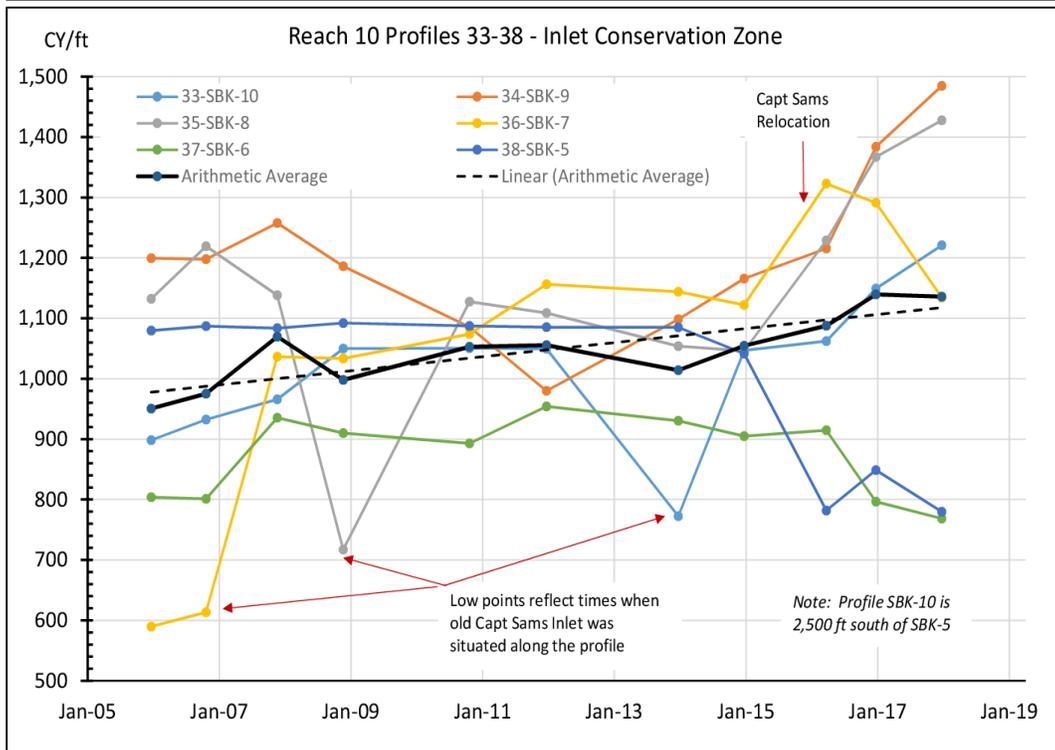
**FIGURE 5.1.2j.** Reaches 9–10 showing the 14-year average unit-volume change rate by station. Order of transects is from downcoast to upcoast (generally southwest to northeast). Linear average of all stations within the reach is shown in black.

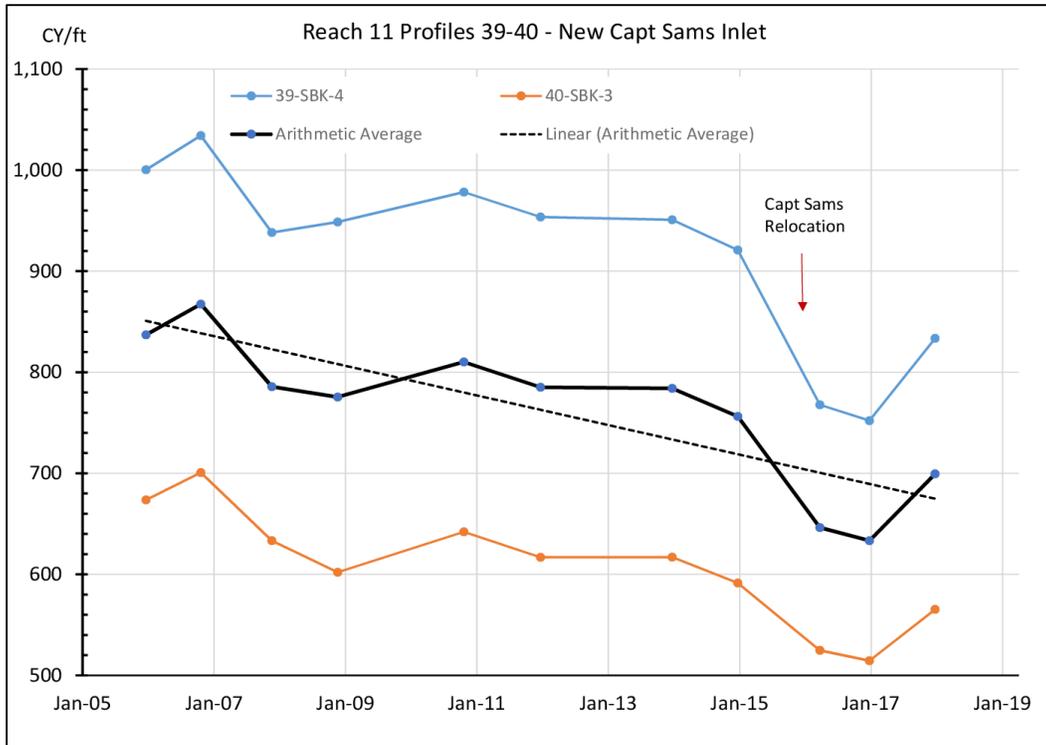
**FIGURE 5.1.2k.** Reach 11 showing the 14-year average unit-volume change rate by station. Order of transects is from downcoast to upcoast (generally southwest to northeast). Linear average of all stations within the reach is shown in black.

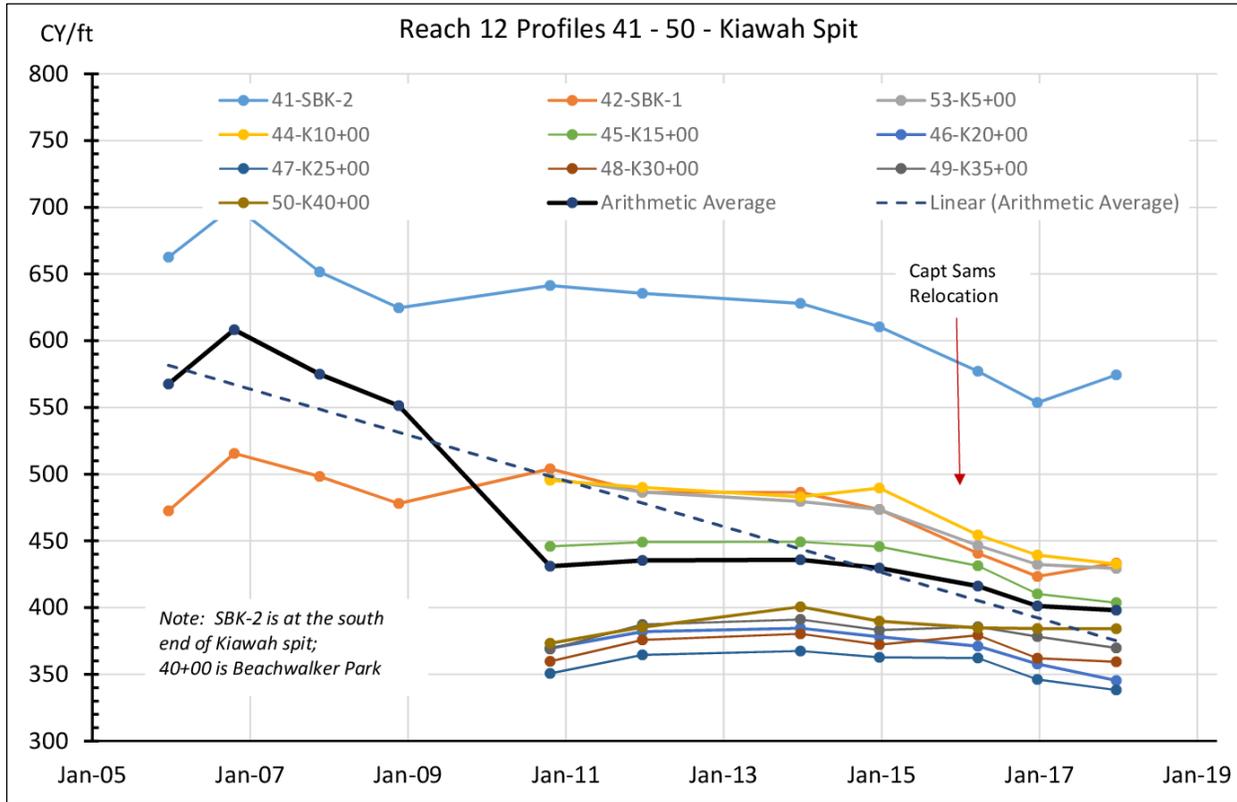
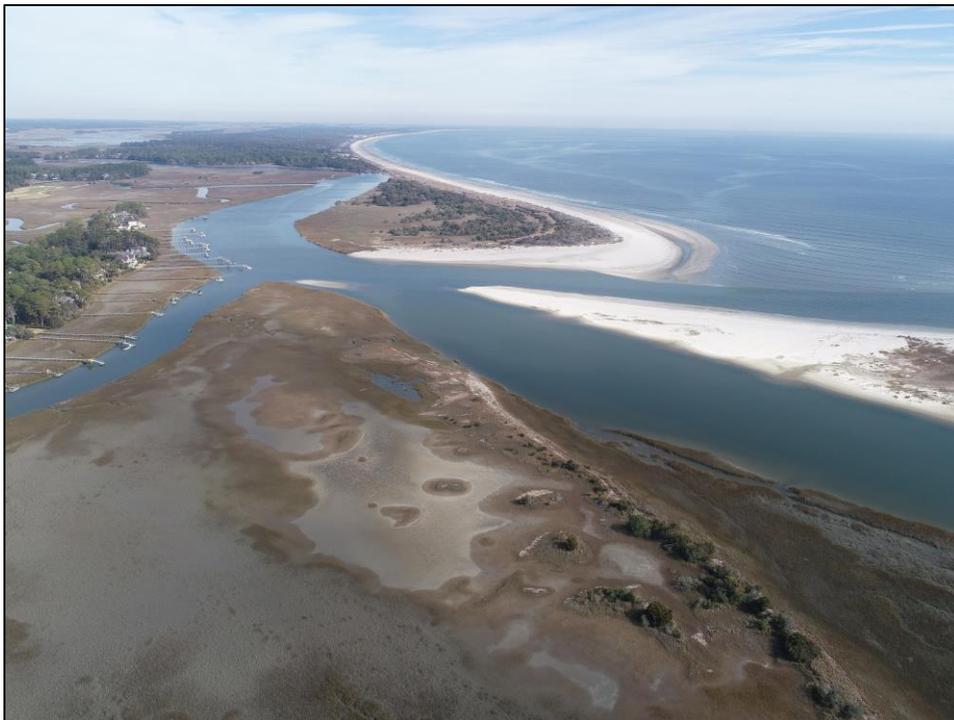
**FIGURE 5.1.2I. [UPPER]** Volume changes in reach 12 along Kiawah Spit since 2005. The western half of the reach has eroded since 2010, while the eastern half (including the area near the neck of the spit) has accreted. **[LOWER]** Kiawah Spit at low tide in January 2019. The large dry-sand beach on the down-stream side of the spit suggests it is growing southwest towards Seabrook as the inlet channel migrates down shore.

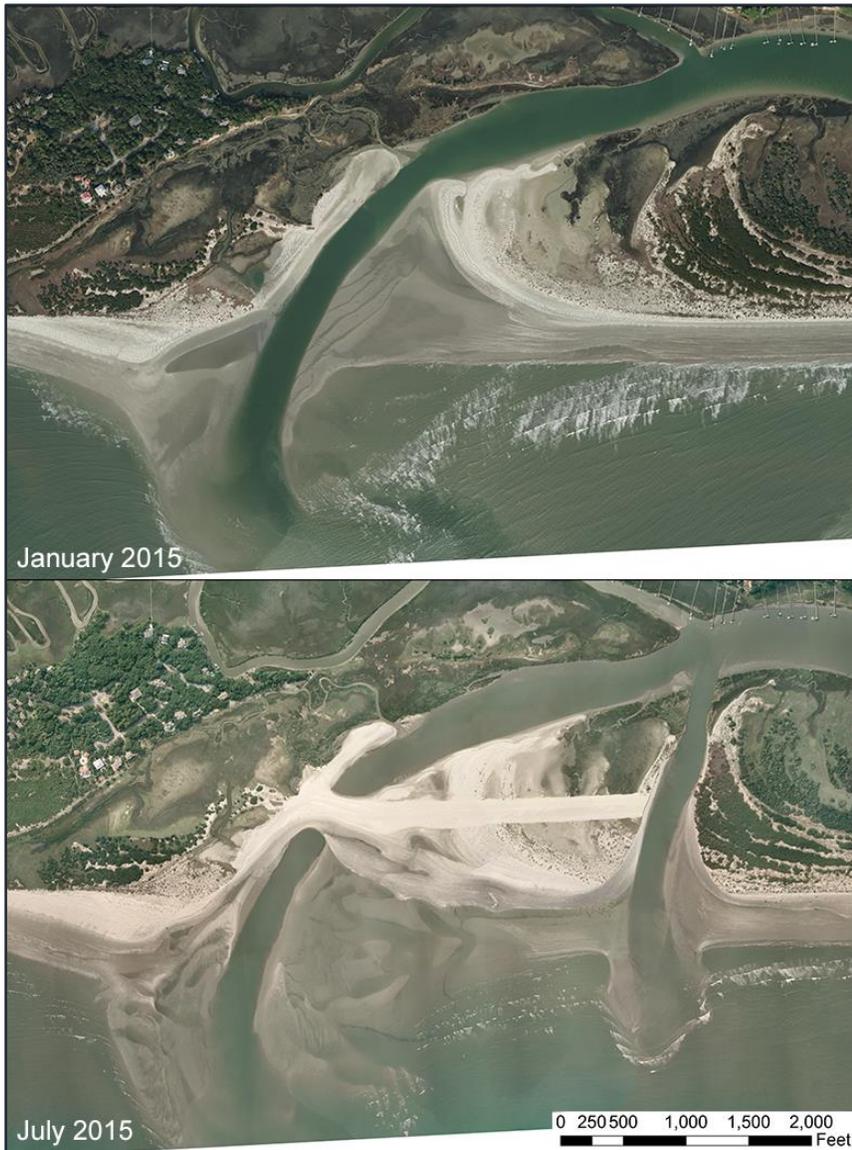
**FIGURE 5.1.3a.** Captain Sams Inlet before and after inlet relocation in 2015. Kiawah spit is to the right and Captain Sams Creek is at the upper right corner of each image. Ortho-rectified aerial photos were prepared by Independent Mapping Consultants Inc (Charlotte NC).

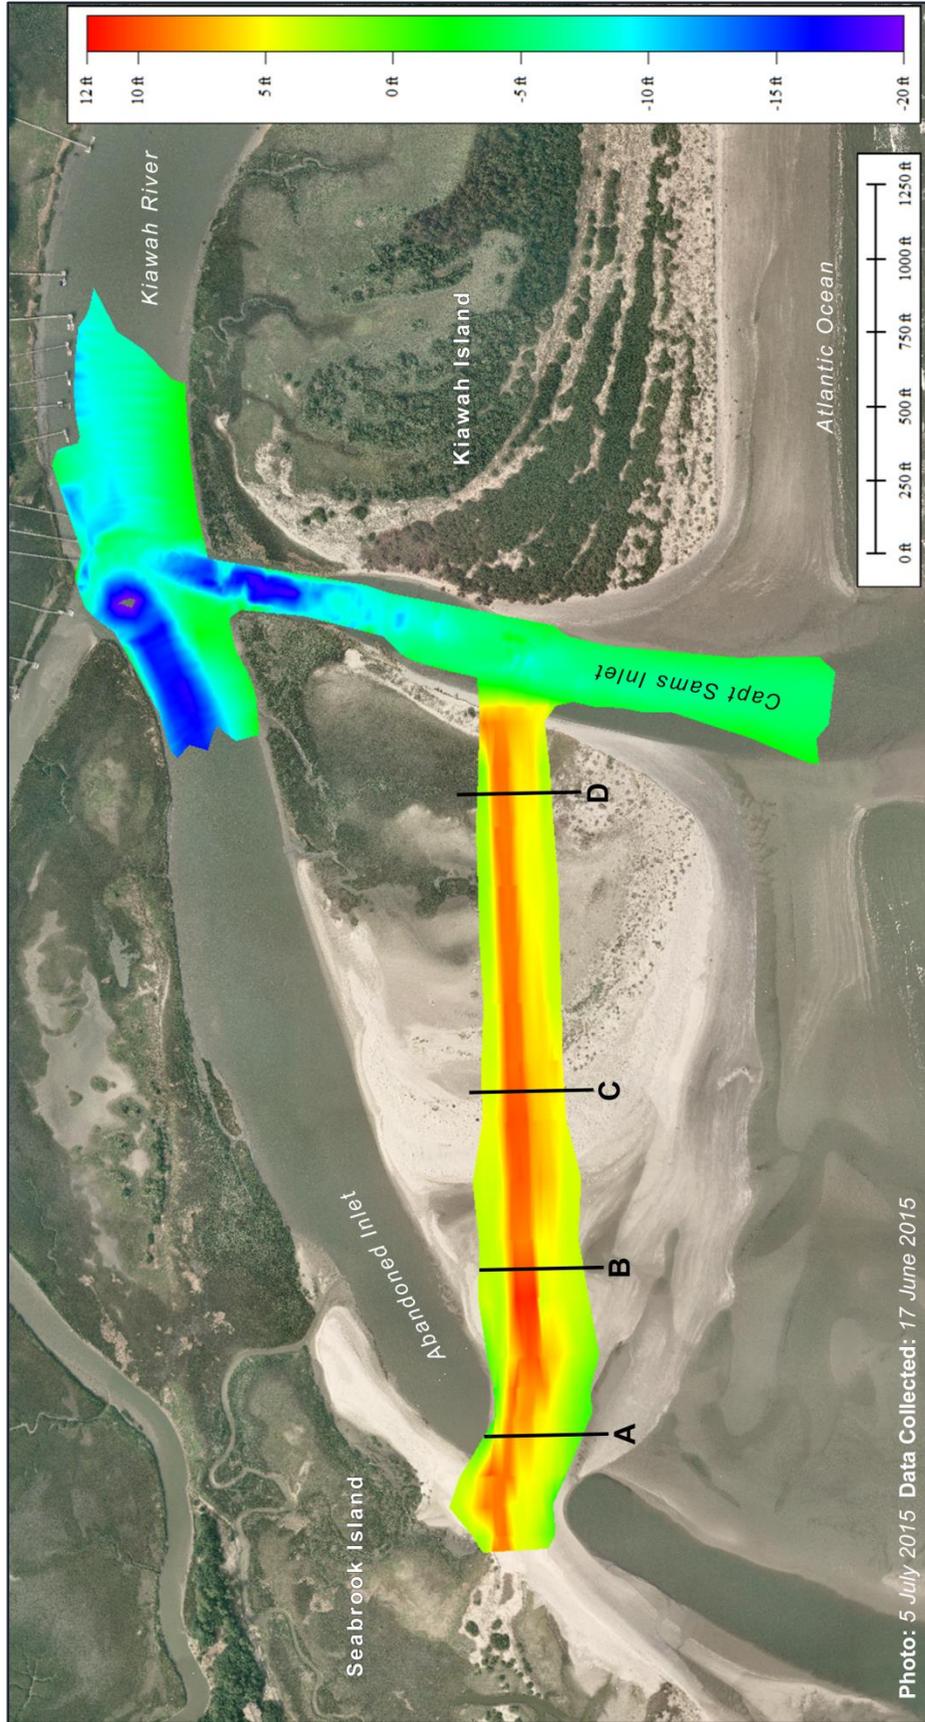
**FIGURE 5.1.3a.** Digital terrain model (DTM) of the completed channel and dike based on RTK-GPS measurements by CSE on 18 June 2015, the day before construction stopped.

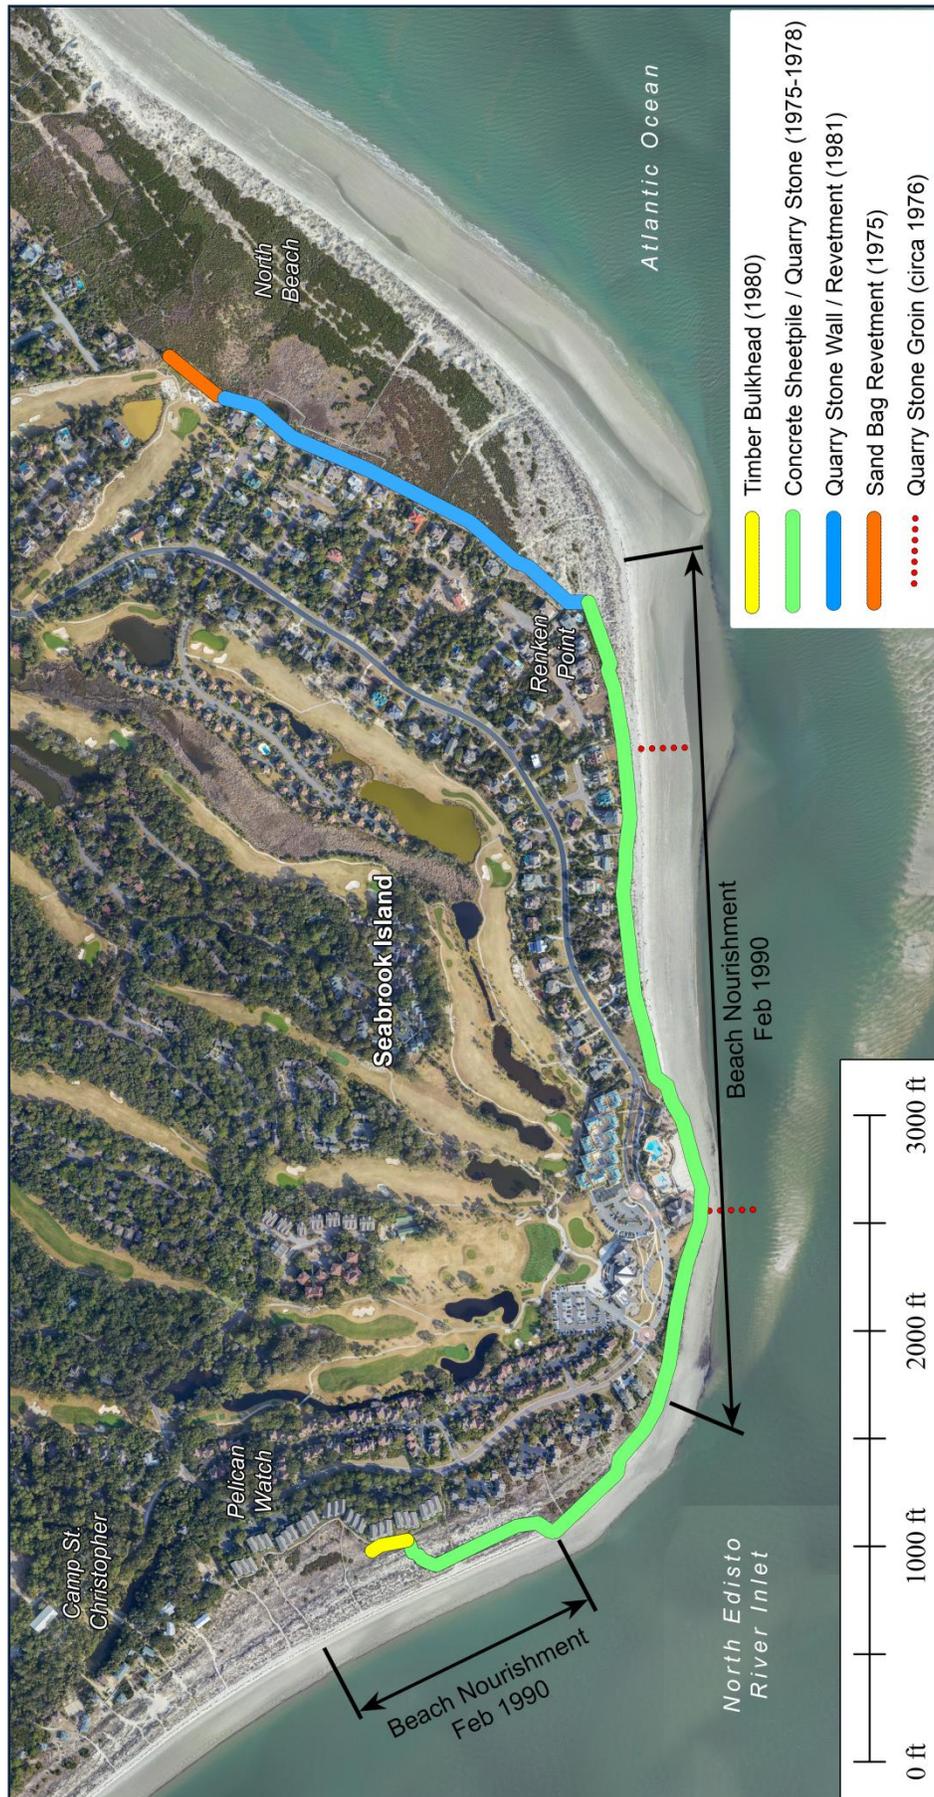
**FIGURE 5.2a** Location of shore-protection projects along Seabrook Island since the 1970s. Captain Sams Inlet relocation (1983, 1996, 2015) occurred between OCRM 2575 and the Kiawah/Seabrook Town easement line (outside image range, see Fig T-3).

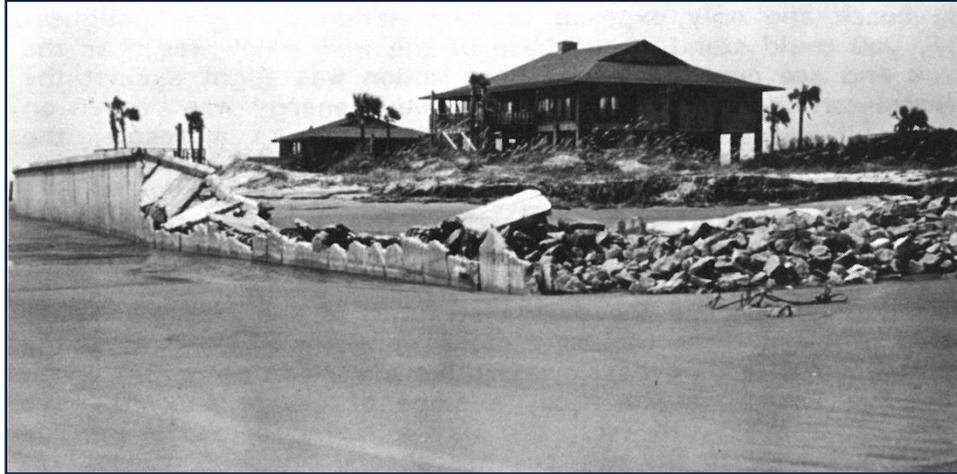
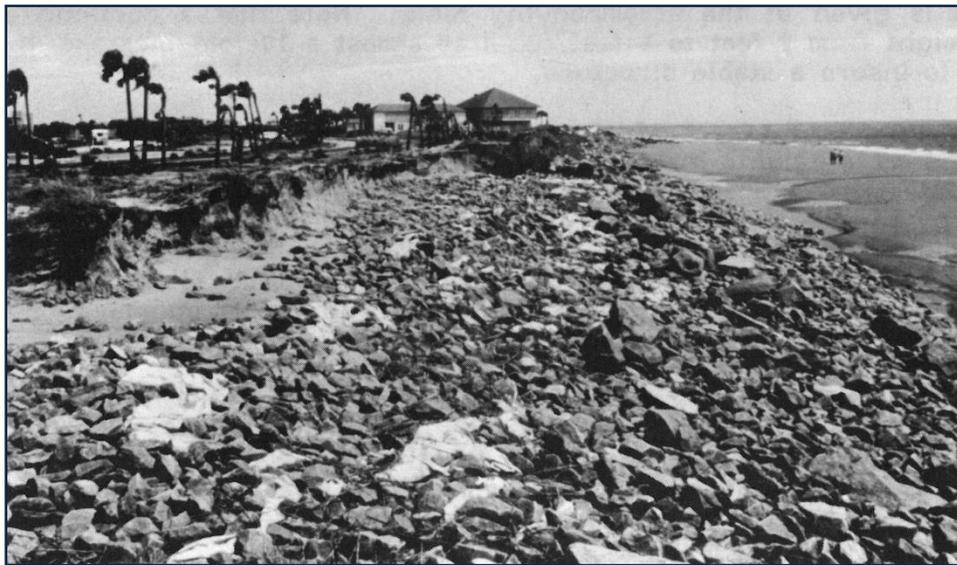
**FIGURE 5.2.3a.** Damages along Seabrook Island due to Hurricane *David* (5 September 1979). **[UPPER]** The concrete seawall and armor-stone “wingwall” at Renken Point on 7 September 1979. **[LOWER]** Collapsed riprap revetment south of the Beach Club on 5 September 1979. [Photos by WJ Sexton]

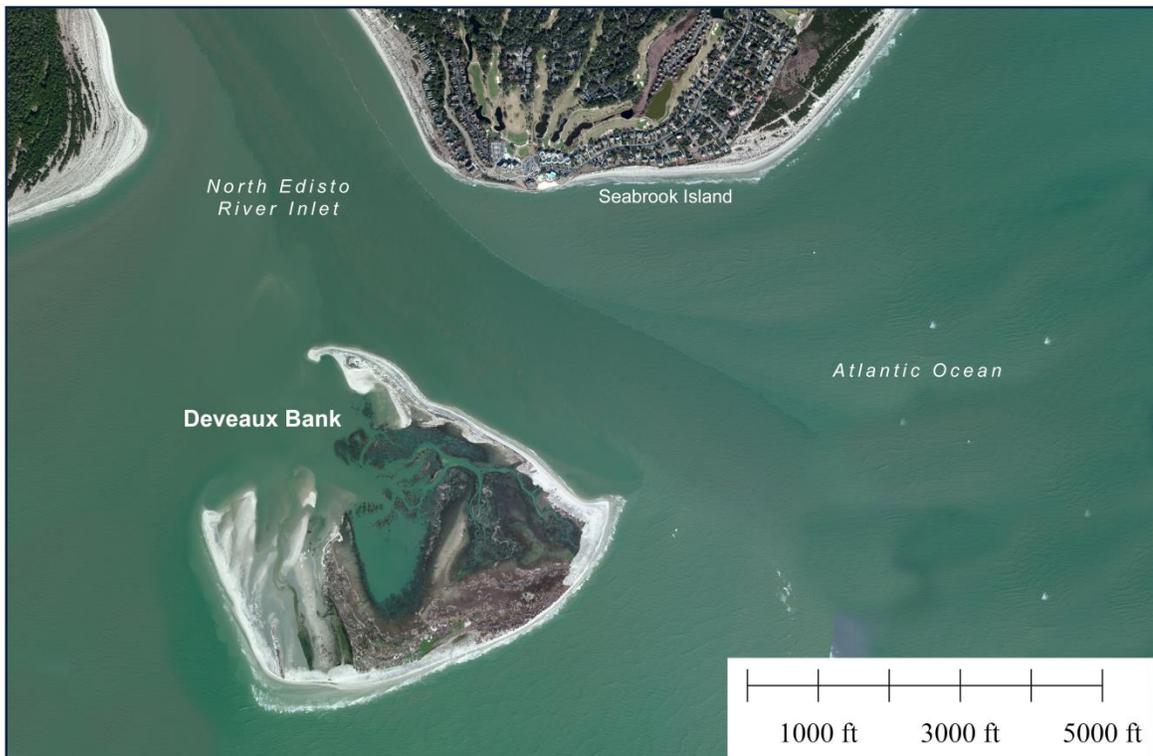
**FIGURE 5.2.3b.** Aerial photo of Deveaux Bank in 2012. Deveaux Bank is presently a well-established island, which serves as a natural breakwater to the south shoreline of Seabrook Island.
