# TOWN OF SEABROOK ISLAND

**TOWN OF SEABROOK ISLAND, SC  
ORDINANCE NO. 2014-05  
ADOPTED DECEMBER 16, 2014**

**AN ORDINANCE TO ADOPT AN UPDATED COMPREHENSIVE BEACH  
MANAGEMENT PLAN FOR THE TOWN OF SEABROOK ISLAND**

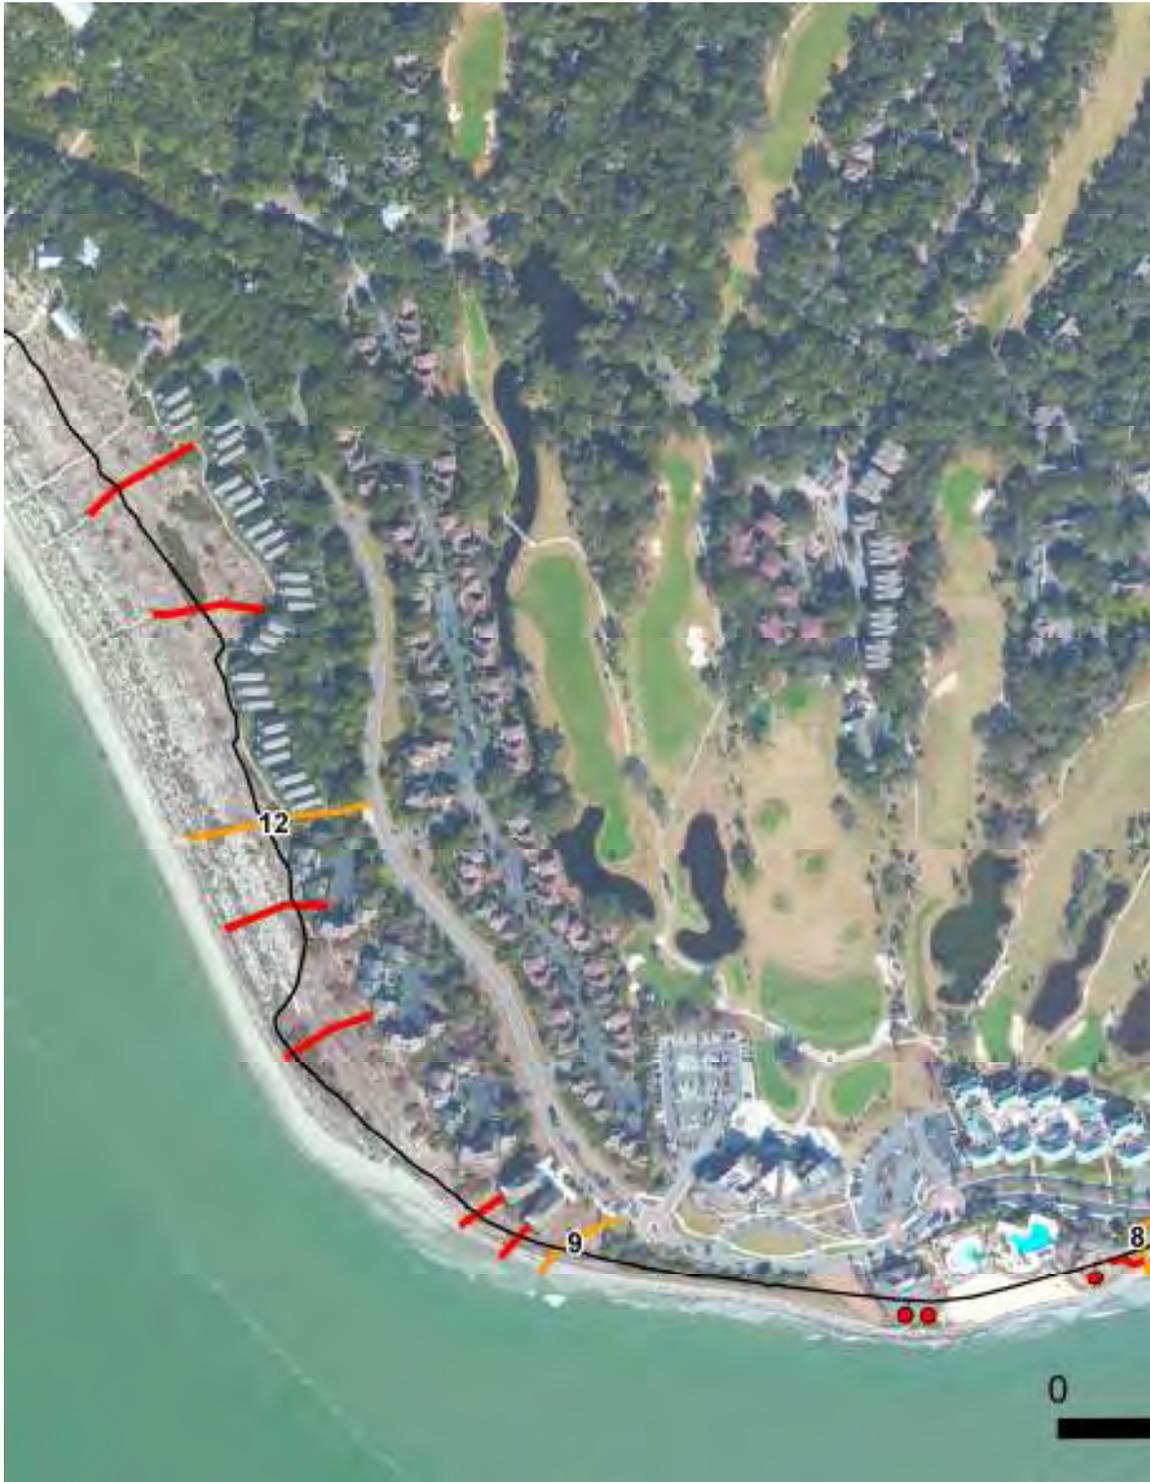
Picture 2.3.1 (a) West Seabrook Island Beach accesses and structures seaward of the Setback Line

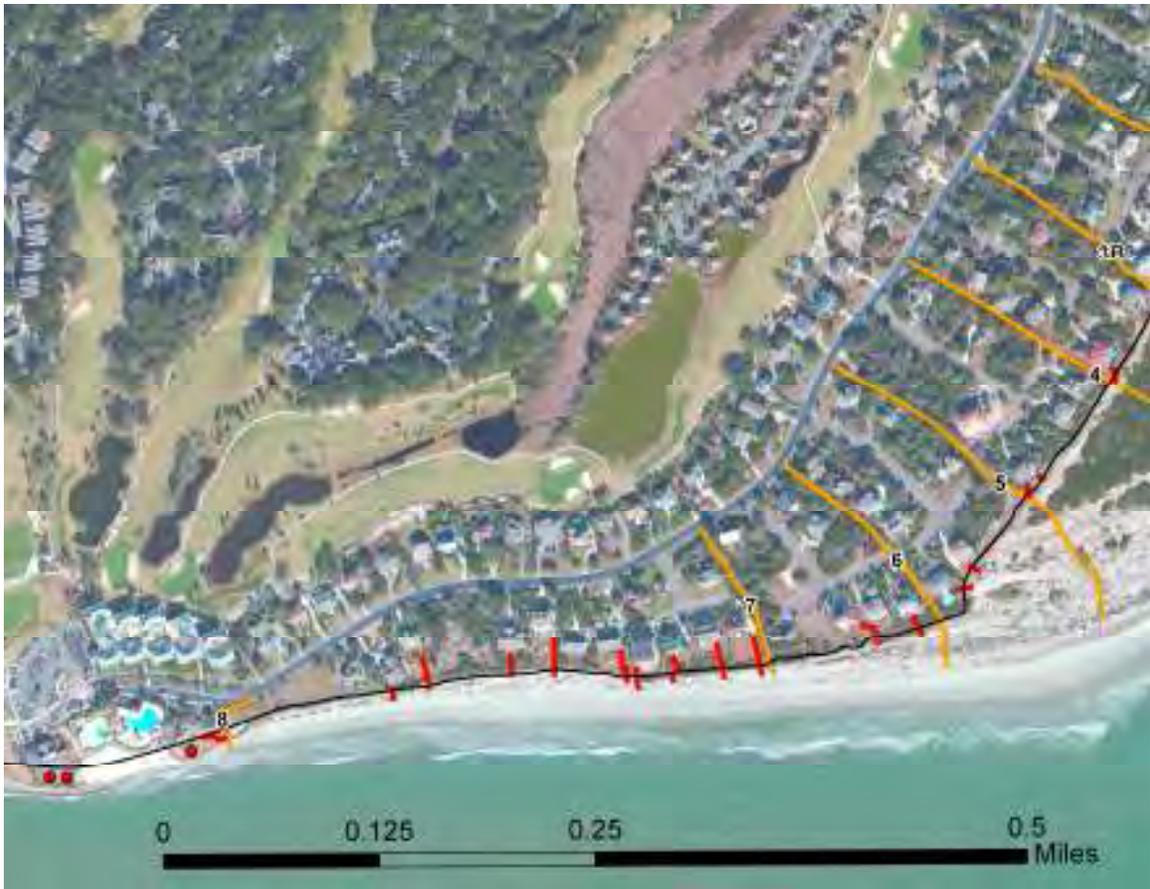
Picture 2.3.1 (b) South Beach Seabrook Island beach accesses and structures seaward of the Setback Line

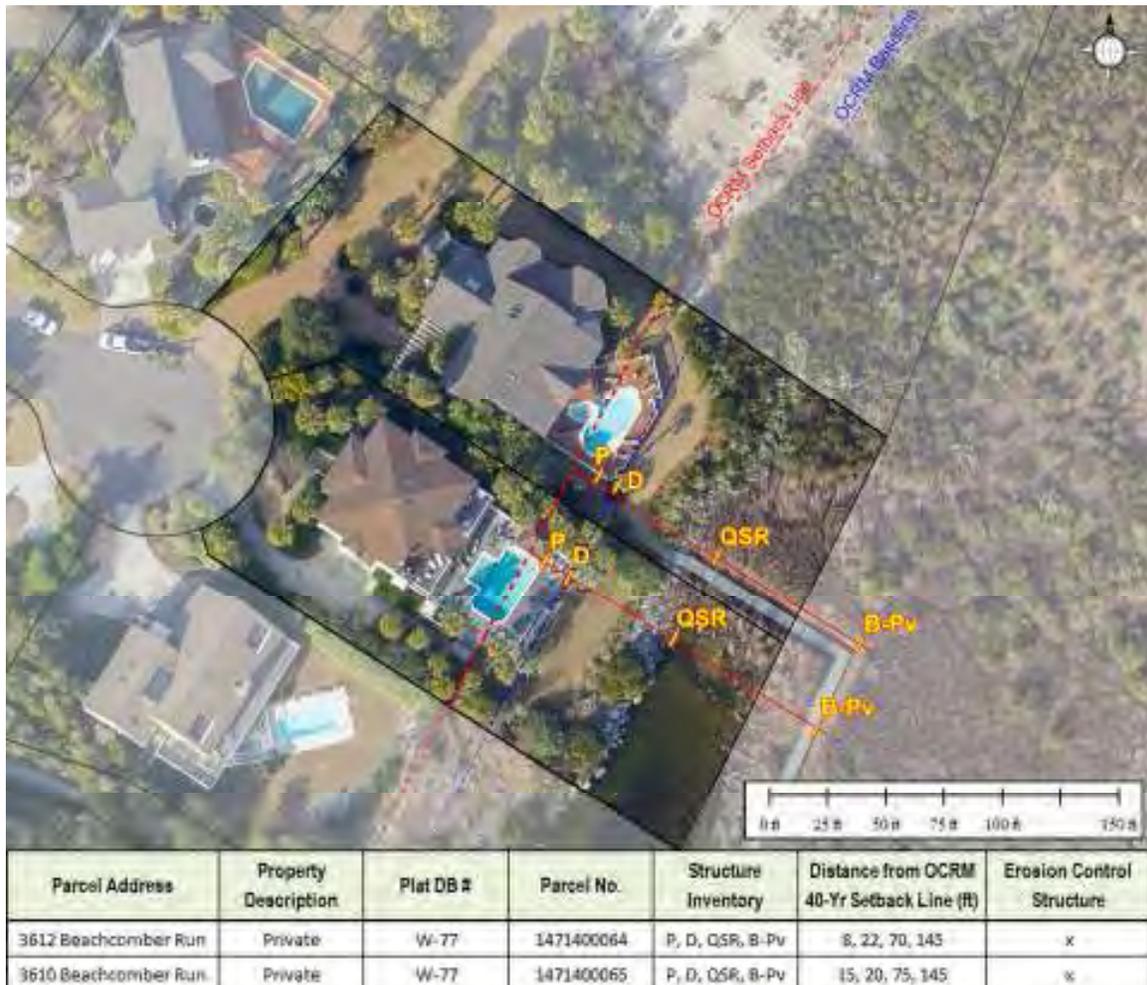
Again there are five structures that are not beach access boardwalks or revetment sections that are Seaward of the Setback Line. Two of the structures are swimming pools that were built before incorporation of the Town. They are both consistent with the State’s policy requiring that they be located as landward as possible of an existing, functional erosion control device. The revetment seaward of these two pools also meets this criteria. The picture below shows these two pools that are on adjacent properties on the beach end of Beachcomber Run.

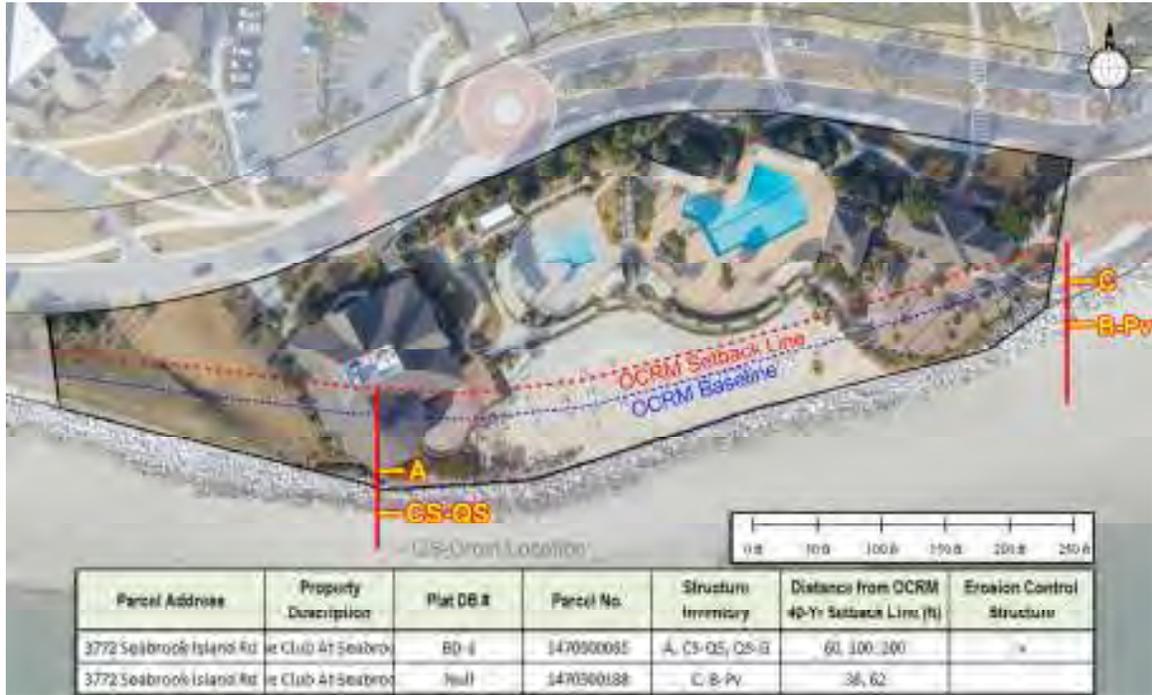
The third structure is the patio cover over the Pelican’s Nest bar and restaurant area. This structure replaced a much older, larger and less robust structure and it is less infringing on the Setback Line. When the Town approved the project and the county granted the necessary permits, this structure was landward of the setback line. Changes in the location of the Baseline and Setback Line in 2009 changed the status to seaward of the line. Another Seabrook Island Club structure seaward of the Setback Line is a special events building that has been a part of the Club facilities for many years. It was remodeled, without change to its footprint, with the overall Club facility improvements as a part of the “Horizon Plan” project in 2007. It has remained within the original footprint since it was built. The project implementing these major improvements to the Seabrook Island Club facilities that include these two structures reduced the total floor space for

Club structures seaward of the Setback Line. The picture below shows the position of these structures in relation to the current Setback Line, Baseline and to each other.

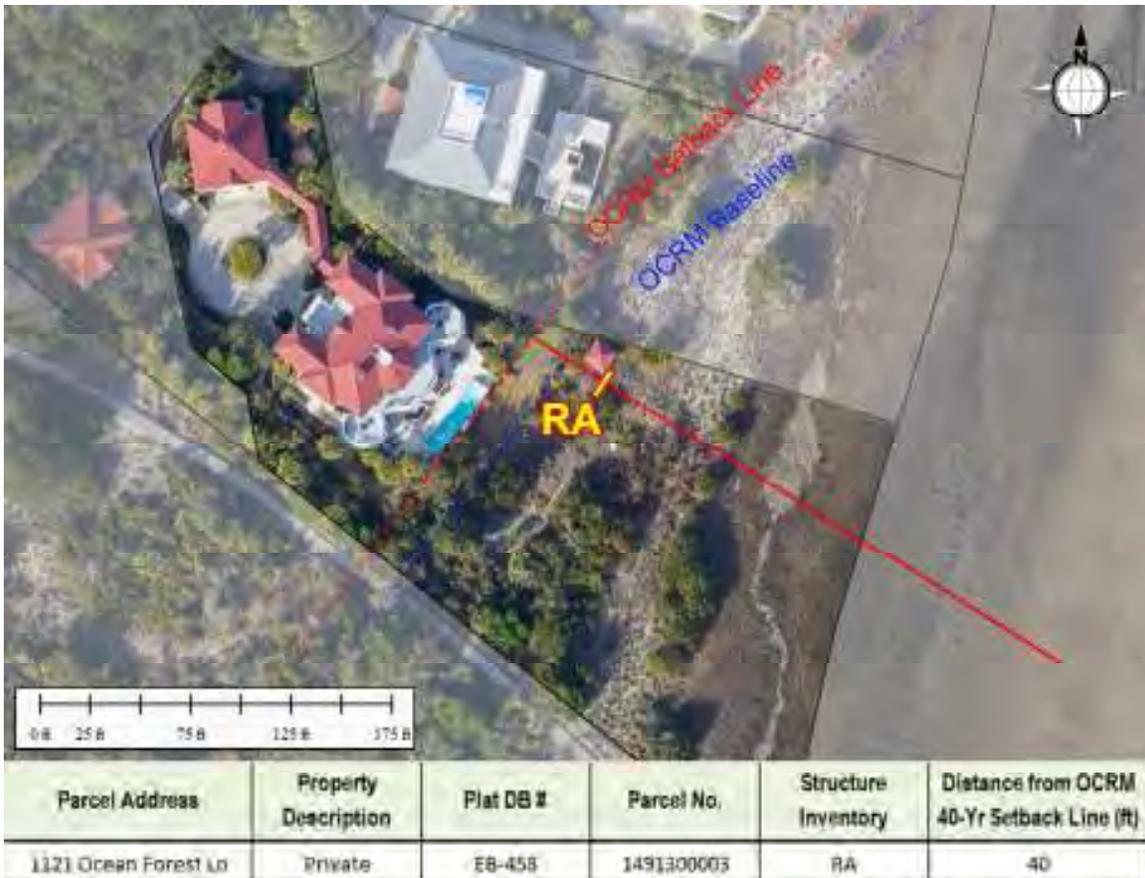
The fifth and last structure on Seabrook Island that is seaward of the Setback Line is a gazebo behind the property at 1121 Ocean Forrest lane. This small structure was properly permitted when it was built along with the home on that lot. The picture below shows the position of this structure in relation to the current Setback Line and Baseline.

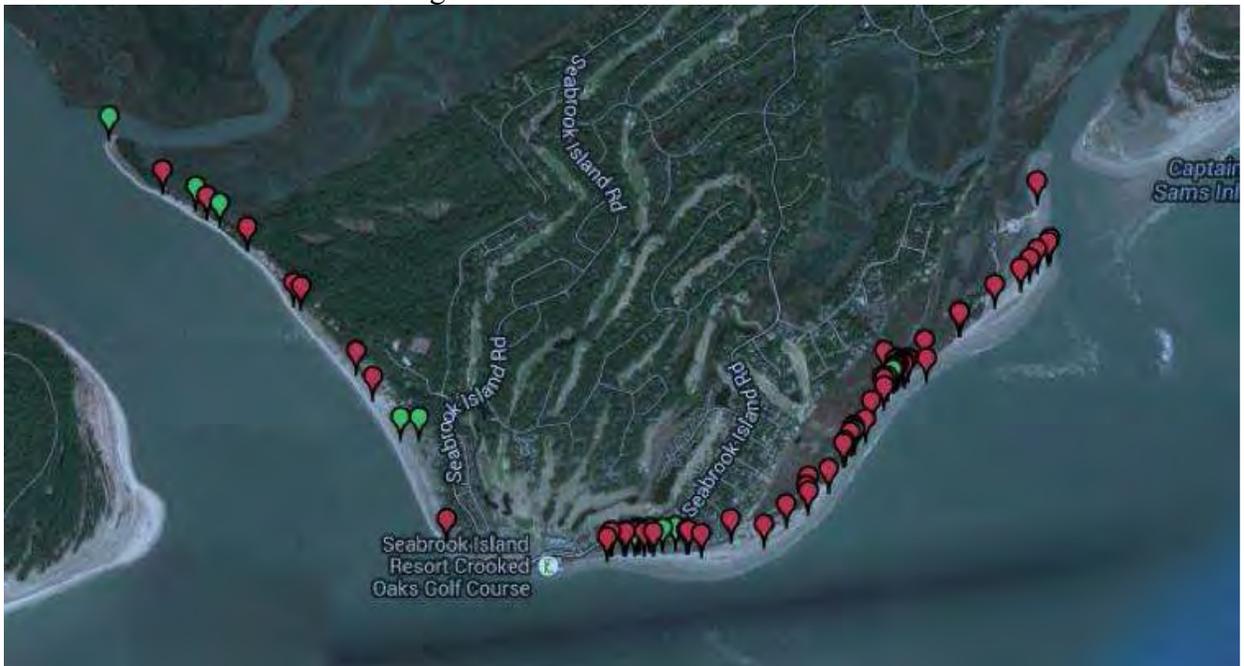
Picture 2.4 2013 Loggerhead sea turtle nests for Seabrook Island (as described above)

Map 2.4 below depicts the Seabrook Island loggerhead sea turtle nests for the year 2013. The green figures indicate in situ nests and the red figures indicate the pre move location of the nests that were relocated. The high level of nest moves was due to concerns about erosion causing over wash or complete destruction from erosion. This map shows the fairly even spread of nests along the entire Seabrook Island shore. In 2014, much of the upper coast part of Seabrook Island lost its dry sand beach due to erosion resulting from delays in relocation of Captain Sams Inlet. This erosion has eliminated a large section of beach where the turtles laid their nests in prior years. This process should be reversed if we are able to relocate the inlet. The inlet relocation project is discussed in detail in Section 5 “Erosion Control Management” of this Plan.

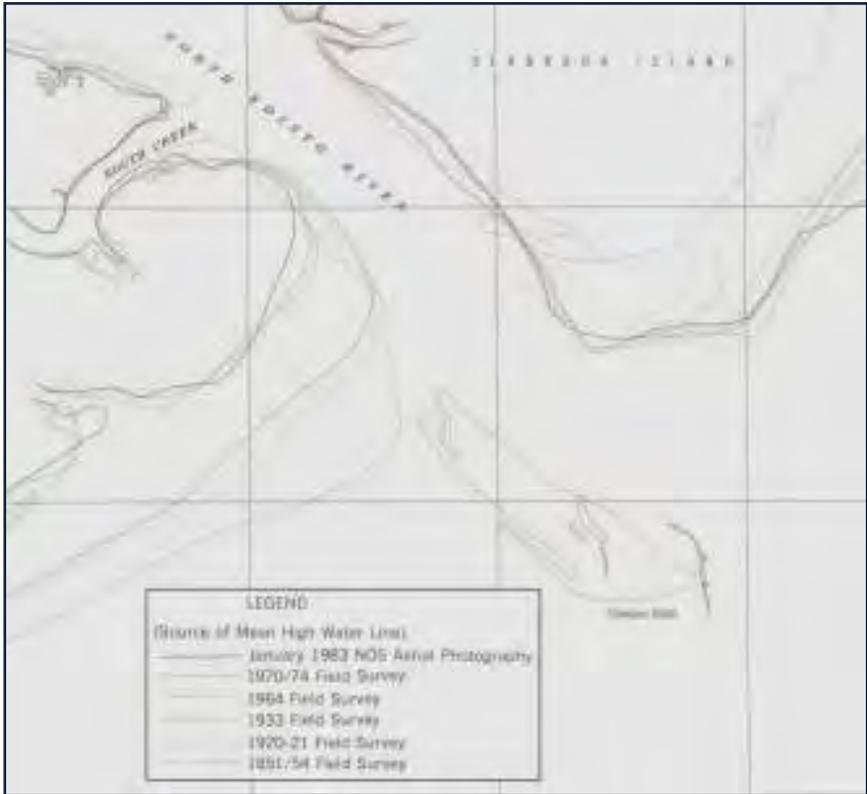
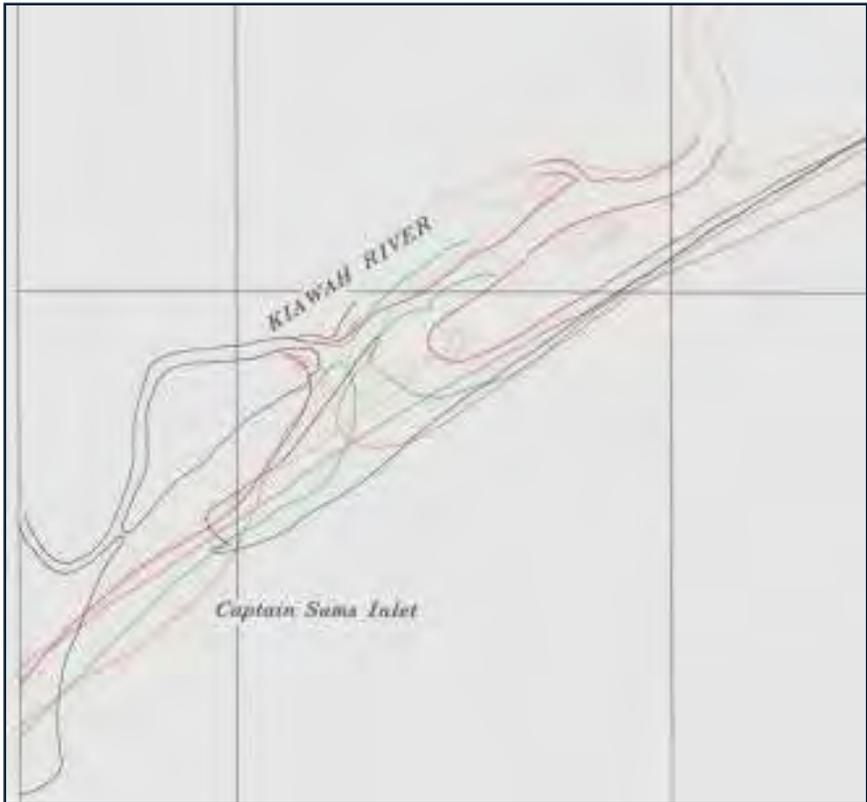
**FIGURE 5.1d** Official historical shorelines developed by NOAA-NOS Cooperative Shoreline Study (1983) for the Seabrook Island area.

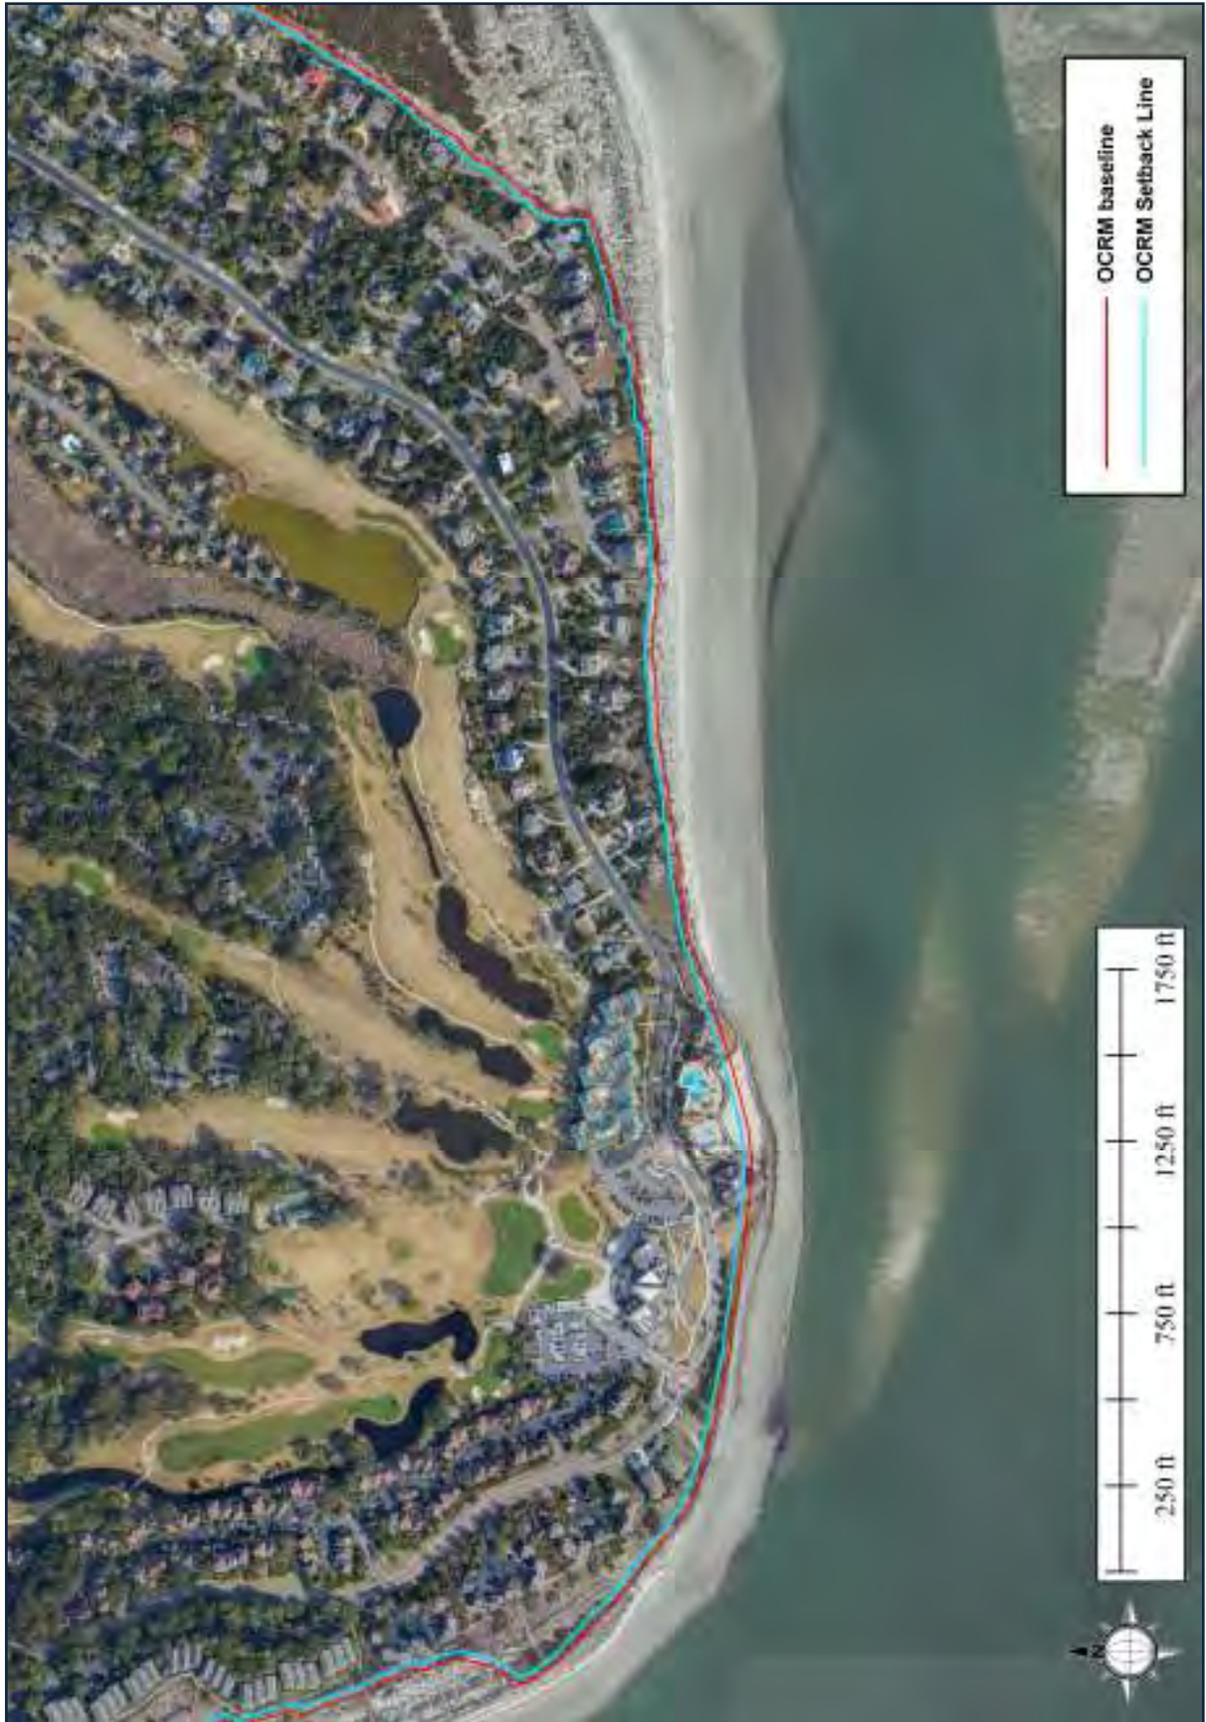
**FIGURE 5.1j** Official 2012 OCRM Baselines and Setback Line for a portion of Seabrook Island superimposed on a 2012 rectified aerial orthophotograph. The only structure encroached by the lines is the “Beach Club” at the lower left side of the image.

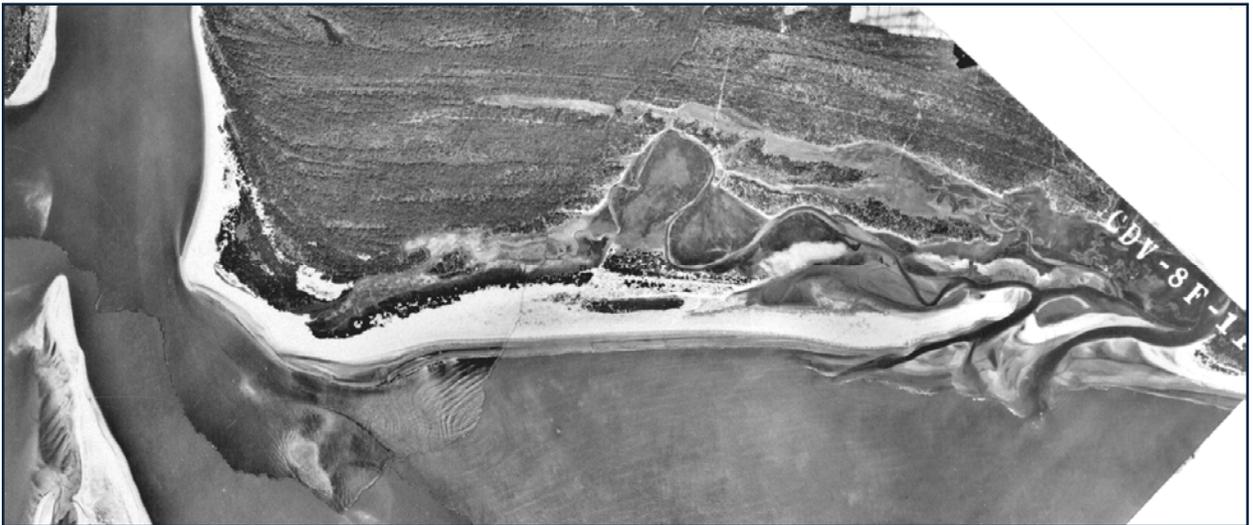
**FIGURE T-2.** Vertical photograph (1949) of Seabrook Island before development. Sometime in 1948, Captain Sams Inlet breached the Kiawah Spit near present-day Beachwalker Park (right side of image). The northeastern channel became dominant in the 1950s.

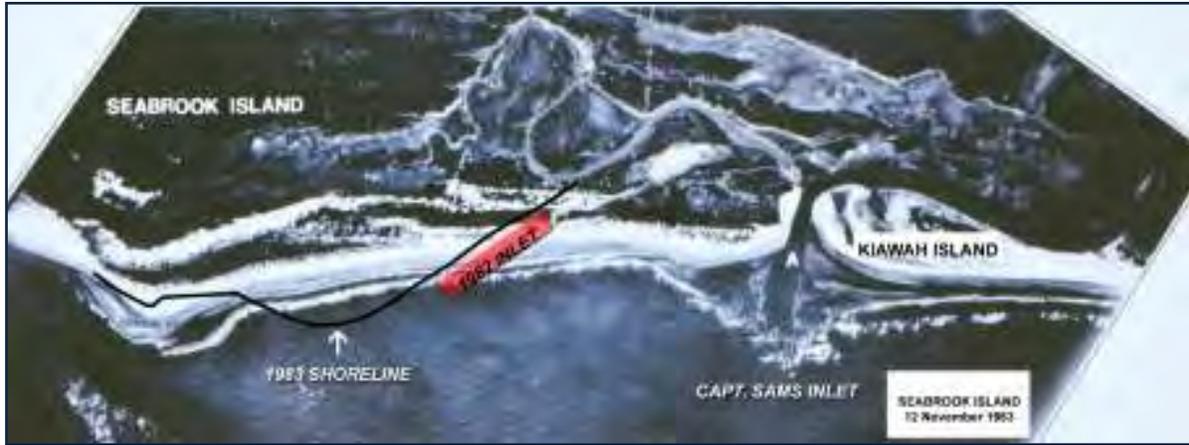
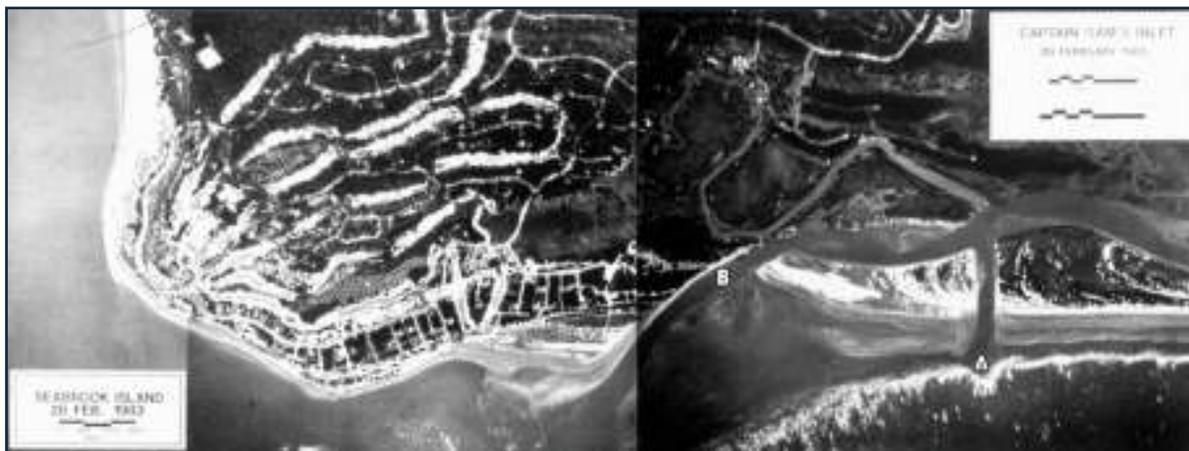
**FIGURE T-3.** Seabrook Island and Captain Sams Inlet in 1963 (upper) and 1983 (lower). The 1963 condition served as a model for the plan to relocate Captain Sams Inlet. Lower photo shows the new channel (A) open before the old channel (B) was closed on 4 March 1983.

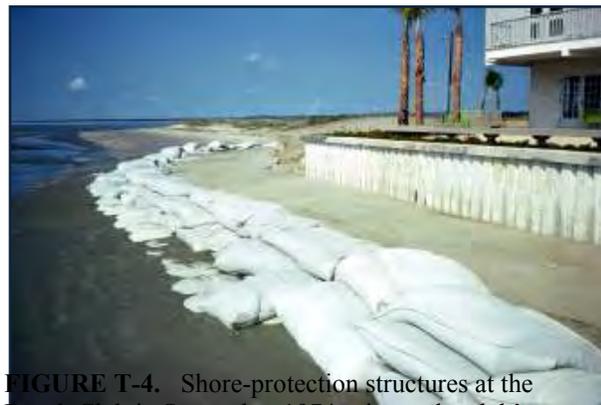
**FIGURE T-4.** Shore-protection structures at the Beach Club in September 1974 prior to the club's opening.

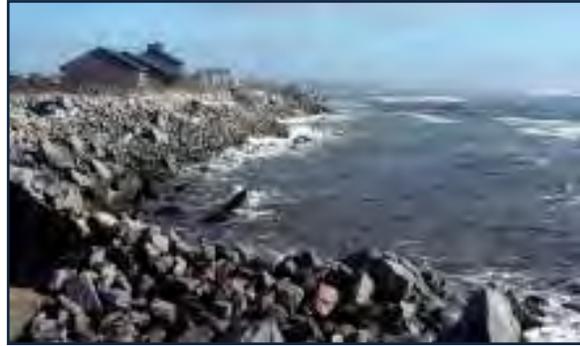
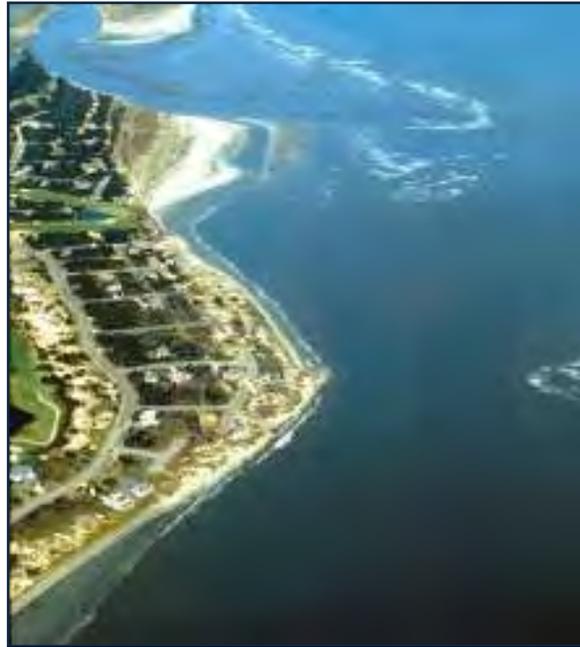
**FIGURE T-5.** During the early 1980s, much of Seabrook lacked any beach even at low tide. [UPPER] View north from Renken Point at mid tide. [LOWER] Oblique aerial (1982) looking north at low tide showing no beach around Renken Point.

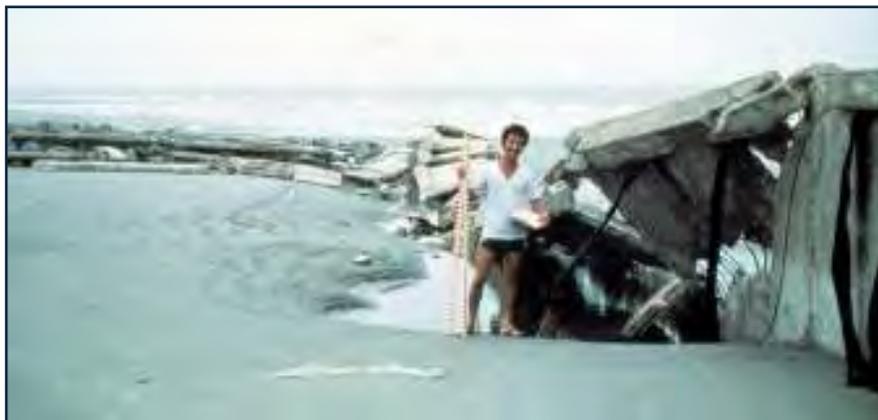
**FIGURE T-6.** Collapse of the concrete seawall at Renken Point in September 1979 during Hurricane *David*.

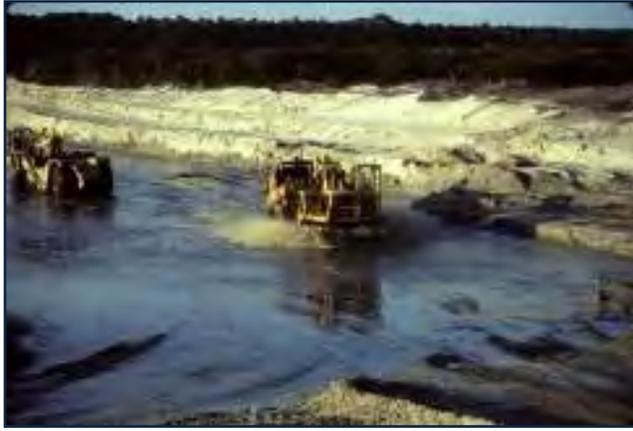
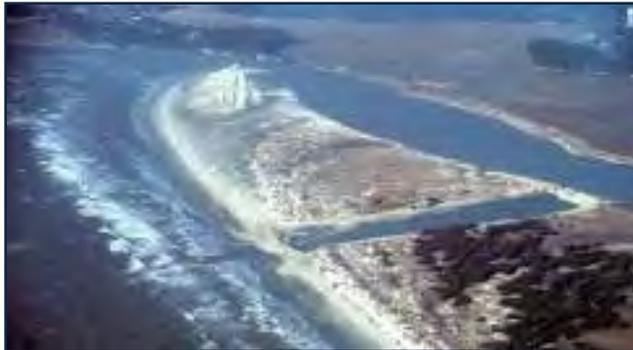
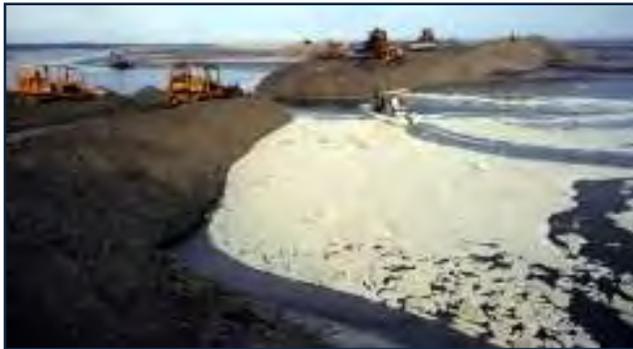
**FIGURE T-7.** February-March 1983.

**MAR 1983** First relocation of Captain Sams Inlet ~1.5 miles north to its 1963 position. Old inlet closed by trucks hauling sand from the new channel basin. Cost of project is (~)\$300,000 (Fig T-7).

**LATE 1980s** North Beach is restored by natural processes as sand from the delta of abandoned Captain Sams Inlet migrates onshore, adding over 1 million cubic yards to Seabrook Island's beach. North Beach is upward of 1,000 ft wide in places, a dry beach is restored, and the rock revetment north of Renken Point begins to be buried by windblown sand.

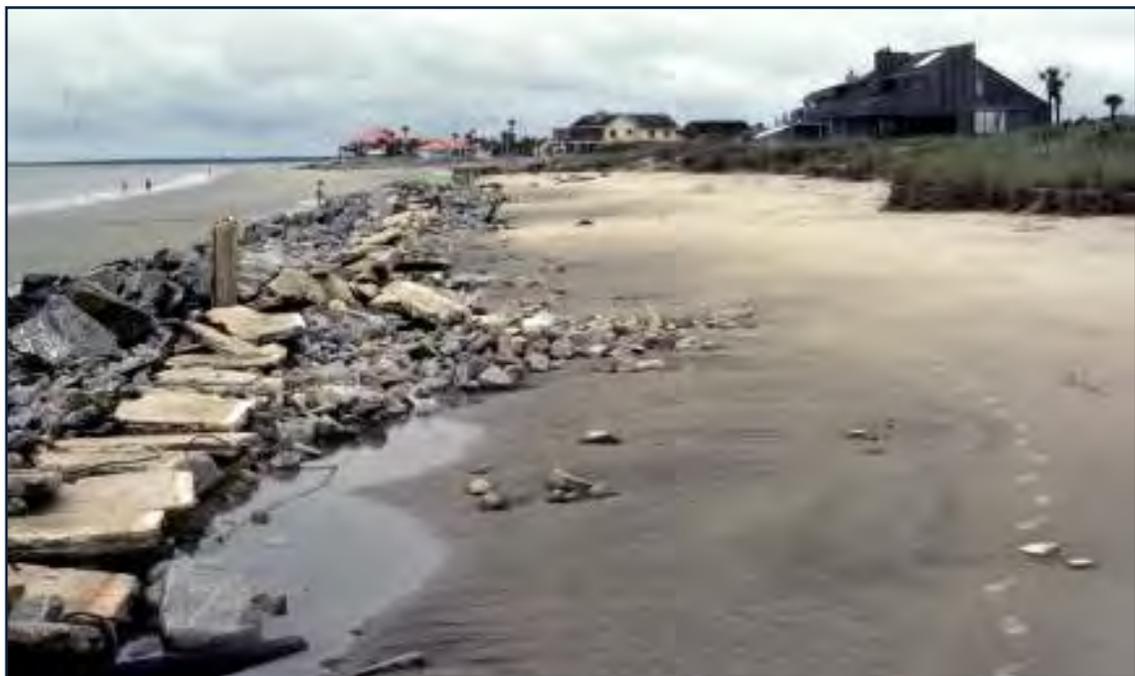
**FIGURE T-8.** [UPPER] Encroachment of the northern channel (deep blue area) of North Edisto Inlet and lack of maintenance leads to [LOWER] collapse of a section of seawall near Beach Court in 1983.

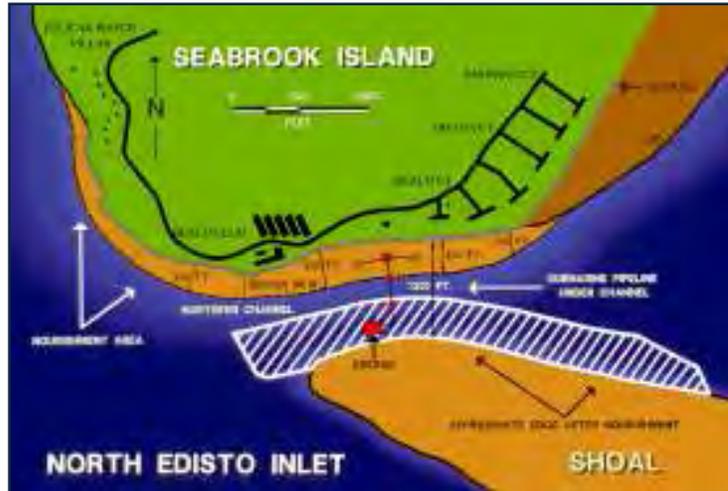
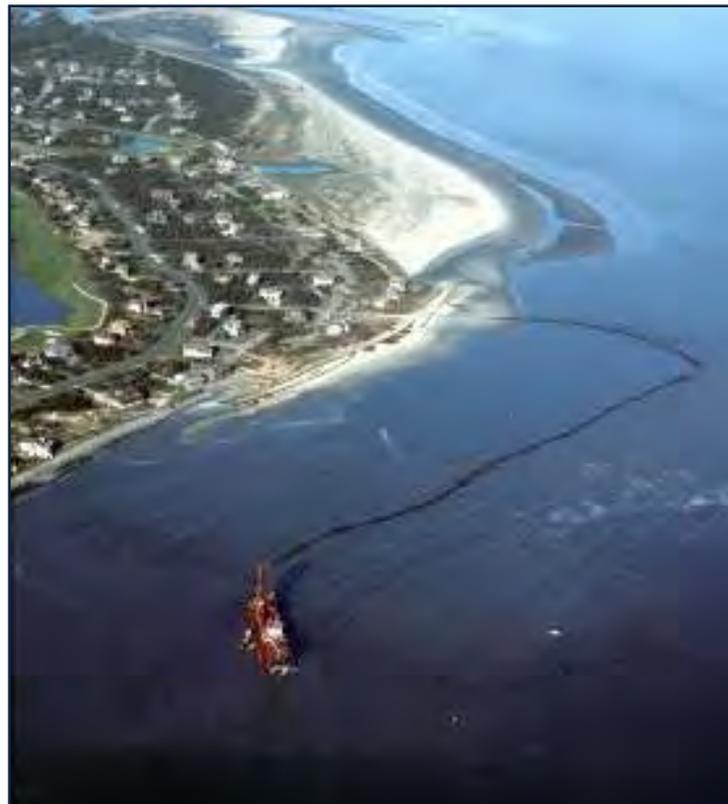
**FIGURE T-9.** [UPPER] 1989 plan for realignment of the northern channel and nourishment south of Renken Point. [LOWER] Start of dredging operations in February 1990 at Renken Point.

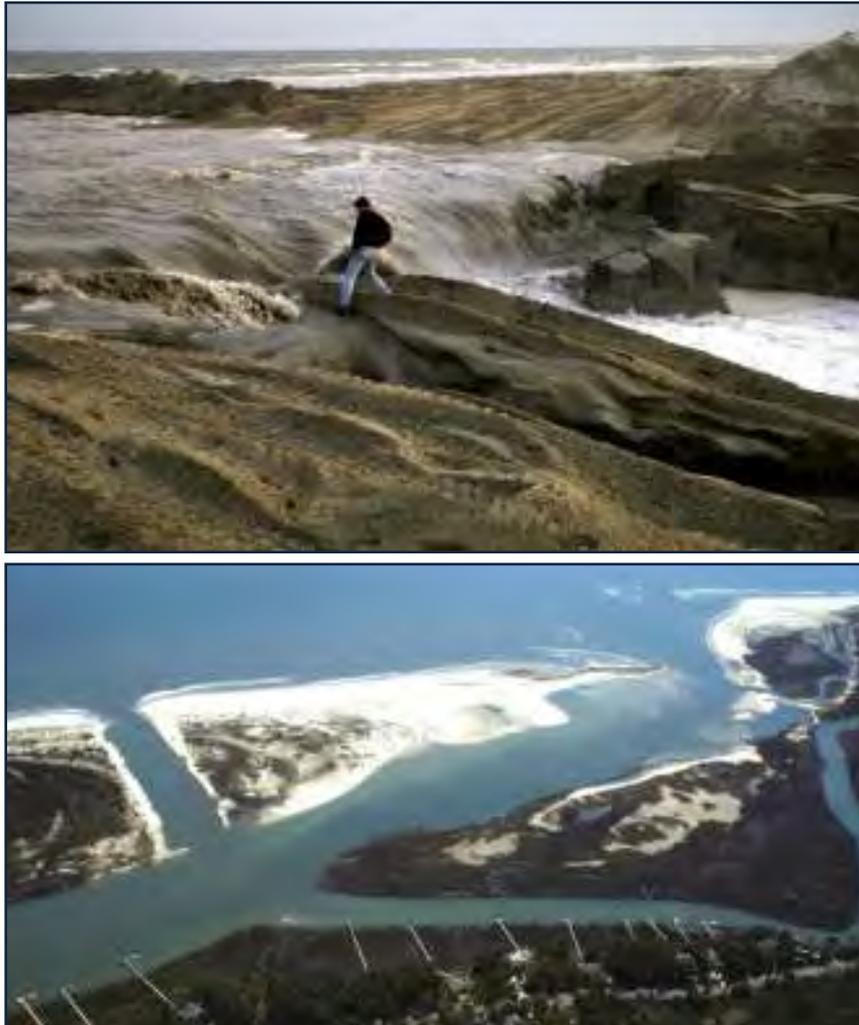
**FIGURE T-10.** The second relocation of Captain Sams Inlet in April 1996. [UPPER] First tide into the channel basin on 4 April during a rising tide. [LOWER] The new channel (left side) before completion of the closure dike across the old channel.

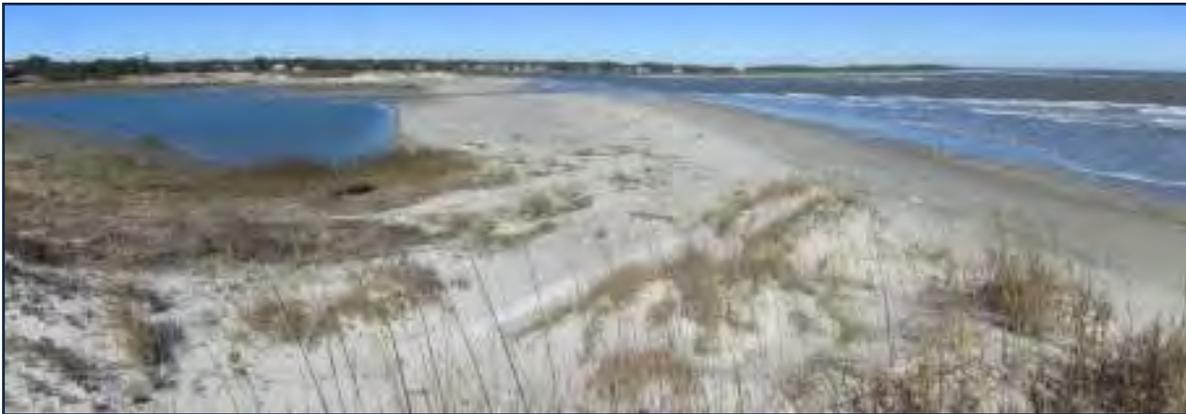
**FIGURE T-11.** Composite image of Captain Sams Inlet area from the Seabrook side in January 2014. The lagoon formed in the abandoned 1996 channel is on the left side of the image.

**2008–Present** Captain Sams Inlet continues to migrate to the west, reaching the approximate location of the 1996 channel. Erosion intensifies along portions of North Beach. Without sand-scraping, sediment supply to the rest of Seabrook Island is reduced, resulting in erosion of the area near the Seabrook Island Club facilities.

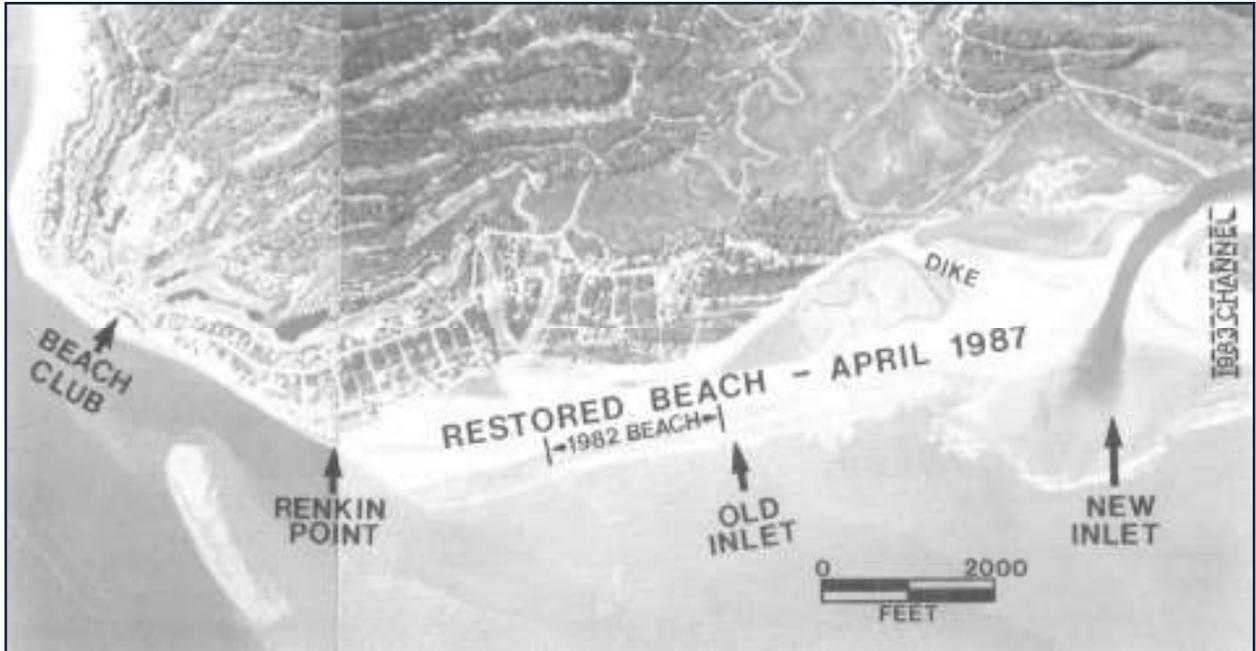
**FIGURE 5.1.2e.** Seabrook Island in April 1987 after natural restoration by inlet relocation. Area south of Renken Point remained unrestored. (Photo: Courtesy of Seabrook Island POA) [After Kana 1989]

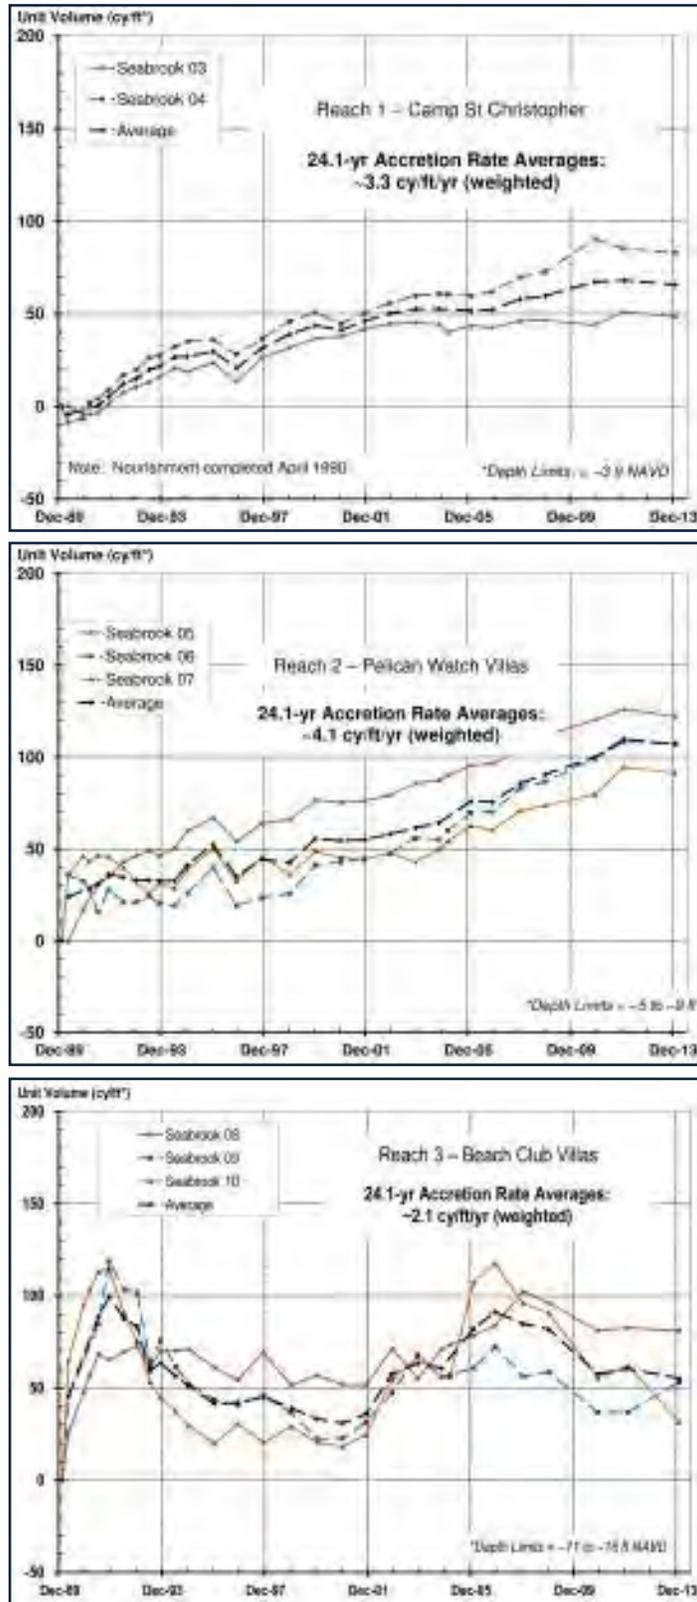
**FIGURE 5.1.2f.** Reaches 1–3 showing the 24-year average, unit-volume change rate by reach. Order of transects is from downcoast to upcoast (generally southwest to northeast). [Source: CSE 2014]

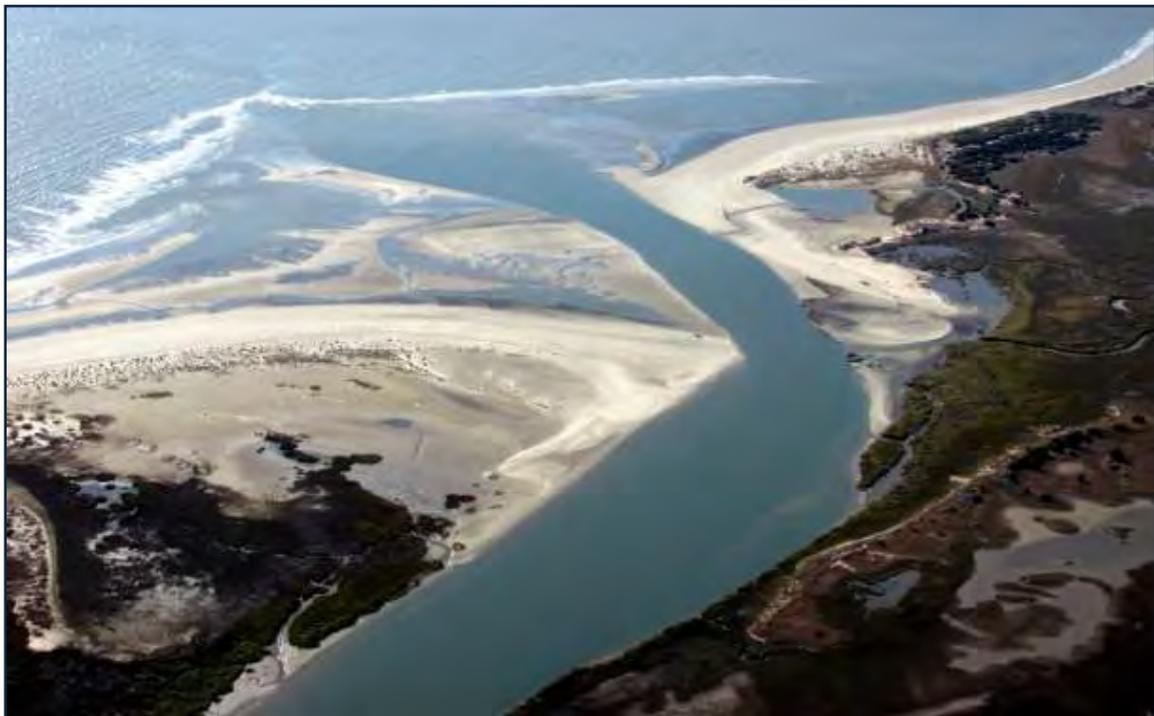
**FIGURE 5.1.2I.** [UPPER] Approximate distances from the downcoast edge of the 1996 Captain Sams Inlet to the low-water shoreline on the indicated date. The average migration rate is 160 ft/yr. [LOWER] Captain Sams Inlet in November 2013. [Source: CSE 2014]

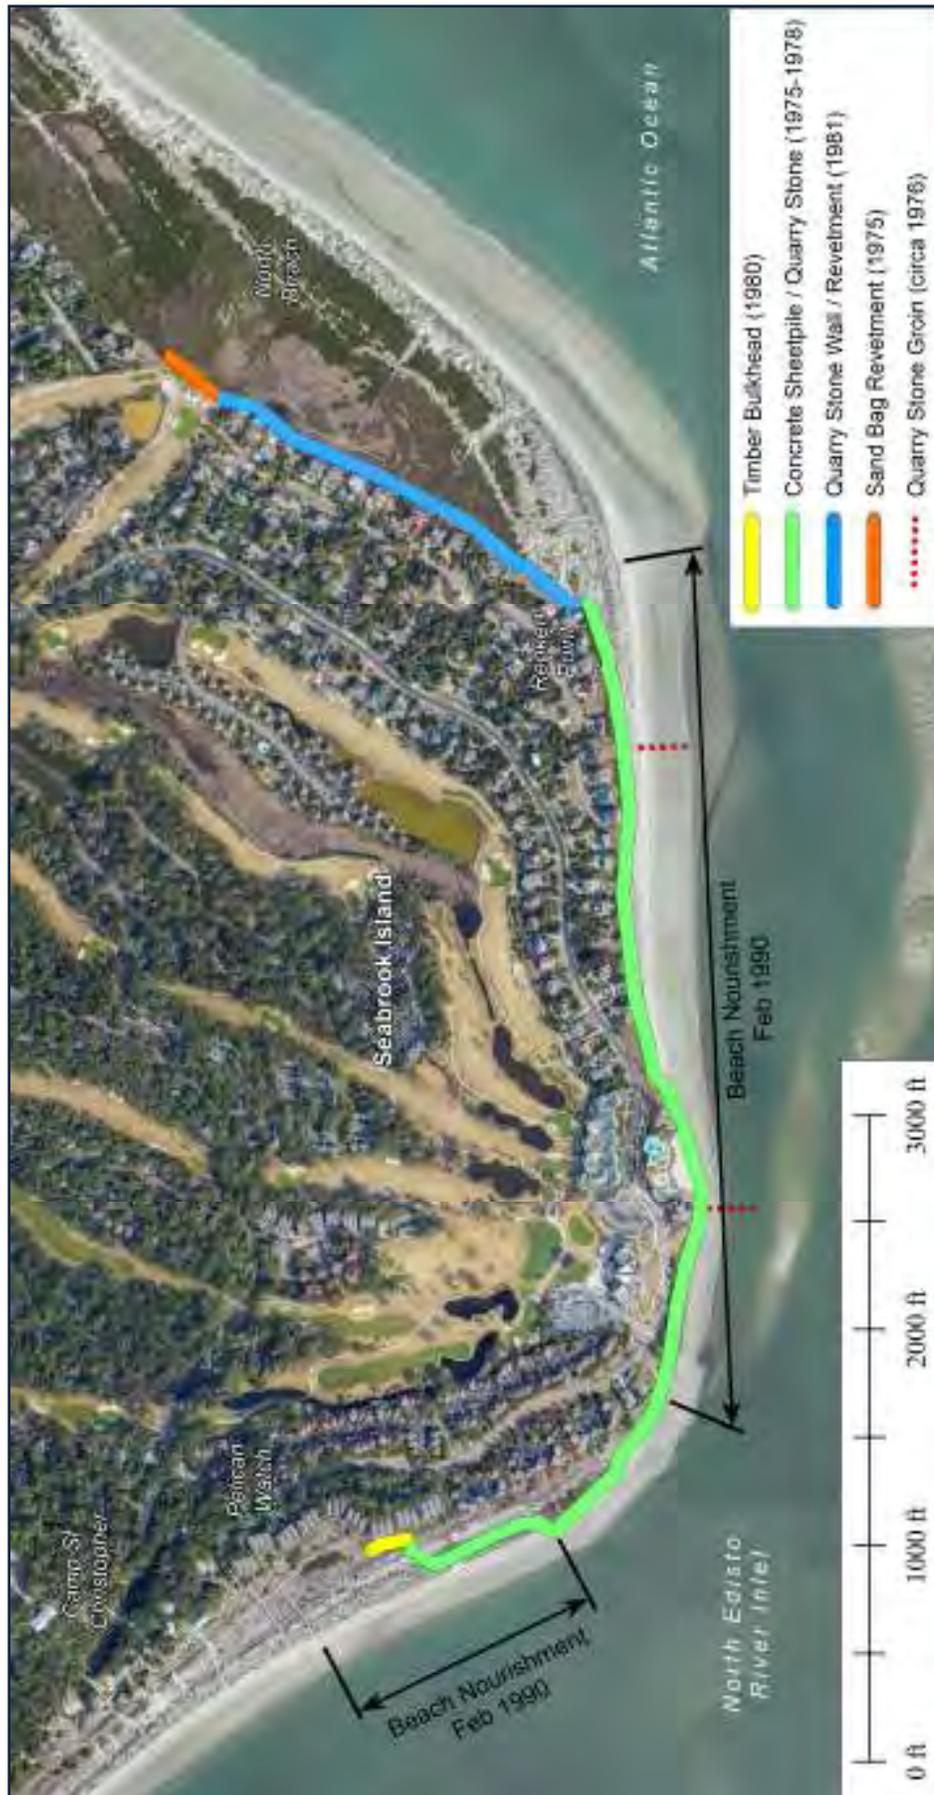
**FIGURE 5.2a** Location of shore-protection projects along Seabrook Island since the 1970s. Captain Sams Inlet relocation (1983, 1996) occurred between OCRM 2575 and the Kiawah/Seabrook Town easement line (outside image range, see Fig T-3).
