# TOWN OF SEABROOK ISLAND

**TOWN OF SEABROOK ISLAND, SC  
ORDINANCE NO. 2014-05  
ADOPTED DECEMBER 16, 2014**

**AN ORDINANCE TO ADOPT AN UPDATED COMPREHENSIVE BEACH  
MANAGEMENT PLAN FOR THE TOWN OF SEABROOK ISLAND**

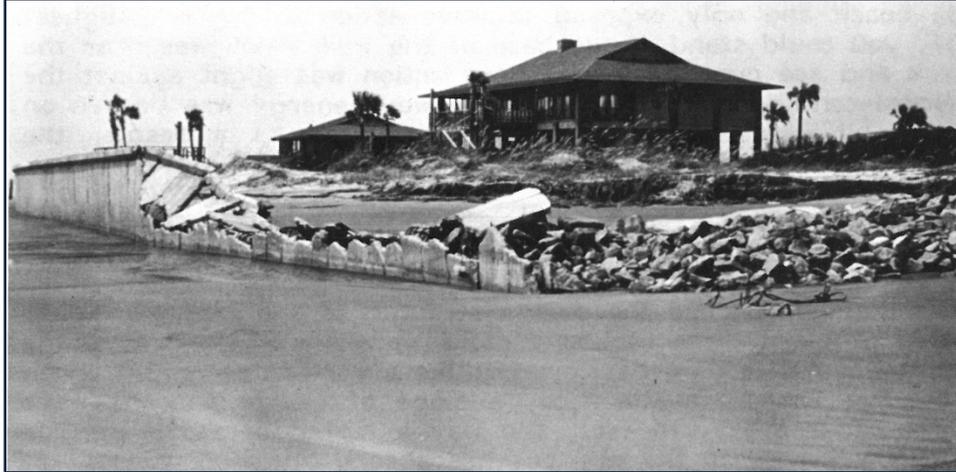
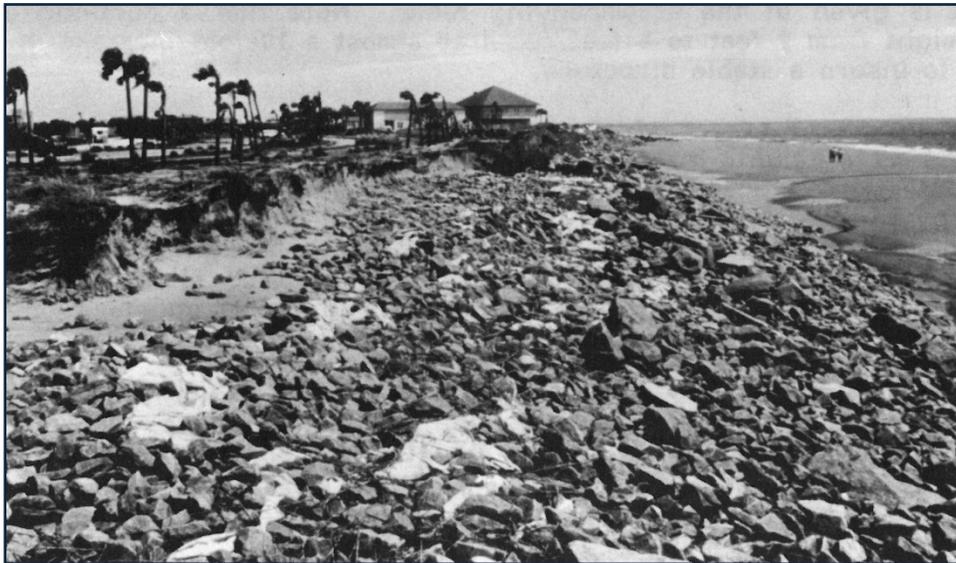
**FIGURE 5.2.3a.** Damages along Seabrook Island due to Hurricane *David* (5 September 1979). [UPPER] The concrete seawall and armor-stone “wingwall” at Renken Point on 7 September 1979. [LOWER] Collapsed riprap revetment south of the Beach Club on 5 September 1979. [Photos by WJ Sexton]

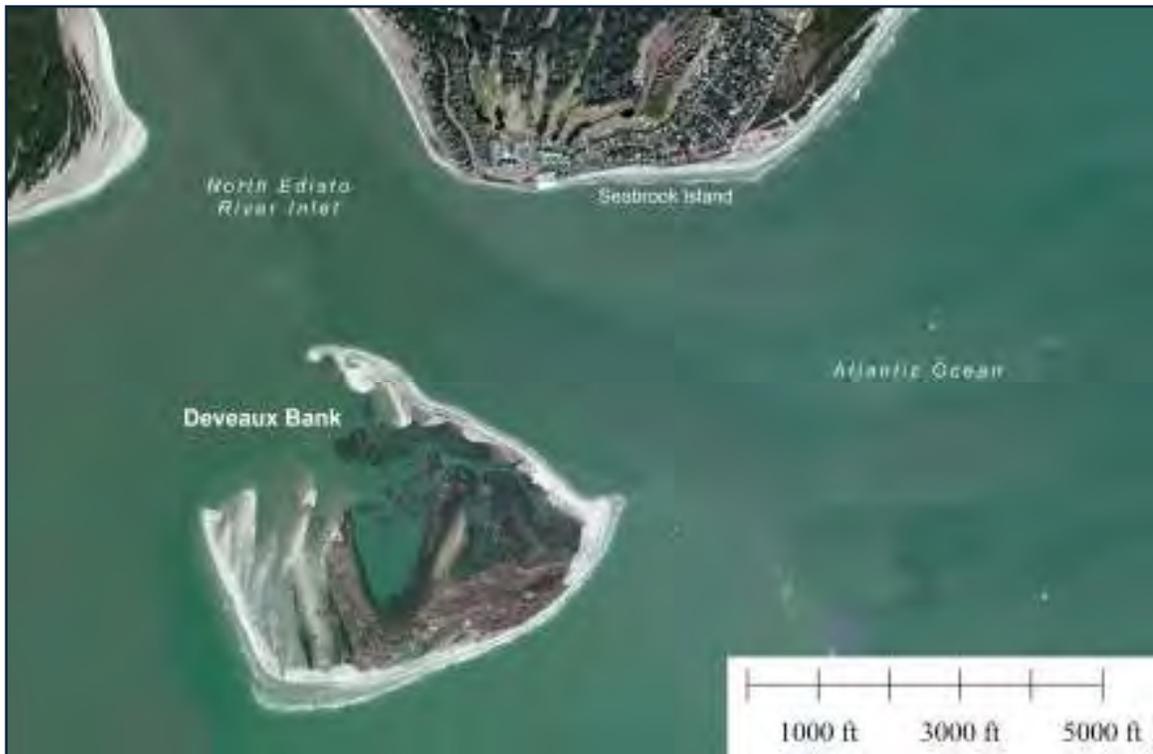
**FIGURE 5.2.3b.** Aerial photo of Deveaux Bank in 2012. Deveaux Bank is presently a well-established island, which serves as a natural breakwater to the south shoreline of Seabrook Island.

The impact of storms along Seabrook Island is partially buffered by protective shoals of the North Edisto River Inlet. Deveaux Bank is presently an island at the mouth of the inlet encompassing hundreds of acres of dunes and wetland habitat (Fig 5.2.3b). It serves to intercept waves from the south before they strike Seabrook Island's shoreline. At some times during the past 50 years, Deveaux Bank has been much smaller and offered less sheltering. For example, between 1973 and 1978, much of the emergent portion of Deveaux Bank eroded and left a remnant island further west (Fig 5.2.3c, Kana & Sexton 1982). This may have exacerbated damages during Hurricane David by allowing waves to propagate directly toward the Beach Club and Renken Point. By the mid 1980s, an emergent dune line had reformed to produce the nucleus of today's Deveaux Bank (CSE 1989).

- Deveaux Bank provides sheltering for the southern half of Seabrook Island. In 1978, only a small remnant of Deveaux Bank extended above the normal high waterline (Hayes et al 1979, Kana & Sexton 1982). With less protective shoals of Deveaux Bank, Hurricane David (September 1979) caused extensive damage to the seawall. Hayes et al (1980) recommended restoration of Deveaux Bank as one of three key soft-engineering solutions for Seabrook Island (inlet relocation and northern channel realignment were the other two). Of the three recommendations, the community implemented two and the third (Deveaux Bank restoration) occurred naturally. Today Deveaux Bank is broad and provides a one-mile-long barrier beach with well-established dunes that block waves from the south (Fig 5.2.3b).

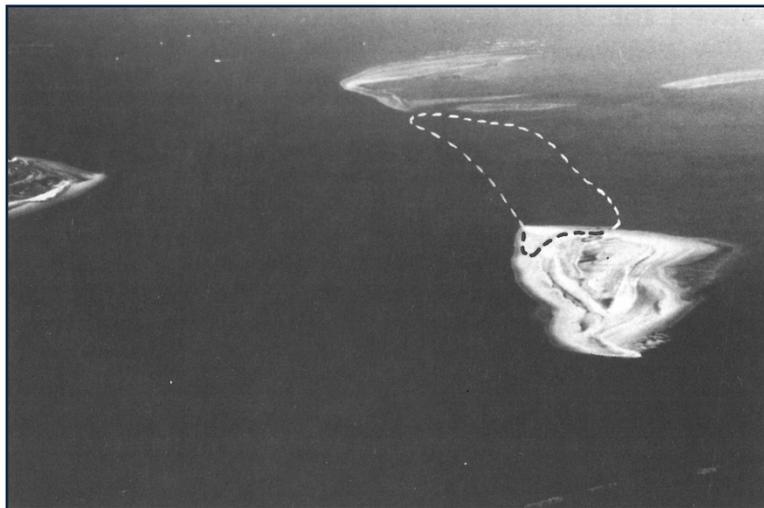
**FIGURE 5.2.3c.**

Deveaux Bank (D) off Seabrook Island in 1973 (upper), July 1978 (middle), and December 1979 (lower).
