Town of Seabrook Island
Comprehensive Beach Management Plan

Document Control

Cover/Document Version

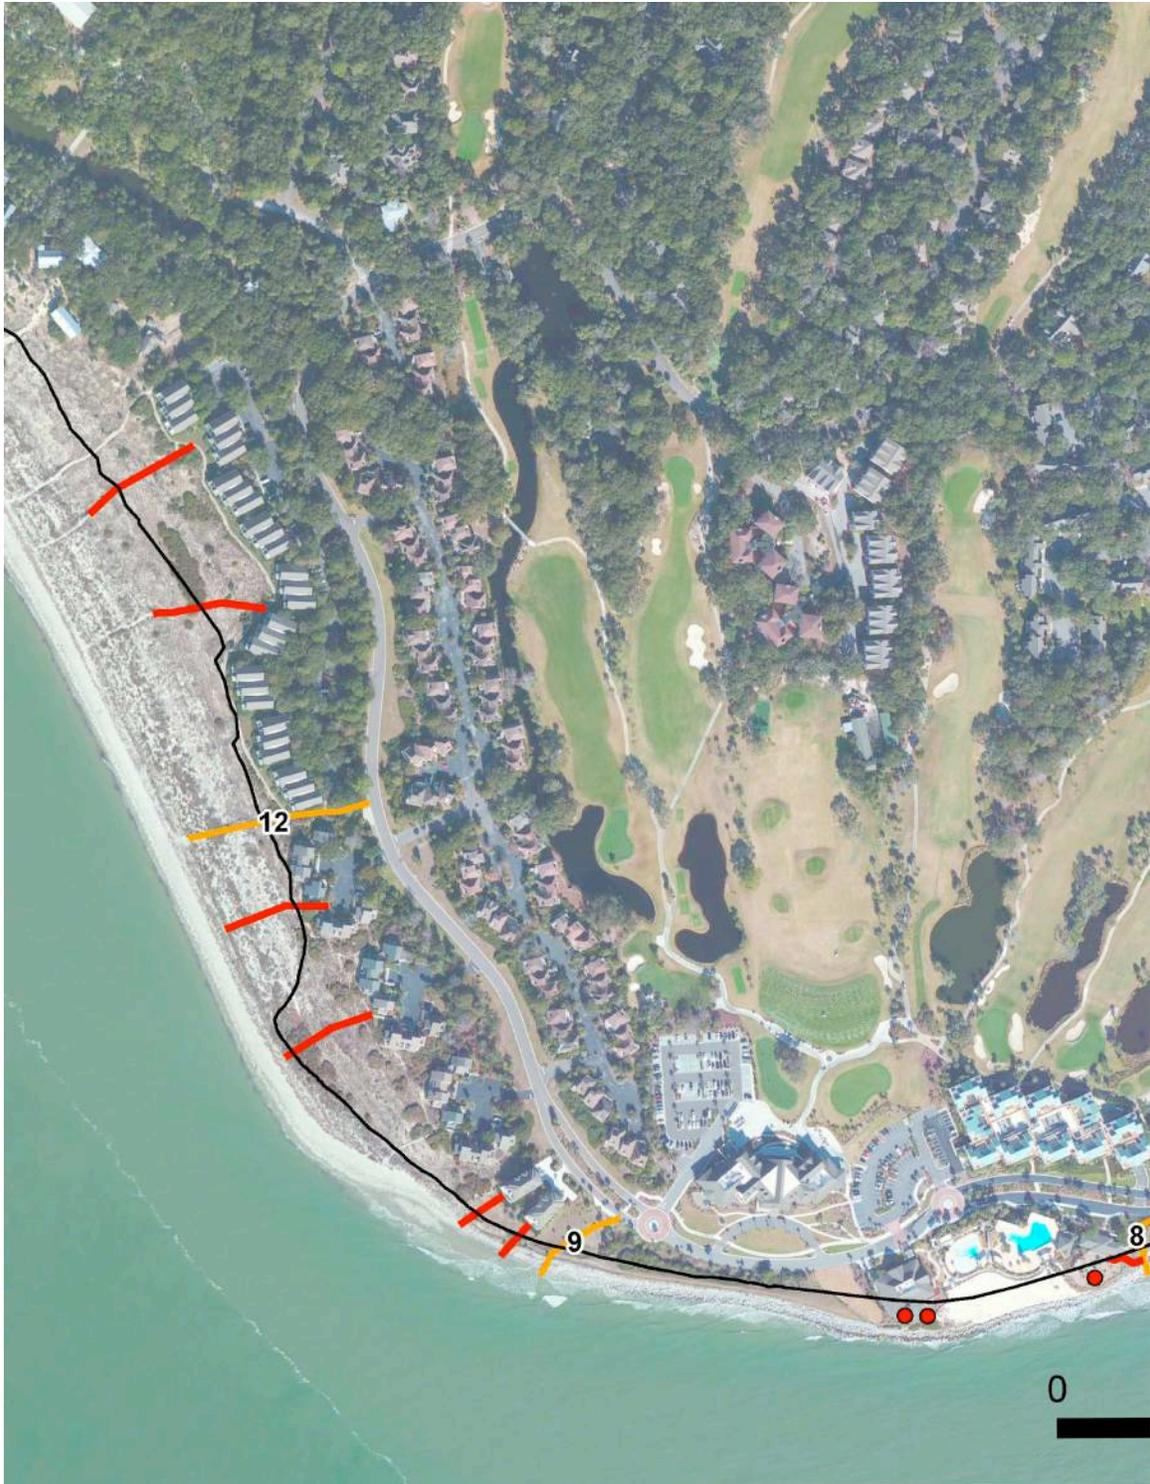
Picture 2.3.1 (a) West Seabrook Island Beach accesses and structures seaward of the Setback Line

Section 2.3.1 “Beachfront Structural Inventory” includes pictures/maps of both the public and private access points as Pictures 2.3.1 (a), (b) and (c).

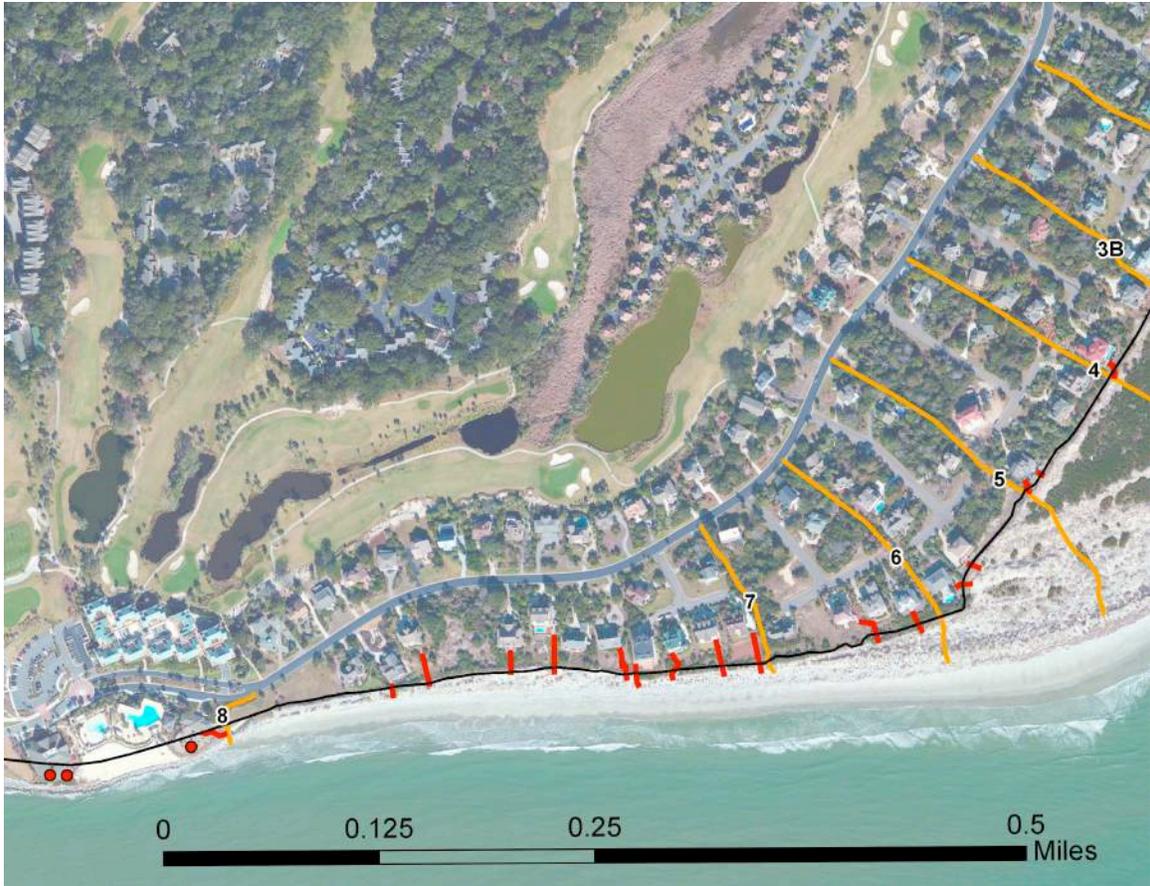
Picture/Map 2.3.1 (b) shows the Island’s beach from the Seabrook Island Club facilities to Boardwalk #5 or Renken Point.

Picture 2.3.1 (b) South Beach Seabrook Island beach accesses and structures seaward of the Setback Line

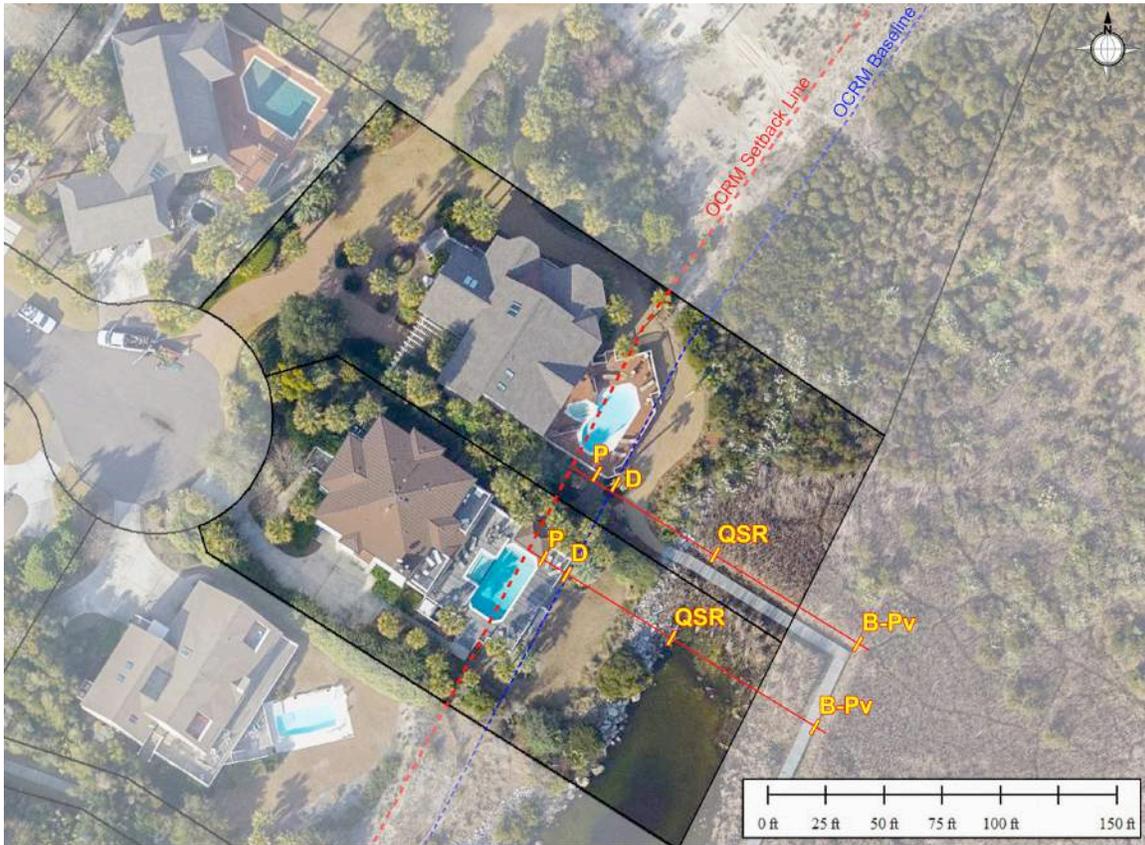
Again there are five structures that are not beach access boardwalks that are Seaward of the Setback Line. Two of the structures are swimming pools that were built before incorporation of the Town. They are both consistent with the State’s policy requiring that they be located as landward as possible of an existing, functional erosion control device. The revetment seaward of these two pools also meets this criteria. The picture below shows these two pools that are on adjacent properties on the beach end of Beachcomber Run.

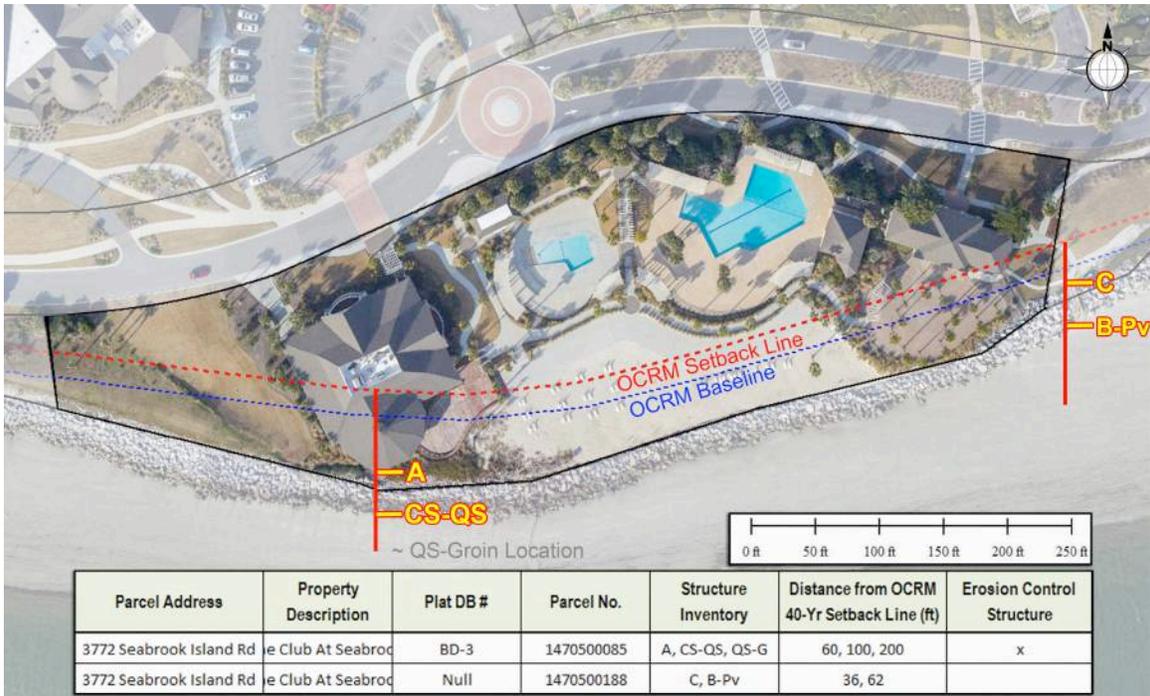
The third structure is the patio cover over the Pelican’s Nest bar and restaurant area. This structure replaced a much older, larger and less robust structure and it is less infringing on the Setback Line. When the Town approved the project and the county granted the necessary permits, this structure was landward of the setback line. Changes in the location of the Baseline and Setback Line in 2009 changed the status to seaward of the line. Another Seabrook Island Club structure seaward of the Setback Line is a special events building that has been a part of the Club facilities for many years. It was remodeled, without change to its footprint, with the overall Club facility improvements as a part of the “Horizon Plan” project in 2007. It has remained within the original footprint since it was built. The project implementing these major improvements to the Seabrook Island Club facilities that include these two structures reduced the total floor space for

Club structures seaward of the Setback Line. The picture below shows the position of these structures in relation to the current Setback Line, Baseline and to each other.

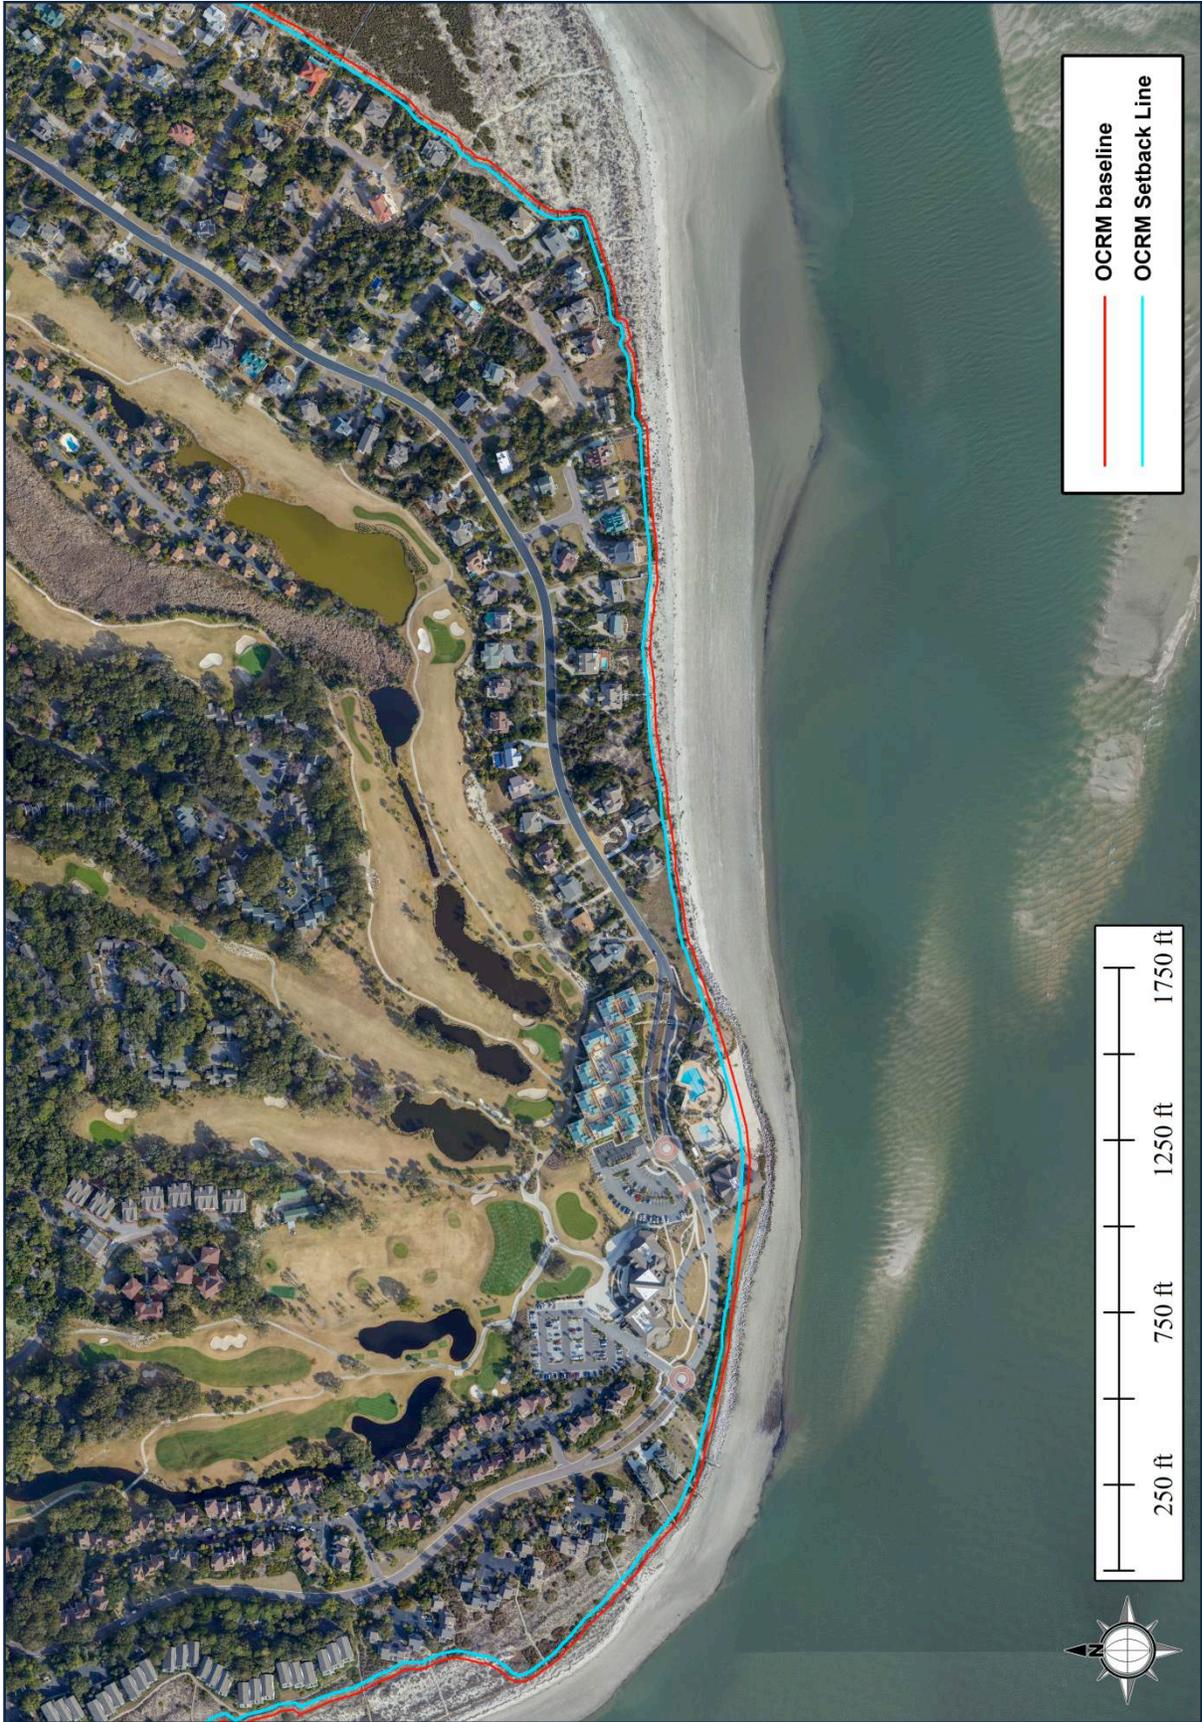
FIGURE 5.1j Official 2012 OCRM Baselines and Setback Line for a portion of Seabrook Island superimposed on a 2012 rectified aerial orthophotograph. The only structure encroached by the lines is the “Beach Club” at the lower left side of the image.

OCRM sets official erosion rates for the island and determines placement of development control lines. Figure 5.1j shows the present OCRM Baseline (set in 2012) and the OCRM Setback Line. OCRM has determined that Seabrook Island has a long-term (nominally 40-year) accretion trend. Therefore, the Setback Line is a minimum of 20 ft landward of the Baseline as prescribed under the Beach Management Act. For most of Seabrook Island, the Baseline follows the seawall (most landward shoreline during the past ~40 years). As described in Section 2.3.1 “Beachfront Structural Inventory,” only five structures encroach on the Setback Line. The official OCRM Baseline/Setback Line maps are included in Section 2.3.1 and table of coordinates are provided in Section 7.2 “Structure Inventory” of this Plan.

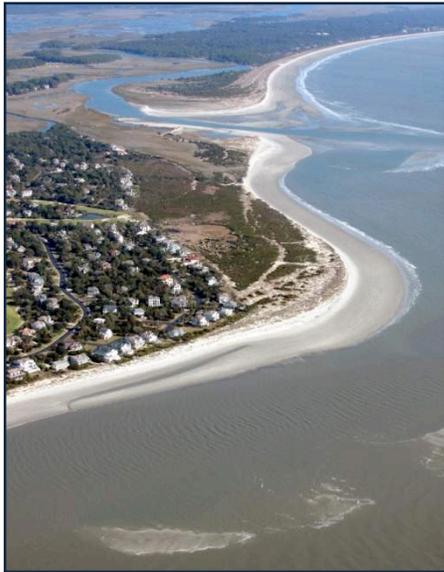
FIGURE T-1. Aerial view of Seabrook Island in November 2013.

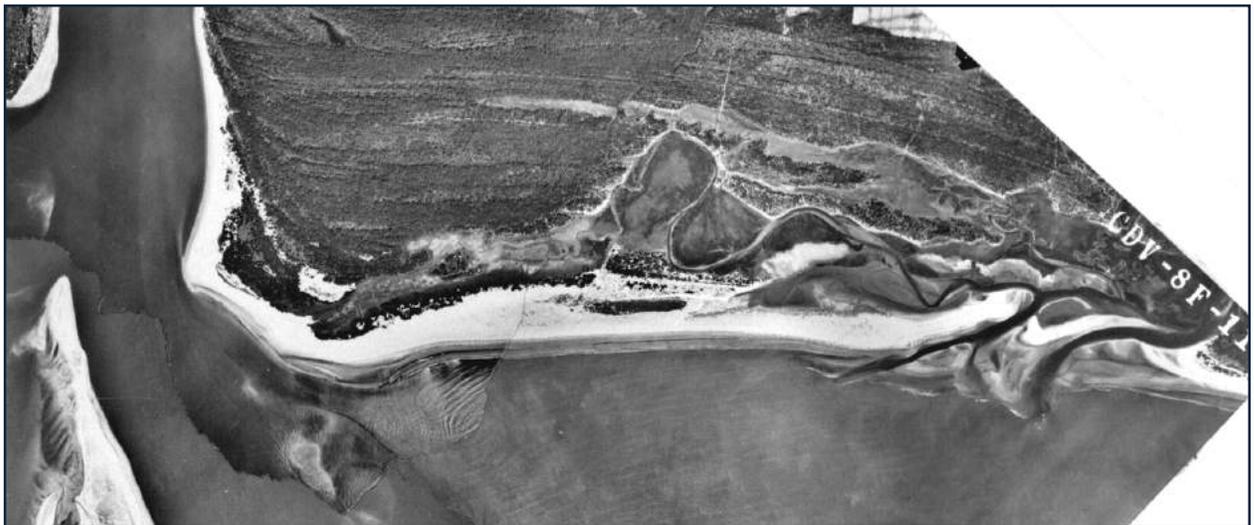
FIGURE T-2. Vertical photograph (1949) of Seabrook Island before development. Sometime in 1948, Captain Sams Inlet breached the Kiawah Spit near present-day Beachwalker Park (right side of image). The northeastern channel became dominant in the 1950s.

1948 Captain Sams Inlet breaches the Kiawah Spit near present-day Beachwalker Park, creating multiple channels. A single channel becomes dominant by early 1950s (Fig T-2).

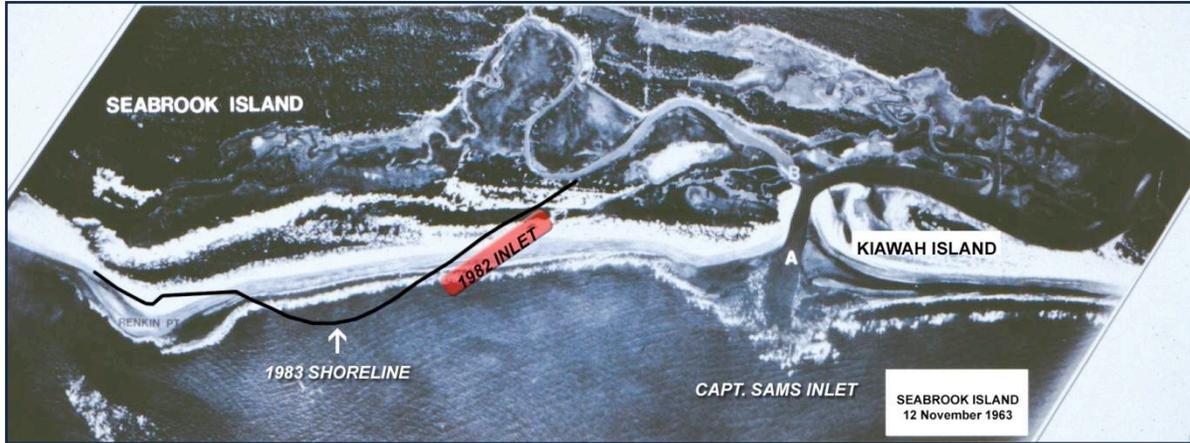
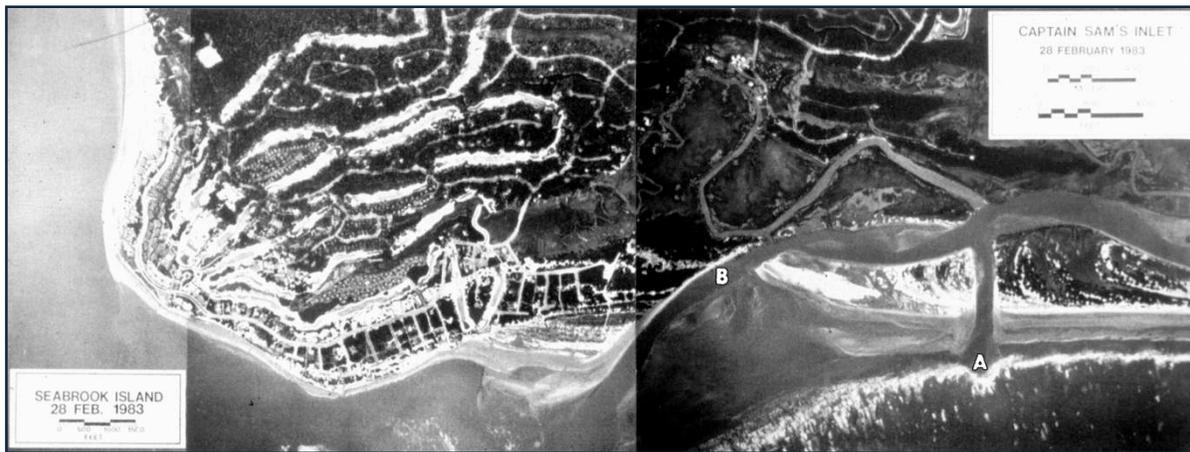
FIGURE T-3. Seabrook Island and Captain Sams Inlet in 1963 (upper) and 1983 (lower). The 1963 condition served as a model for the plan to relocate Captain Sams Inlet. Lower photo shows the new channel (A) open before the old channel (B) was closed on 4 March 1983.

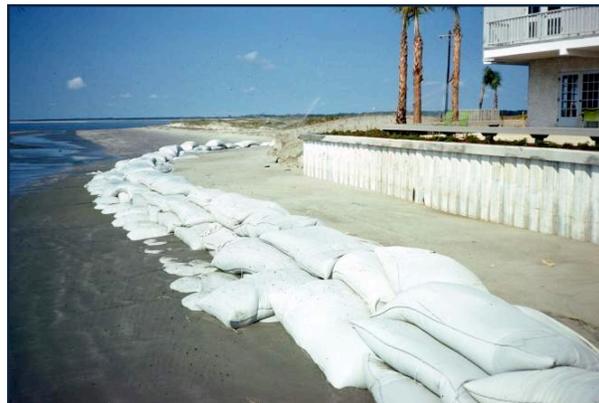
FIGURE T-4. Shore-protection structures at the Beach Club in September 1974 prior to the club's opening.

1974 Erosion impacts the Beach Club before construction is complete. First shore-protection measures consist of large sand bags, sandbag groins, and sheet-pile bulkheads (Fig T-4).

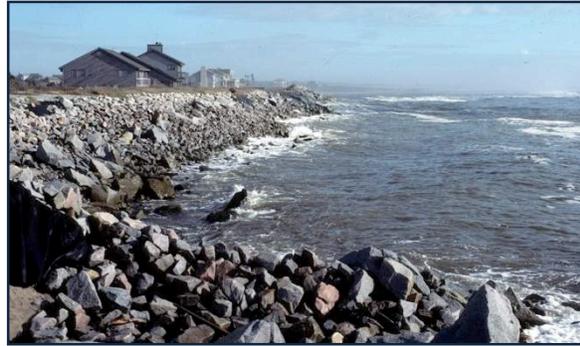
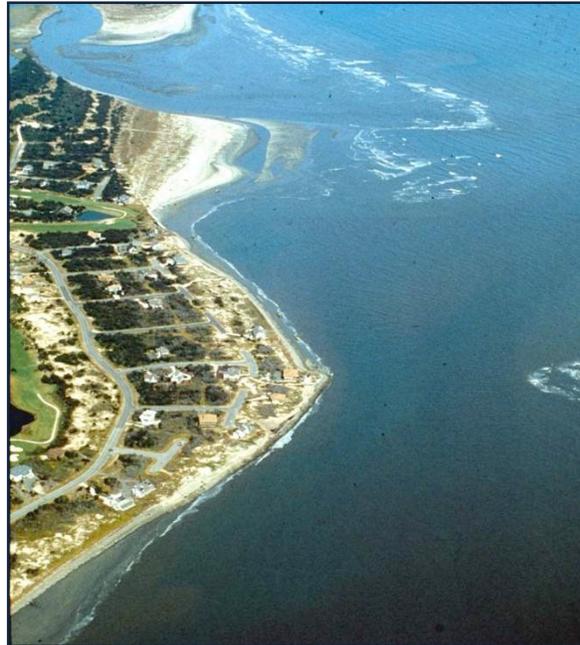
FIGURE T-5. During the early 1980s, much of Seabrook lacked any beach even at low tide. [UPPER] View north from Renken Point at mid tide. [LOWER] Oblique aerial (1982) looking north at low tide showing no beach around Renken Point.

1975–1981 Succession of sandbag revetments, timber and concrete bulkheads/seawalls, and quarry-stone revetments are installed along Seabrook Island between Pelican Watch Villas and the 13th fairway of the golf course (~2 miles). Individual property owners are generally responsible for the cost of shore-protection structures that, by the late 1980s, totals over \$5 million for the island (Fig T-5).

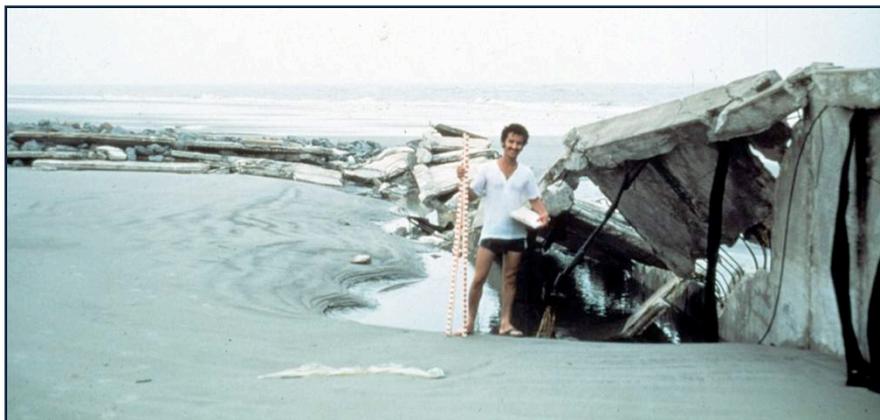
FIGURE T-6. Collapse of the concrete seawall at Renken Point in September 1979 during Hurricane *David*.

SEP 1979 Hurricane *David* causes extensive damage to the seawall (Fig T-6). Mouth of Captain Sams Inlet is near the Oyster Catcher beach access. Seabrook Island’s only dry beach areas are a 2000-ft reach around Oyster Catcher and the North Edisto Inlet shoreline along Pelican Watch Villas.

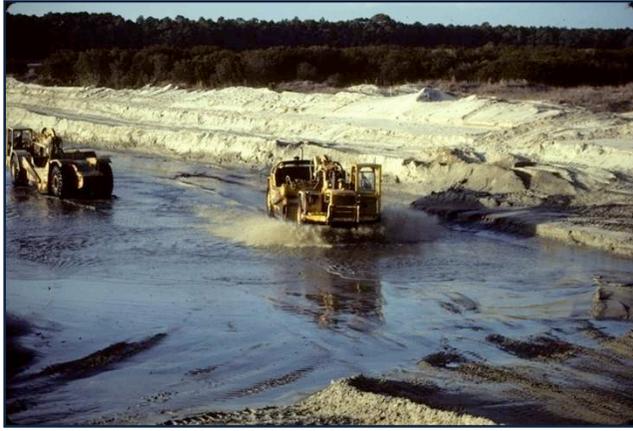
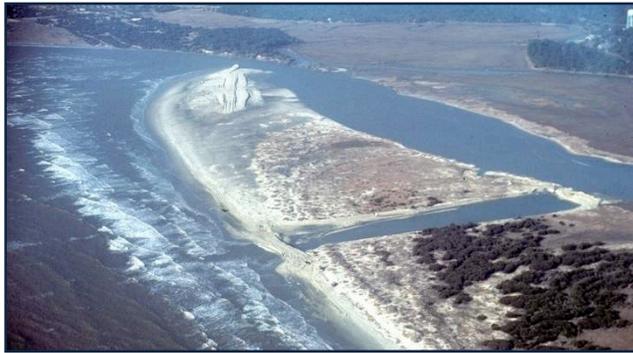
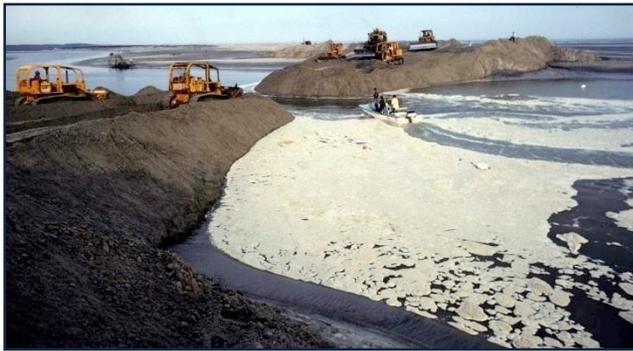
FIGURE T-7. February-March 1983.

[UPPER] Excavation of the basin for the new channel by land-based equipment.

MAR 1983 First relocation of Captain Sams Inlet ~1.5 miles north to its 1963 position. Old inlet closed by trucks hauling sand from the new channel basin. Cost of project is (~)\$300,000 (Fig T-7).

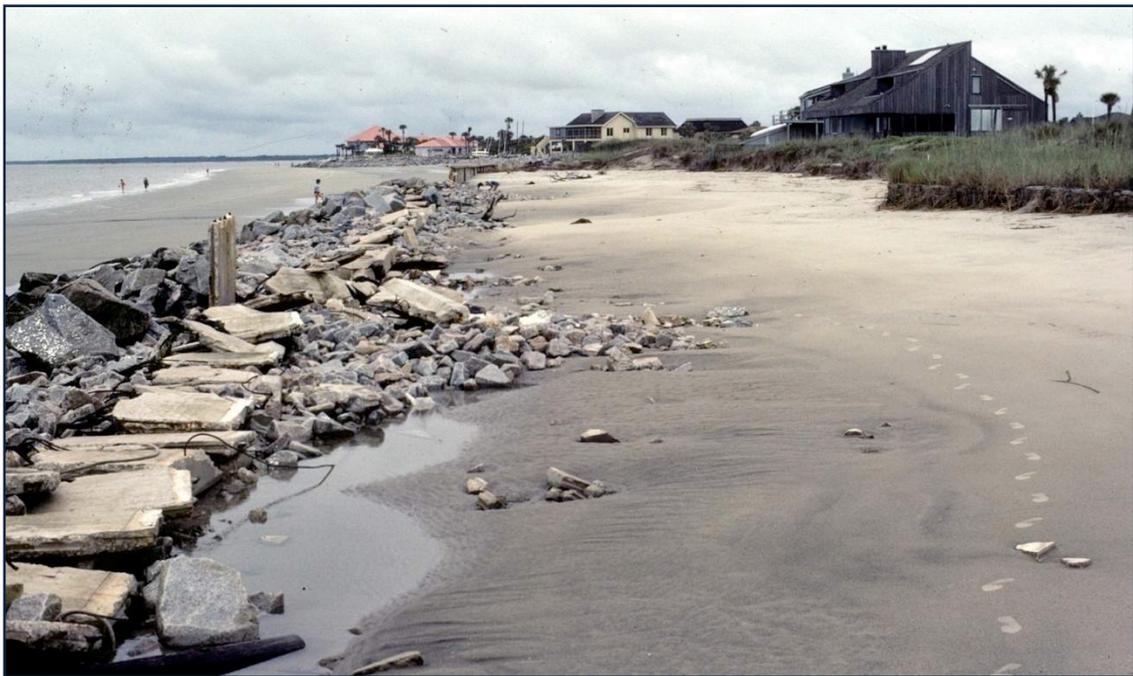
FIGURE T-8. [UPPER] Encroachment of the northern channel (deep blue area) of North Edisto Inlet and lack of maintenance leads to [LOWER] collapse of a section of seawall near Beach Court in 1983.

1980s Several sections of the seawall (south of Renken Point) breach during minor storm events (Fig T-8). No new sand reaches Beach Club Villas or Pelican Watch Villas for nearly a decade, causing loss of the dry beach.

1989 The northern channel of North Edisto Inlet is forced shoreward by the shoal off Renken Point, causing dangerous encroachment along the seawall (Fig T-8). At Amberjack Court, the channel 50 ft from the wall is 22 ft deep. Property owners continue to add rock in this area to shore up the seawall.

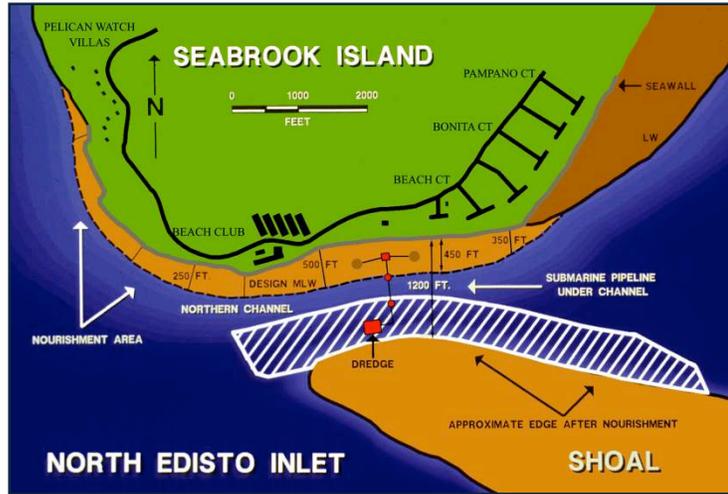
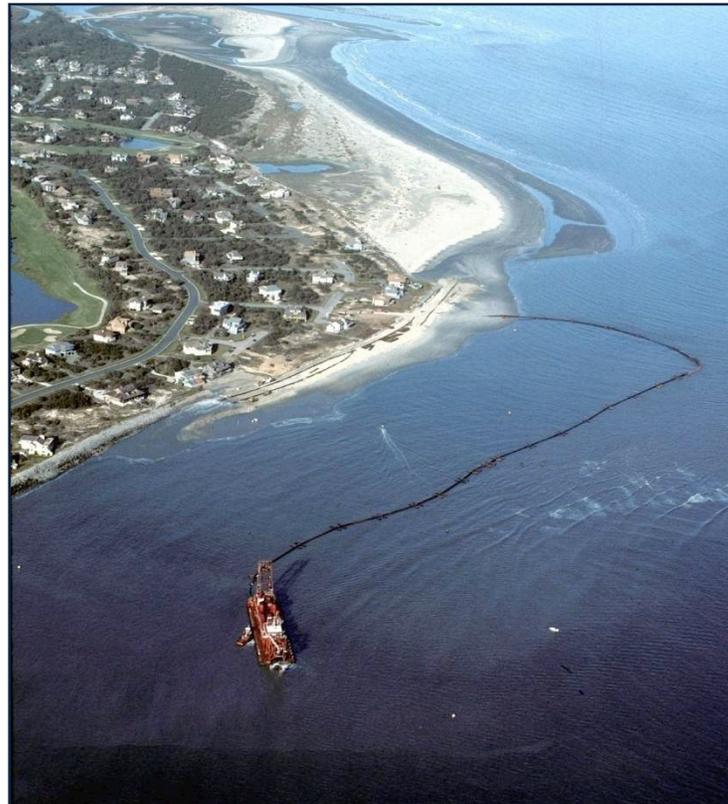
FIGURE T-9. [UPPER] 1989 plan for realignment of the northern channel and nourishment south of Renken Point. [LOWER] Start of dredging operations in February 1990 at Renken Point.

FEB 1990 The northern channel is realigned by an ocean-going dredge (Great Lakes Dredge & Dock Company – dredge *Illinois*) that builds a parallel channel 600 ft seaward while filling the existing channel along the seawall (Fig T-9). The project adds 685,000 cubic yards to the beach between Renken Point and Pelican Watch Villas. A narrow dry beach exists south of Renken Point for less than one year before the project adjusts. A narrow wet-sand beach persists through the 1990s, giving the seawall protection. Cost of nourishment project is \$1.6 million.

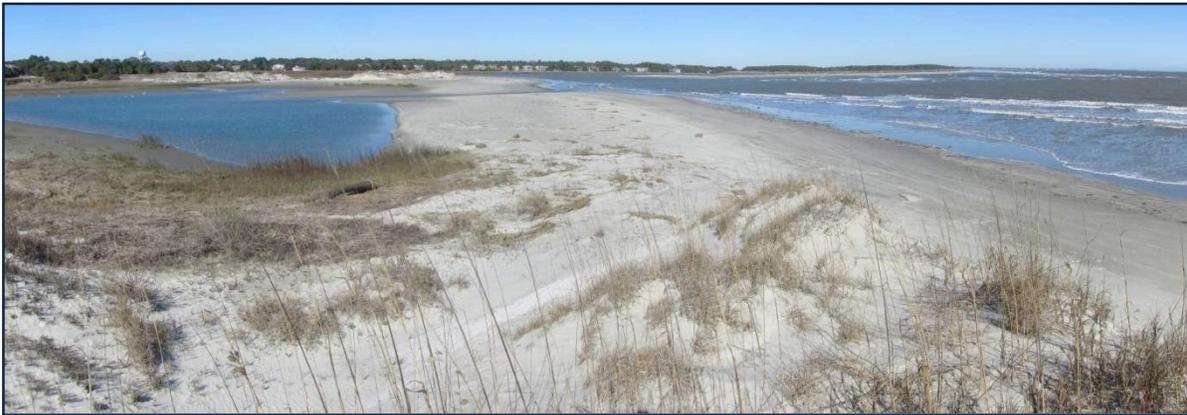
FIGURE T-11. Composite image of Captain Sams Inlet area from the Seabrook side in January 2014. The lagoon formed in the abandoned 1996 channel is on the left side of the image.

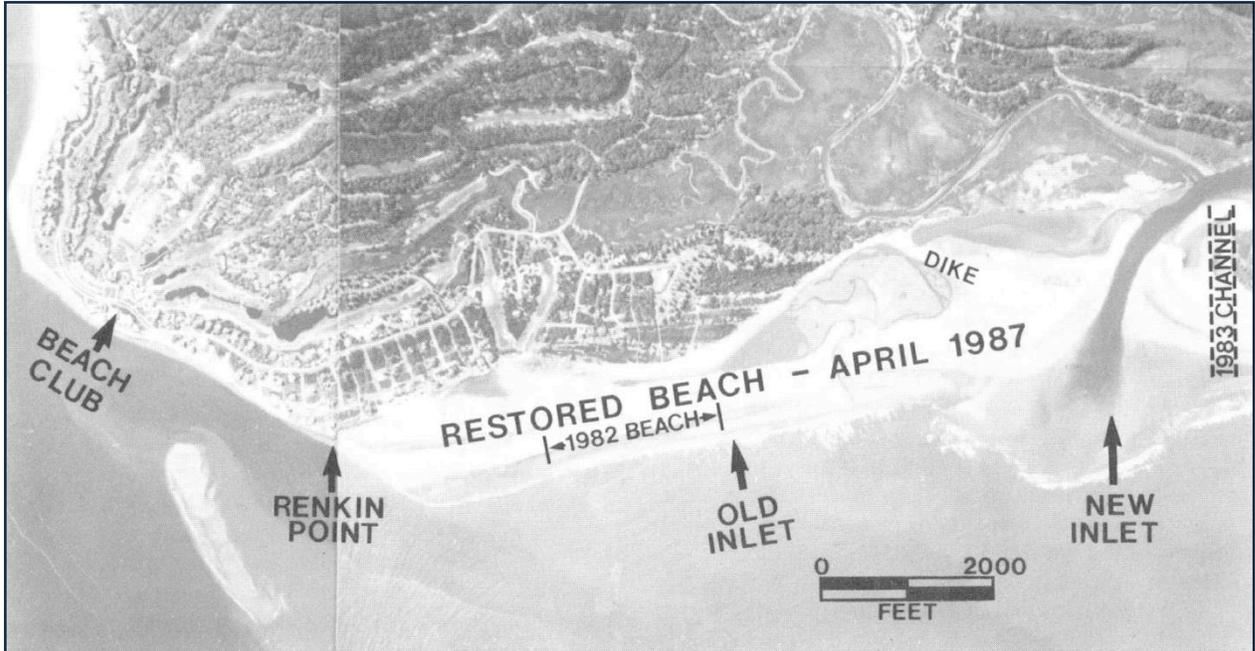
FIGURE 5.1.2e. Seabrook Island in April 1987 after natural restoration by inlet relocation. Area south of Renken Point remained unrestored. (Photo: Courtesy of Seabrook Island POA) [After Kana 1989]

Figure 5.1.2d shows the impact of the 1983 inlet relocation along North Beach between February 1983 and January 1987. Soon after the old inlet was closed by a sand dike, the shoals of the ebb-tidal delta coalesced into intertidal sand bars and migrated onshore. By late 1984, the bars attached to the beach and began spreading downcoast, finally reaching Renken Point (OCRM 2540—promontory at lower left corner of each image) by January 1987. Conditions in April 1987 are shown in Figure 5.1.2e (source: Kana 1989).

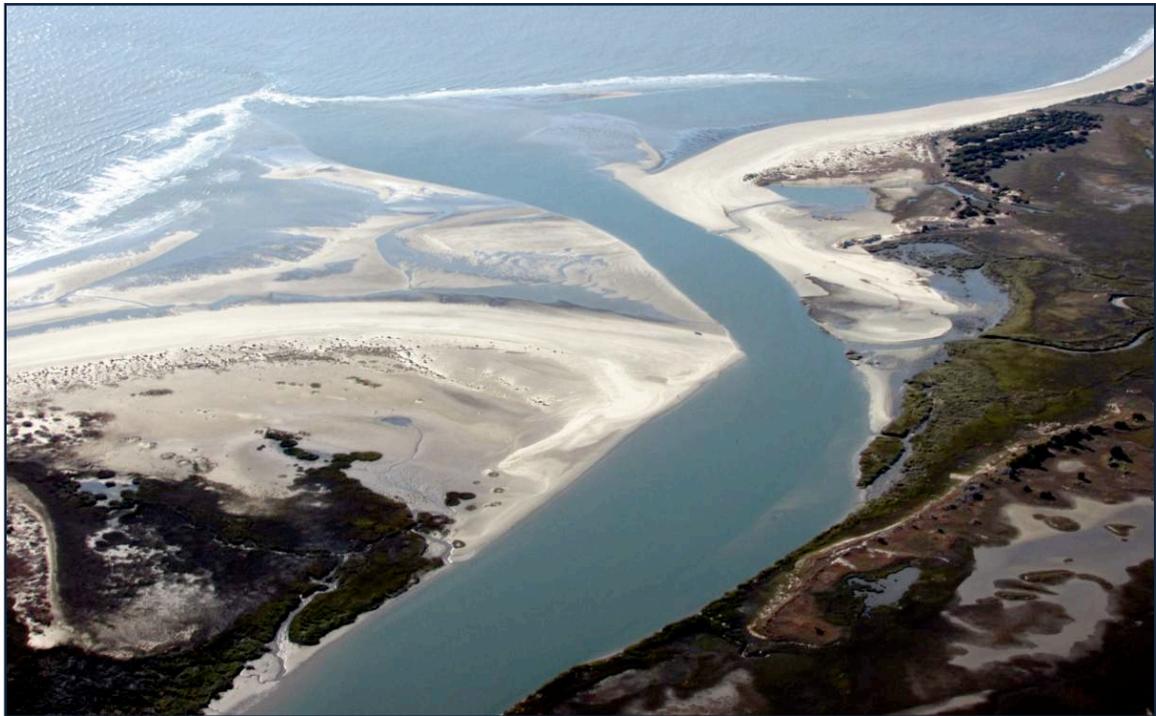
FIGURE 5.1.2I. [UPPER] Approximate distances from the downcoast edge of the 1996 Captain Sams Inlet to the low-water shoreline on the indicated date. The average migration rate is 160 ft/yr. [LOWER] Captain Sams Inlet in November 2013. [Source: CSE 2014]

Captain Sams Inlet migrates (north) east to (south) west due to spit growth under the influence of net longshore transport (Hayes et al 1979, Kana & Mason 1988, CSE 2009, Kana et al 2013) (Fig 5.1.2l, upper). Prior to the 1983 inlet relocation, average annual migration rates were around 200–225 ft/yr (Hayes et al 1979). The rate of migration since the 1996 relocation has averaged 160 ft/yr. The rate of inlet migration is faster at the ocean end of the channel than the river end because of the natural tendency for the new channel to rotate south over time. When relocated, the channel typically discharges directly offshore, perpendicular to the strand line. As it migrates toward Seabrook Island, it tends to rotate and discharge obliquely to the strand. This demonstrates the dominant

Figure 5.1.21 (upper) shows the rates of channel migration along 15 shore-parallel channel sections. The average rate of migration the first decade after inlet relocation was ~135 ft/yr. Since 2006, the rate has accelerated to ~180 ft/yr. This acceleration is due to channel rotation as well as the increasing dominance of south (westerly) sand transport. The further south Captain Sams Inlet migrates, the more it is sheltered by the shoals of the North Edisto River Inlet. Waves from the south diminish and have less effect than conditions when the inlet is situated further upcoast along the Kiawah Spit. As Hayes et al (1979) demonstrated, variations in longshore transport around the shoals of inlets accounts for the varying and cyclic shoreline changes along the beach.

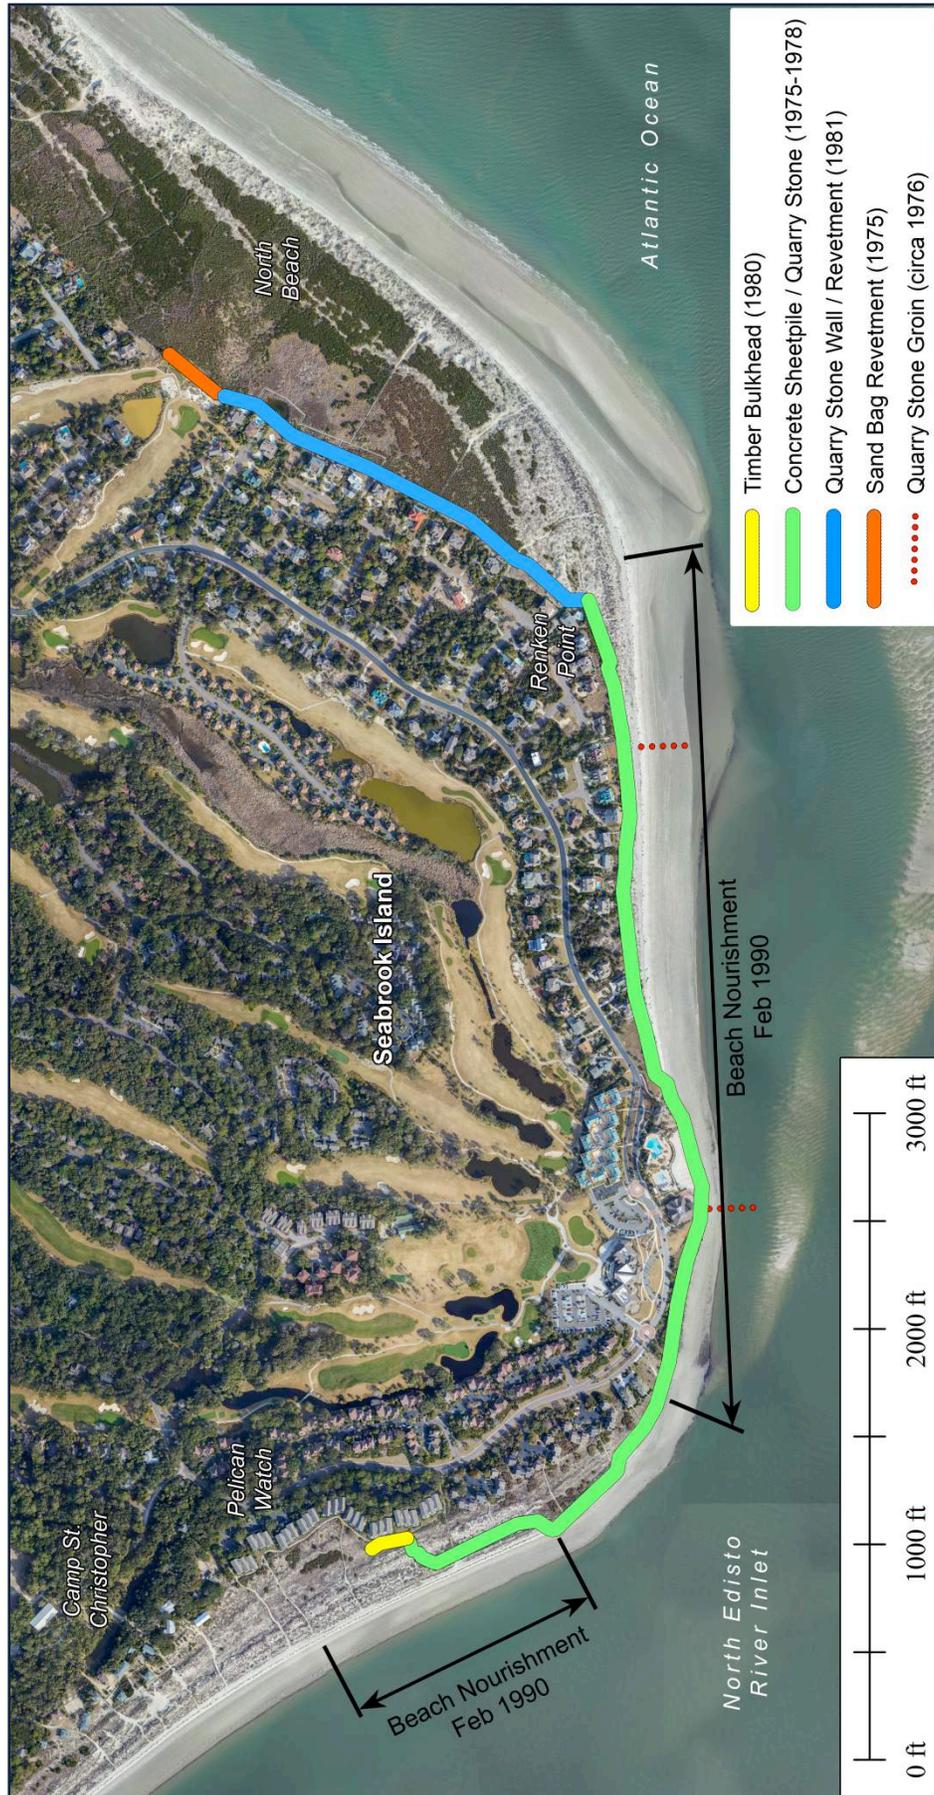
FIGURE 5.2a Location of shore-protection projects along Seabrook Island since the 1970s. Captain Sams Inlet relocation (1983, 1996) occurred between OCRM 2575 and the Kiawah/Seabrook Town easement line (outside image range, see Fig T-3).

Since 1984, there has been one nourishment (channel realignment) project via hydraulic dredge (February 1990), a second relocation of Captain Sams Inlet (April 1996) and several transfers of sand by trucks from accreting zones around Captain Sams Inlet to the area south of Renken Point. Figure 5.2a highlights the location of various erosion control structures along Seabrook Island. Sandbag and quarry-stone groins were short-lived and became non-functional within a couple of years after installation (Hayes et al 1979). Therefore, no shore-perpendicular structures have interrupted sand flow along the Seabrook Island beach since ~1980s.

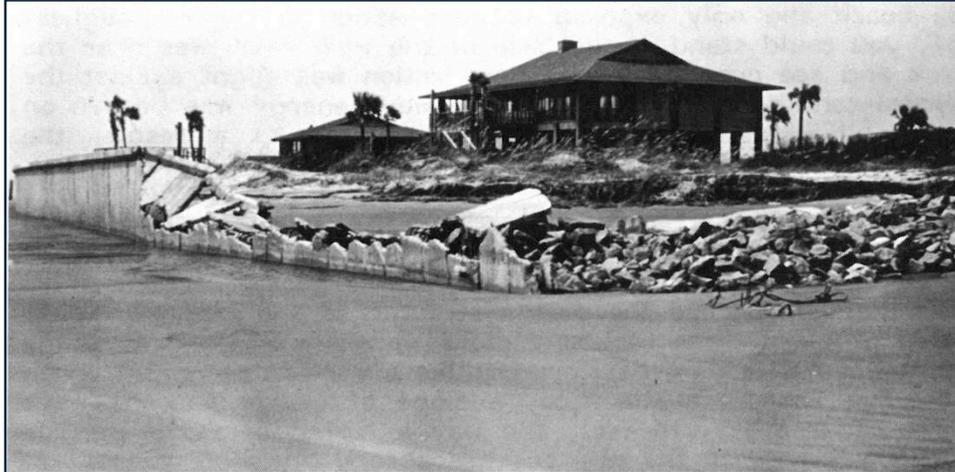
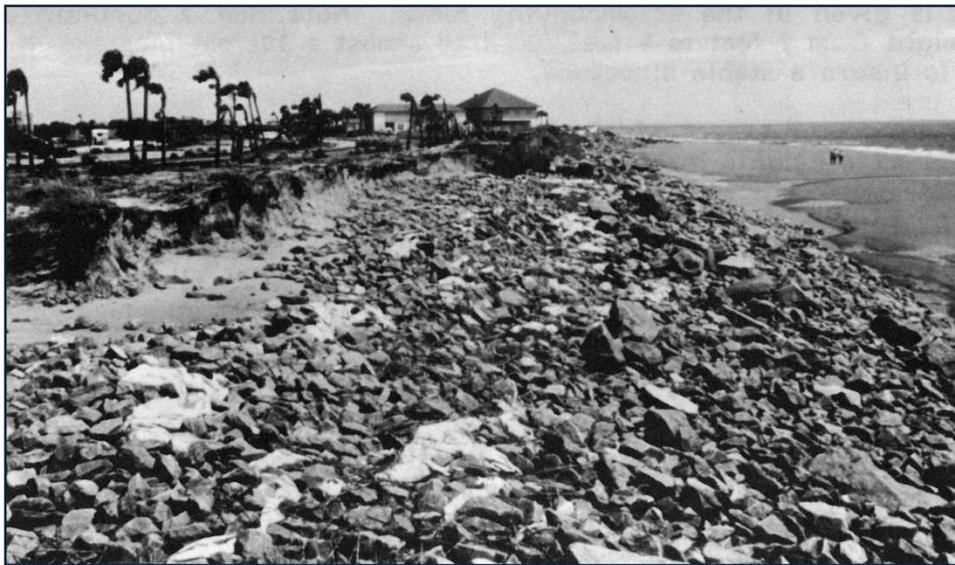
FIGURE 5.2.3a. Damages along Seabrook Island due to Hurricane *David* (5 September 1979). [UPPER] The concrete seawall and armor-stone “wingwall” at Renken Point on 7 September 1979. [LOWER] Collapsed riprap revetment south of the Beach Club on 5 September 1979. [Photos by WJ Sexton]

Over the past 40 years, only one hurricane has caused significant damage along the oceanfront. Hurricane David (September 1979) generated high waves that propagated from the south, crossed the shoals of Deveaux Bank, and severely damaged the seawall in the vicinity of the Beach Club and Renken Point (Fig 5.2.3a). A section of the seawall breached and armor stone was washed across Seabrook Island Road in the event (R Cowan, pers comm, September 1979). This led to reconstruction of the sand dike to a higher elevation and addition of new, larger armor stone along the seaward face of the structure. Prior to David, concrete sheet-pile bulkheads and “riprap” revetments were commonly constructed with a crest elevation around +10 ft NGVD (approximate +9.0 ft NAVD). As the beach eroded along the seawall in the 1970s and 1980s; wave heights and run-up increased at the wall. This led to ad-hoc improvements by property owners at various levels of structural support (Katmarian 1995a,b)

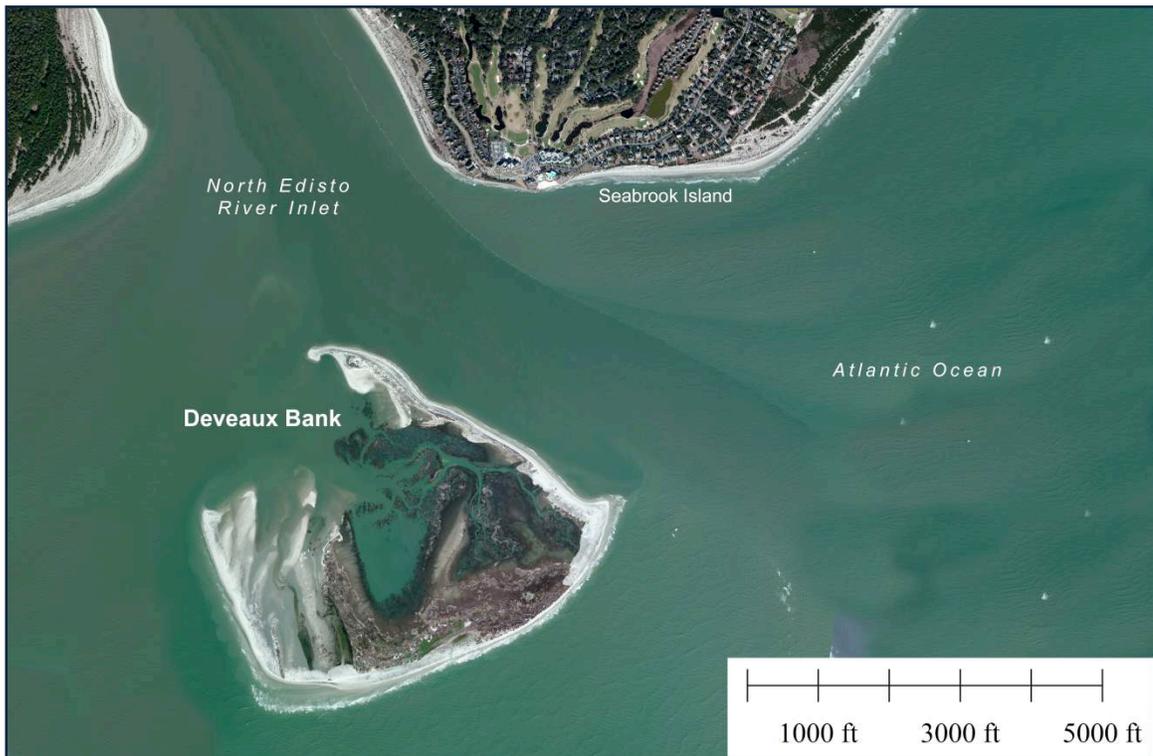
FIGURE 5.2.3b. Aerial photo of Deveaux Bank in 2012. Deveaux Bank is presently a well-established island, which serves as a natural breakwater to the south shoreline of Seabrook Island.

The impact of storms along Seabrook Island is partially buffered by protective shoals of the North Edisto River Inlet. Deveaux Bank is presently an island at the mouth of the inlet encompassing hundreds of acres of dunes and wetland habitat (Fig 5.2.3b). It serves to intercept waves from the south before they strike Seabrook Island's shoreline. At some times during the past 50 years, Deveaux Bank has been much smaller and offered less sheltering. For example, between 1973 and 1978, much of the emergent portion of Deveaux Bank eroded and left a remnant island further west (Fig 5.2.3c, Kana & Sexton 1982). This may have exacerbated damages during Hurricane David by allowing waves to propagate directly toward the Beach Club and Renken Point. By the mid 1980s, an emergent dune line had reformed to produce the nucleus of today's Deveaux Bank (CSE 1989).

- Deveaux Bank provides sheltering for the southern half of Seabrook Island. In 1978, only a small remnant of Deveaux Bank extended above the normal high waterline (Hayes et al 1979, Kana & Sexton 1982). With less protective shoals of Deveaux Bank, Hurricane David (September 1979) caused extensive damage to the seawall. Hayes et al (1980) recommended restoration of Deveaux Bank as one of three key soft-engineering solutions for Seabrook Island (inlet relocation and northern channel realignment were the other two). Of the three recommendations, the community implemented two and the third (Deveaux Bank restoration) occurred naturally. Today Deveaux Bank is broad and provides a one-mile-long barrier beach with well-established dunes that block waves from the south (Fig 5.2.3b).

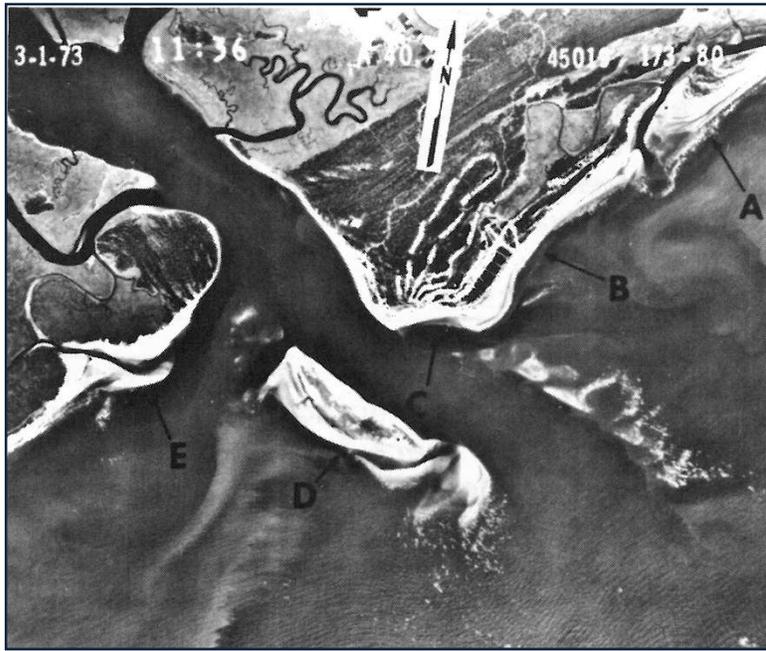
FIGURE 5.2.3c.

Deveaux Bank (D) off Seabrook Island in 1973 (upper), July 1978 (middle), and December 1979 (lower).
